**DRAFT FINAL
FINDING OF SUITABILITY TO TRANSFER**

Fort Monmouth, New Jersey

Fort Monmouth, Charles Wood Area

August, 2013

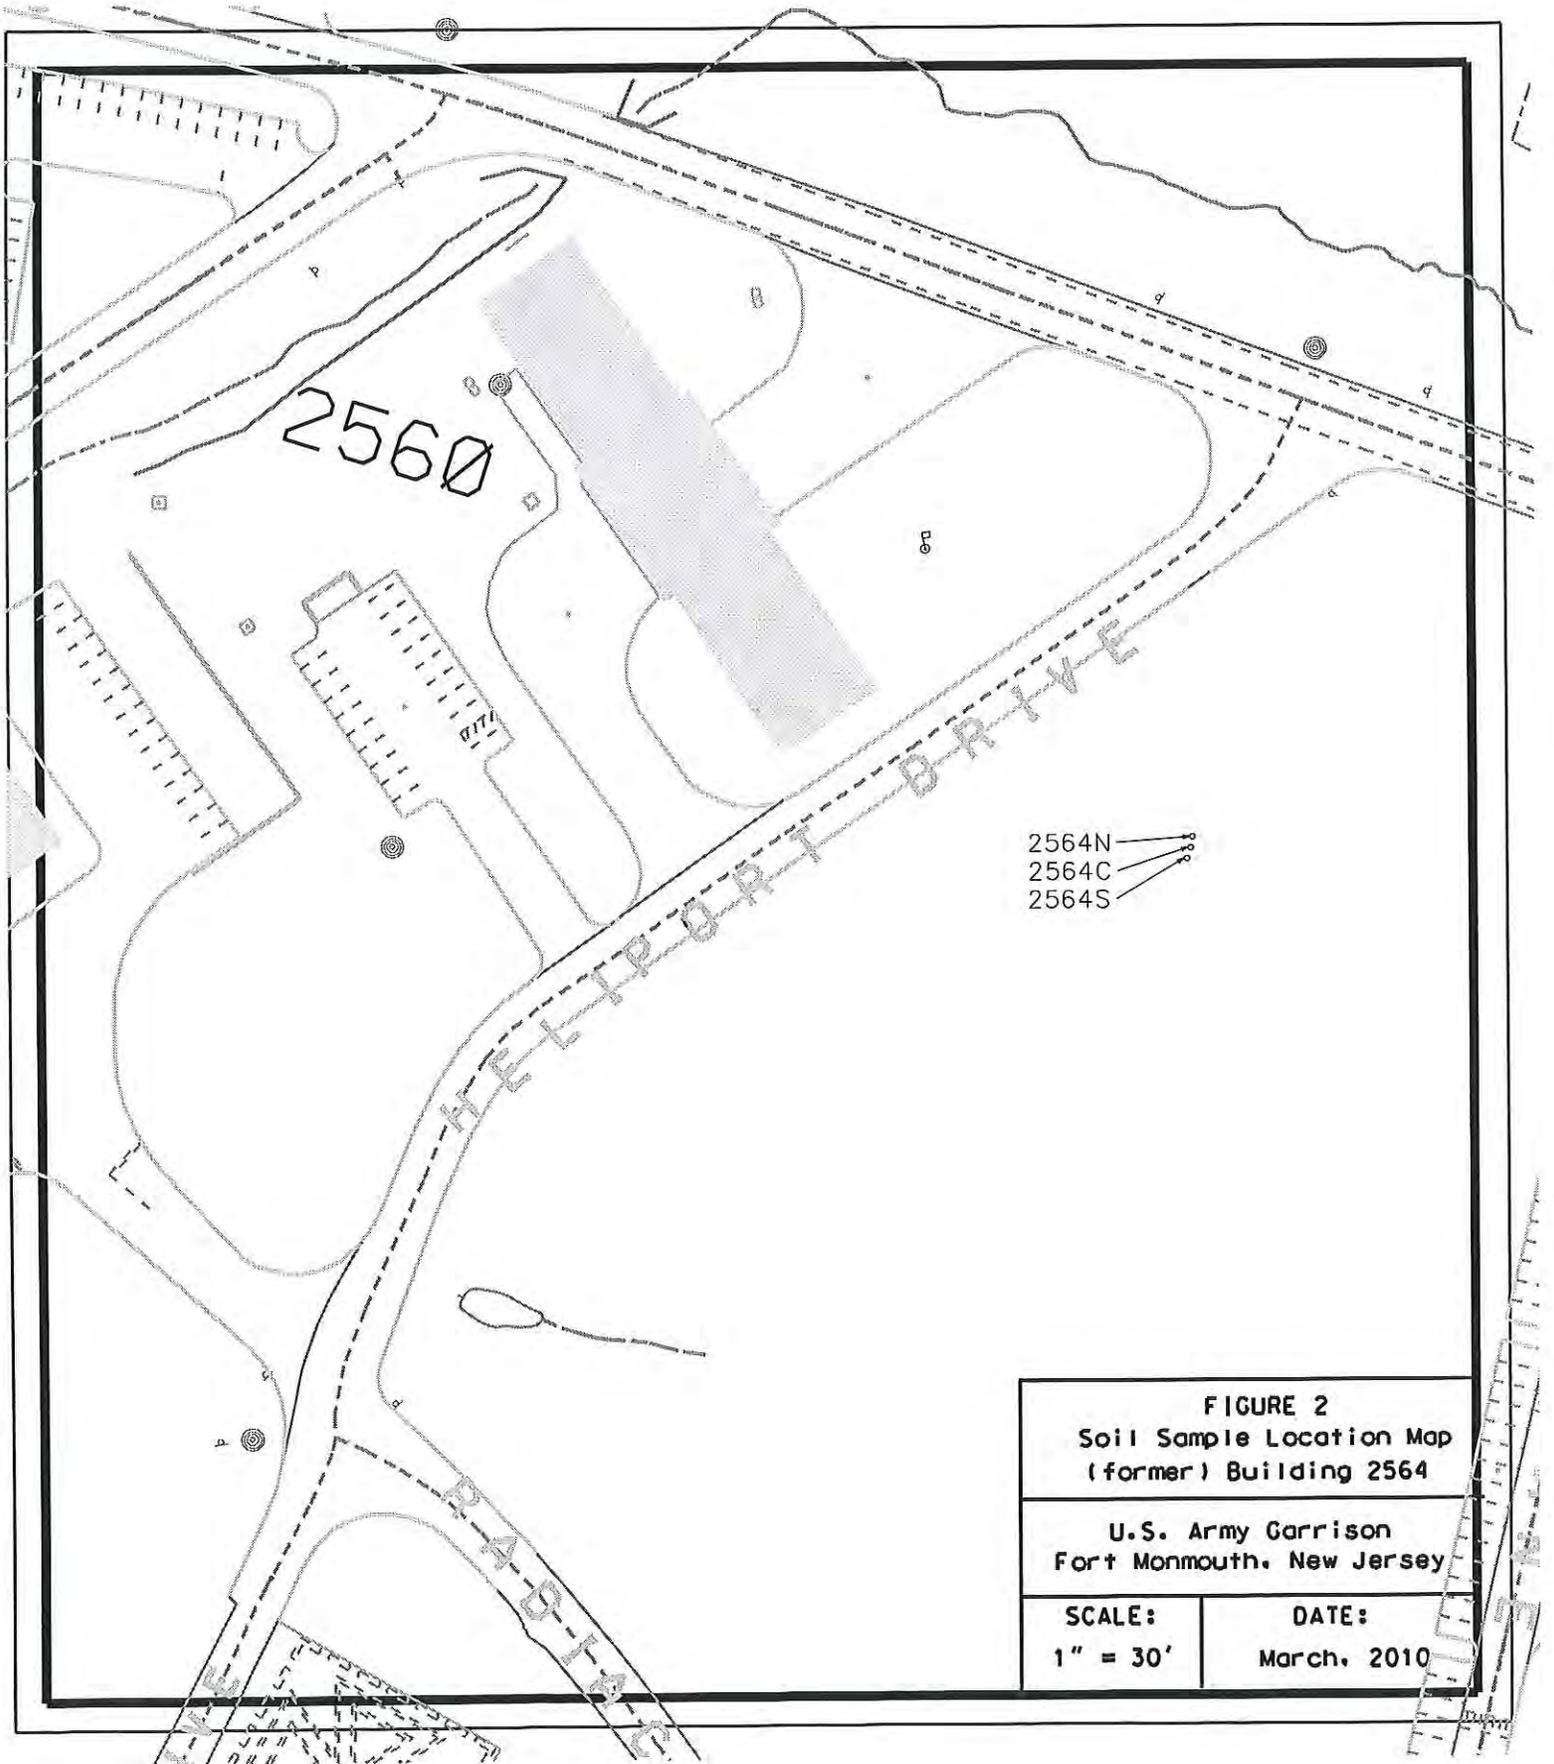
FIGURE 2 Soil Sample Location Map (former) Building 2564	
U.S. Army Garrison Fort Monmouth, New Jersey	
SCALE: 1" = 30'	DATE: March, 2010

2564N
 2564C
 2564S

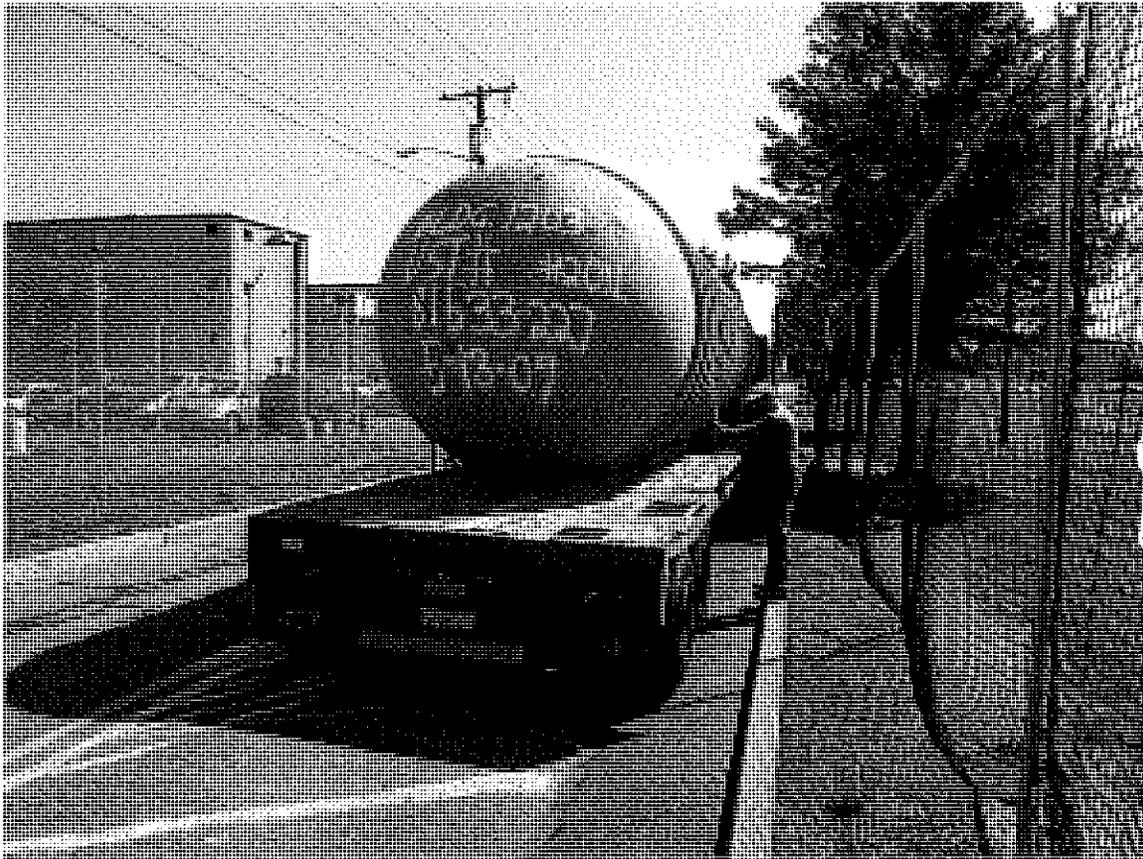
Removed and labeled fiberglass USTs

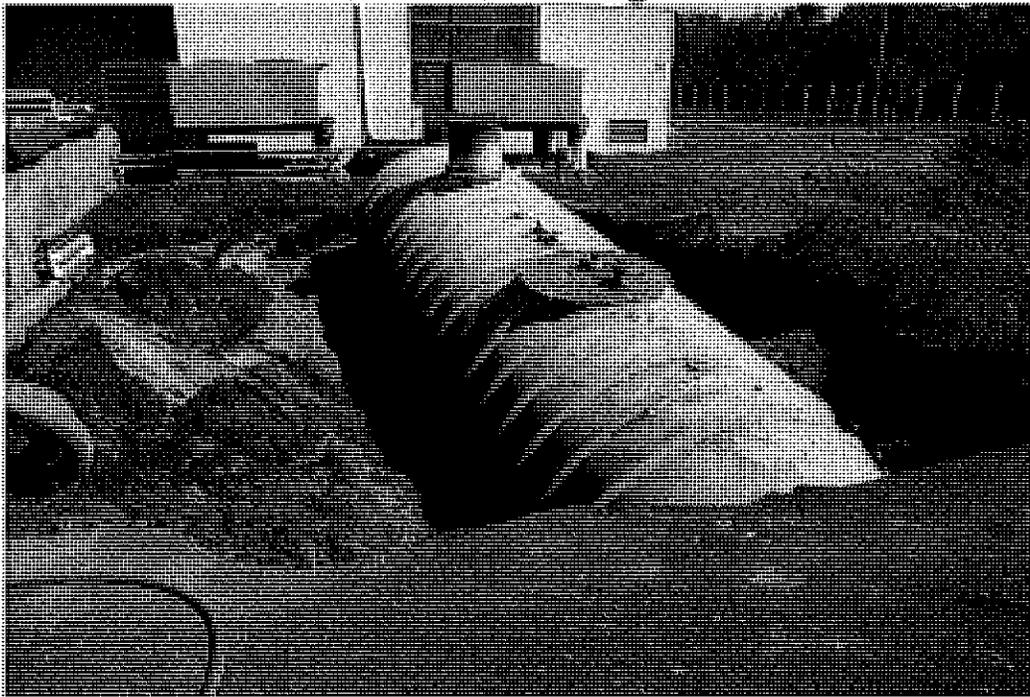
Fiberglass UST being removed from excavation

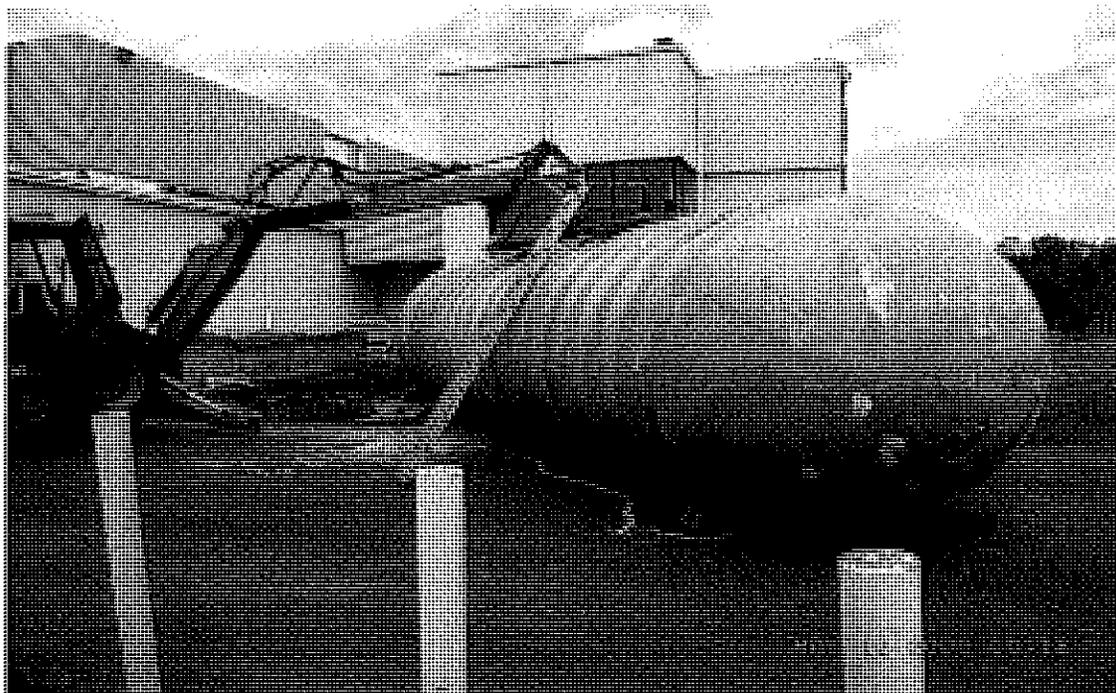
UST on ground ready for SSE inspection

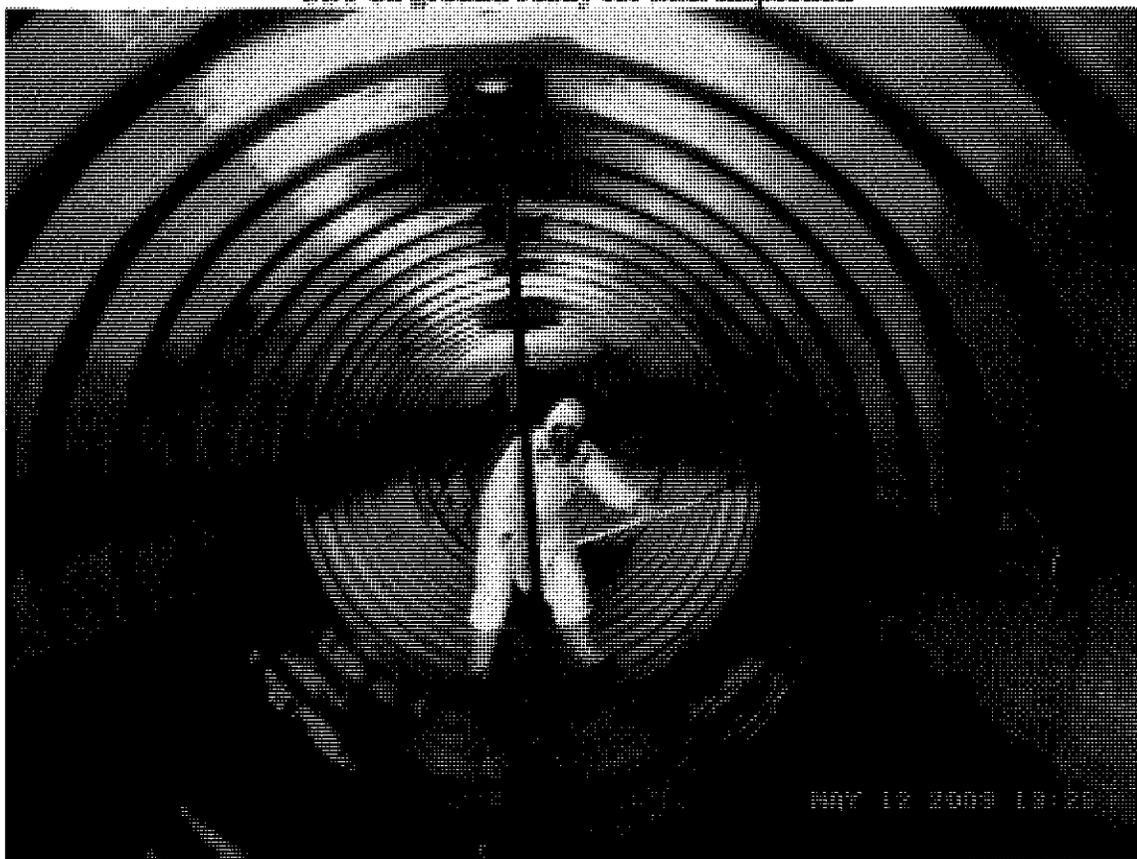
UST being cleaned

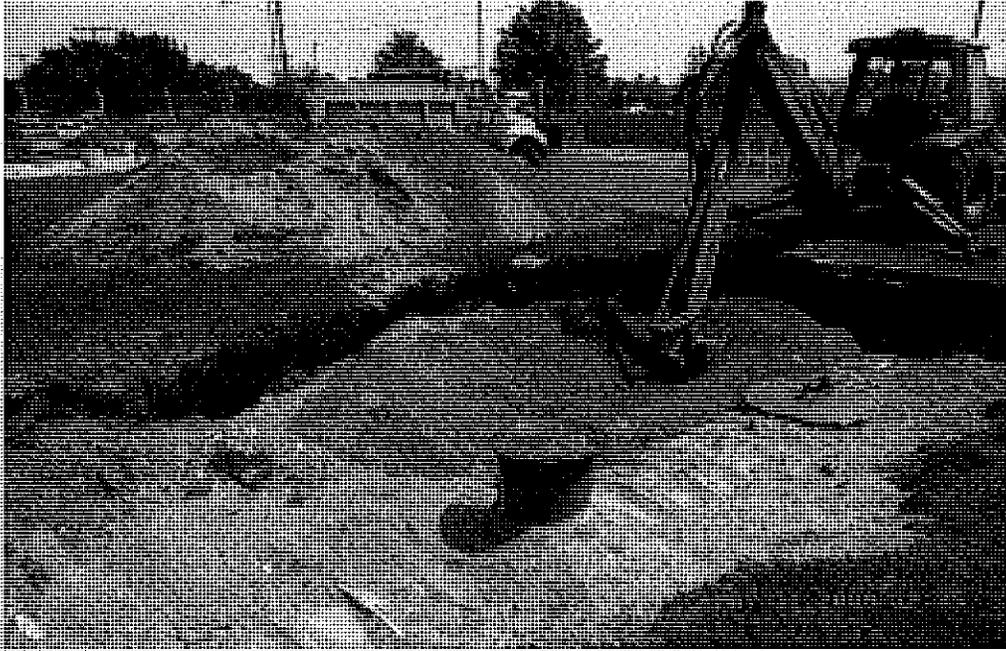
Exposing top of UST prior to removal

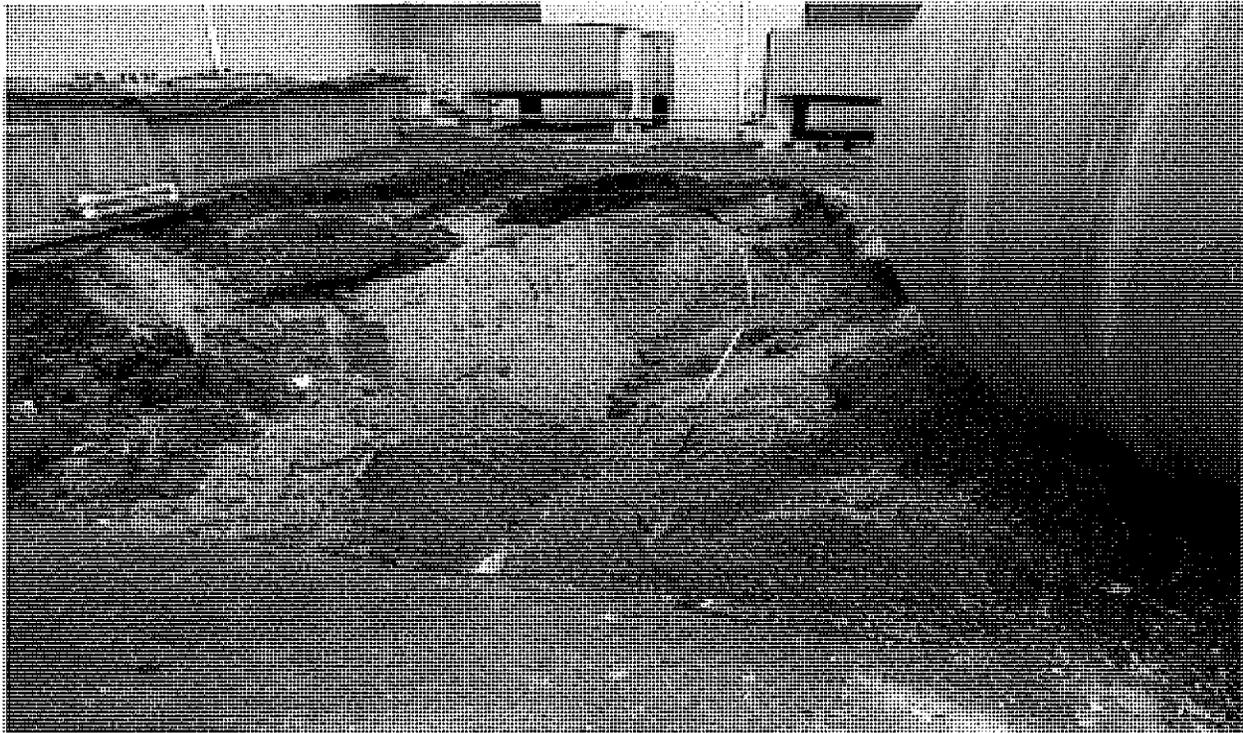
Tank excavation w/tank out of ground
