Agenda for 27 March 2013 Picatinny Arsenal Restoration Advisory Board

Military Munitions Response Program Remedial Investigation

RAB UPDATE

RAB Update

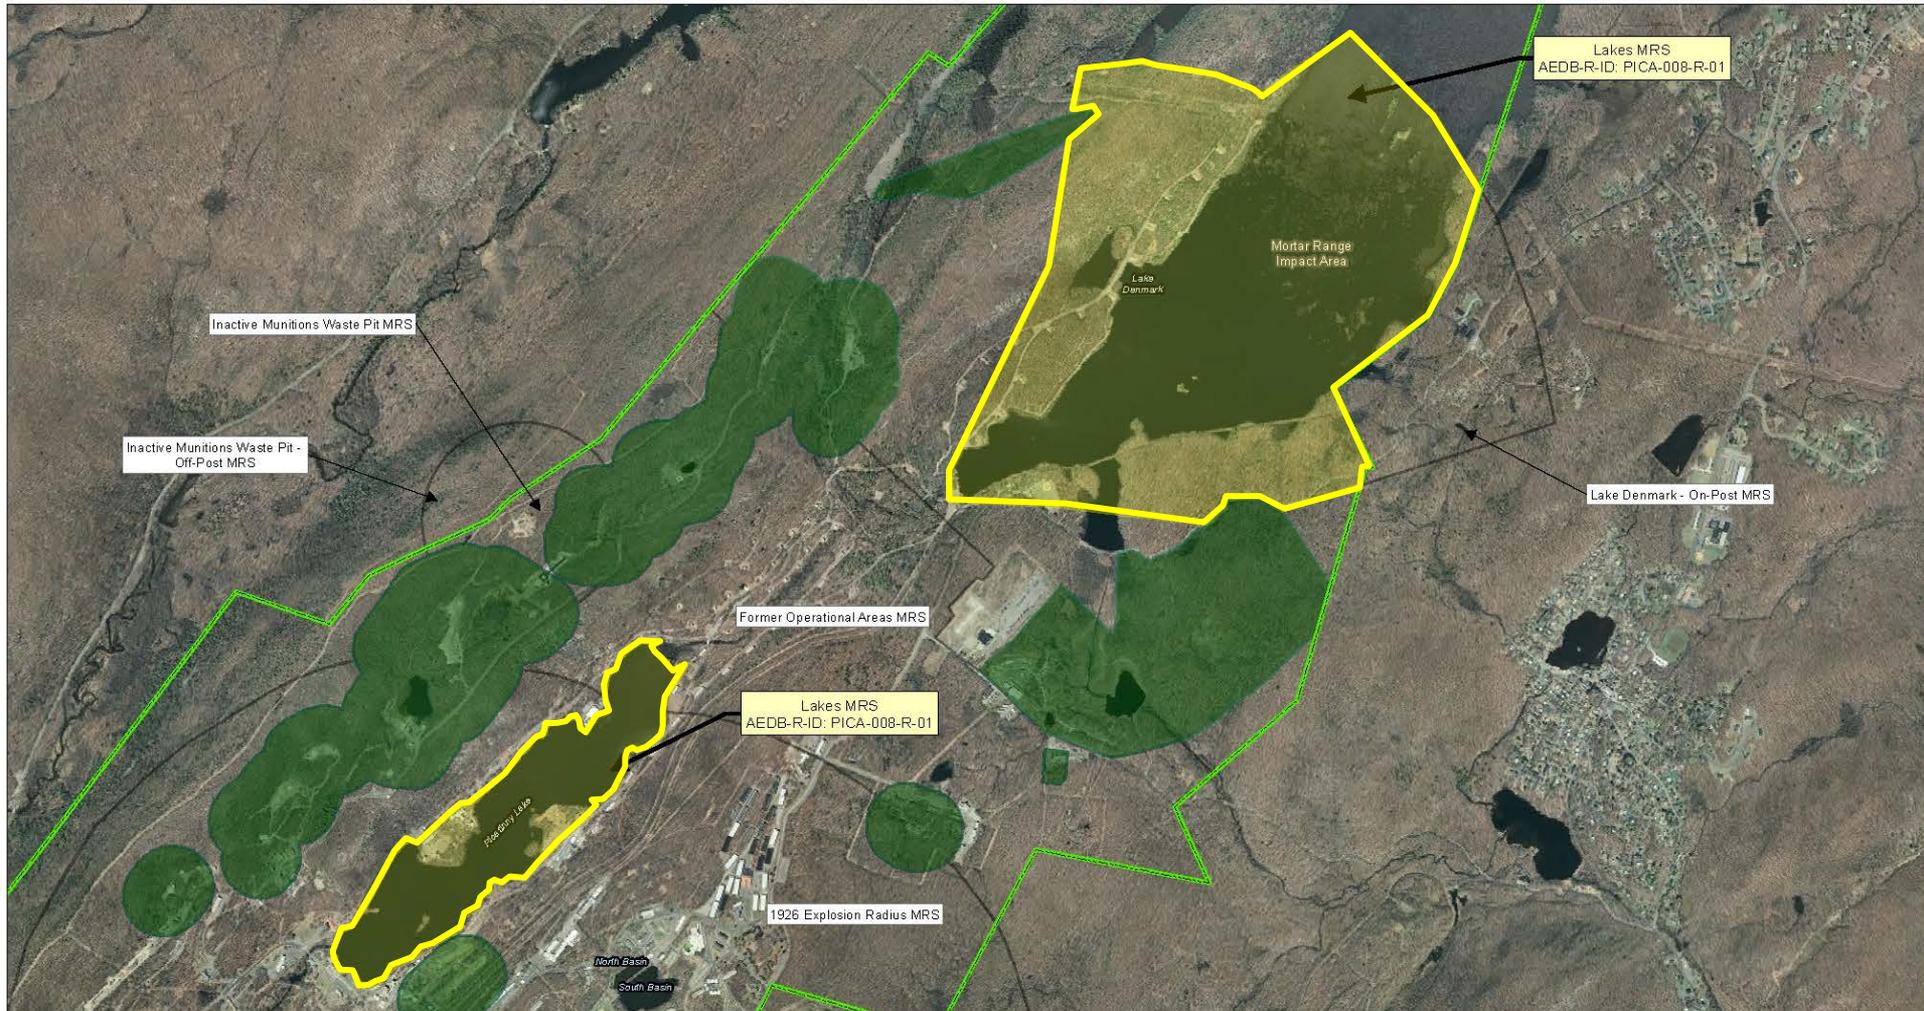
Military Munitions Response Program Lakes Munitions Response Site

- Includes the water and surrounding land portions of Picatinny Lake and Lake Denmark
- Total area: 125 acres
 - Land portion: 17 acres
 - Water portion: 108 acres
- RI Objective: Collect data to define nature and extent of munitions and explosives of concern (MEC)
- Field investigation included land-based and underwater geophysical surveys and anomaly investigations
- Investigation results will be used to assess explosives hazards

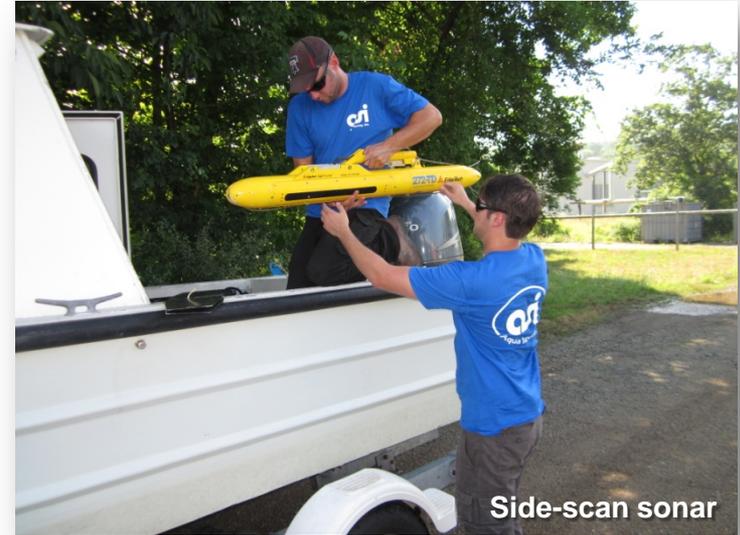
- Side-scan sonar surveys performed across the lake to assess bottom conditions and to identify obstacles
- Bathymetry data collected to determine when to raise and lower sensor to maintain constant altitude
- Underwater electromagnetic (all metals) geophysical surveys conducted along pre-planned transects to detect anomalies
 - 2.82 miles of transect surveys (July 2012)
 - 25 anomalies selected from newly collected and preexisting data
- Underwater anomalies reacquired and investigated using dive operations (November 2012)

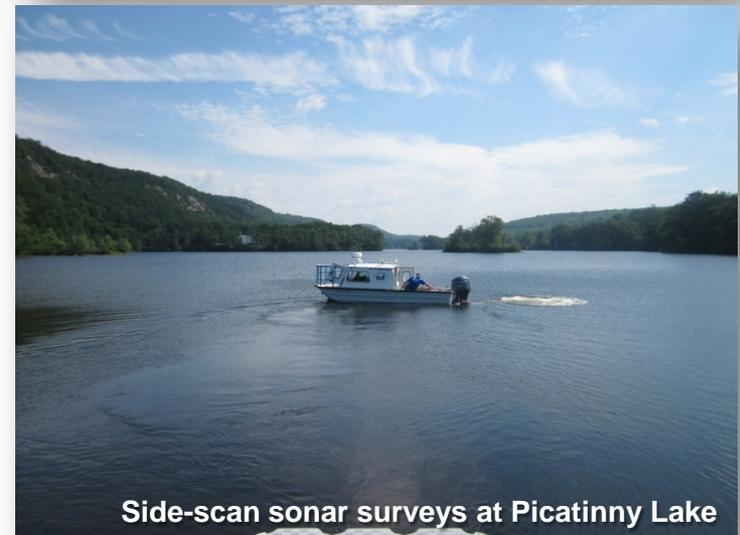
Side-scan sonar surveys at Picatinny Lake

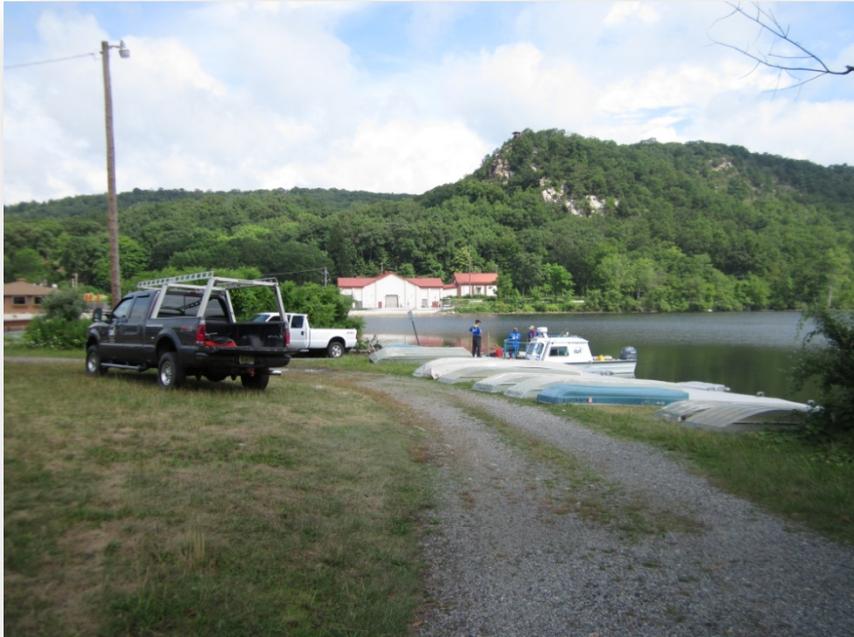
DGM system preparation at Picatinny
Lake dock

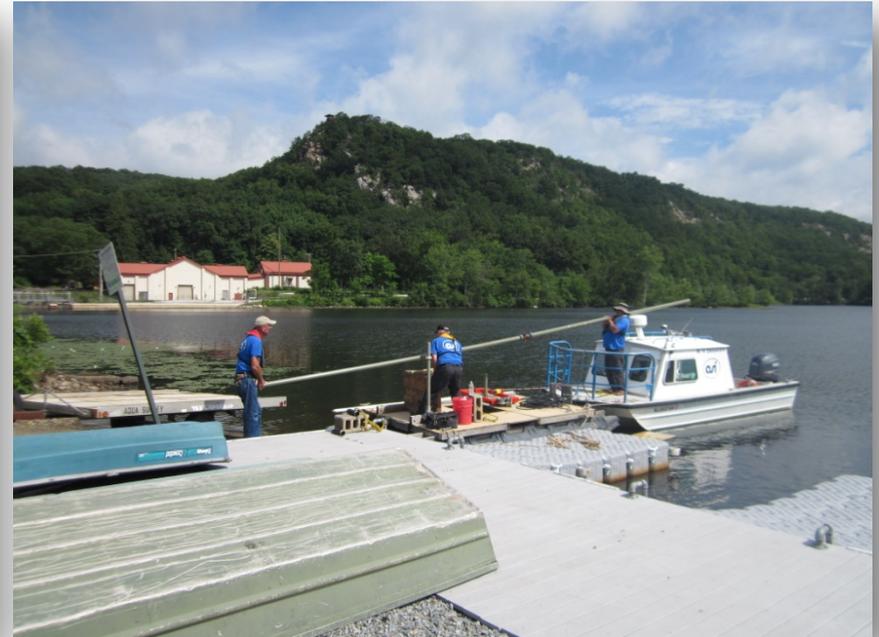
DGM platform construction and
deployment vessel

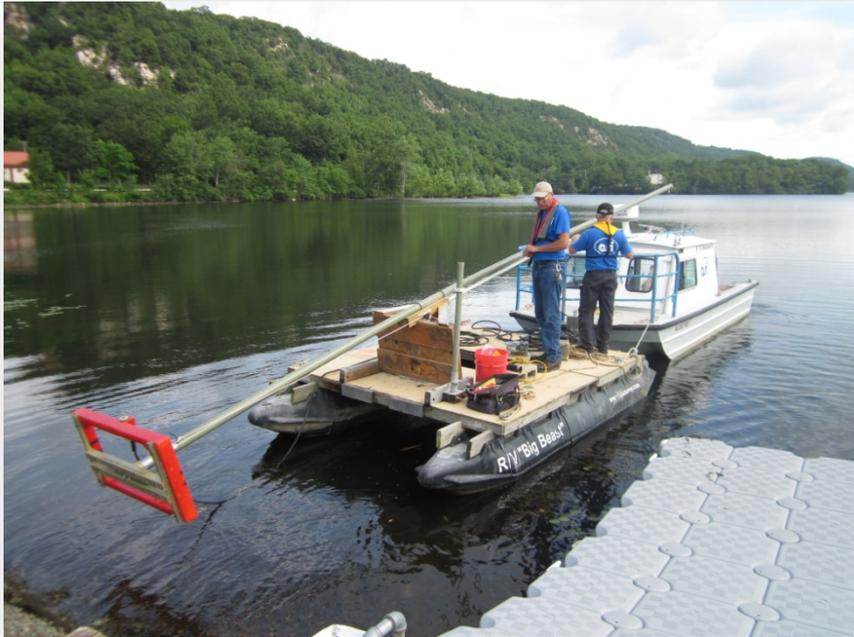
Waterproof EM61 High Power Sensor
on adjustable survey arm

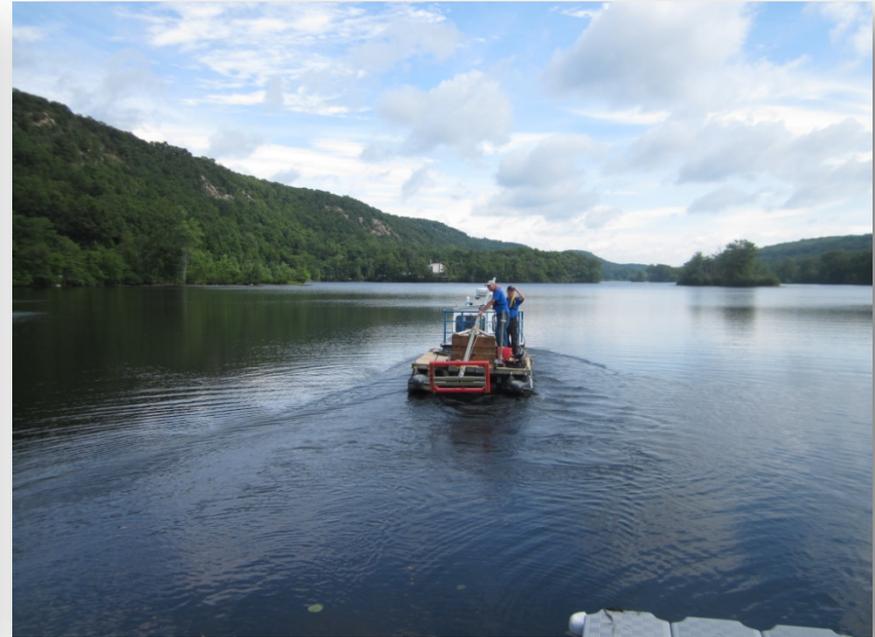
DGM system deployment

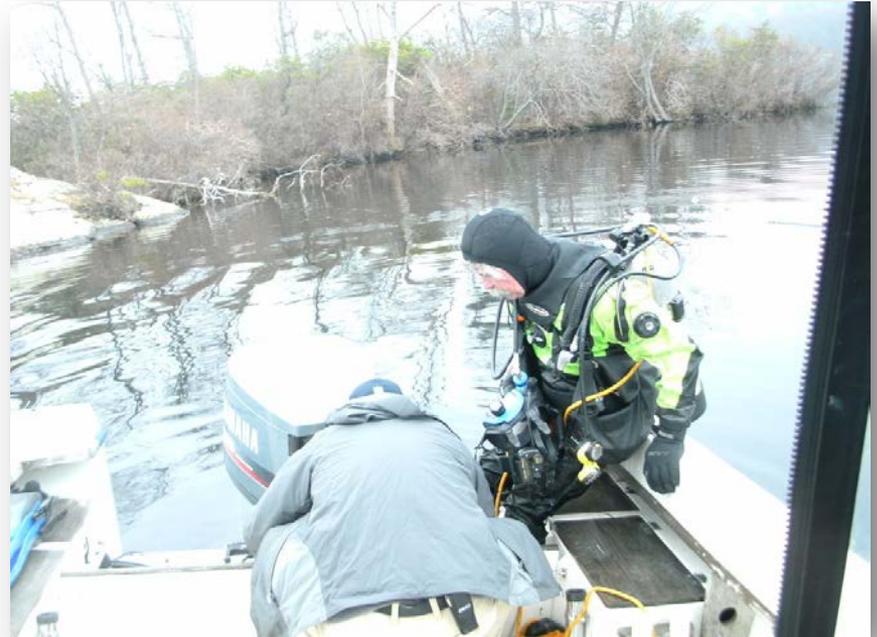
Diver preparation and anomaly reacquisition. The circle-line search method is used to locate the anomaly/anomalies.

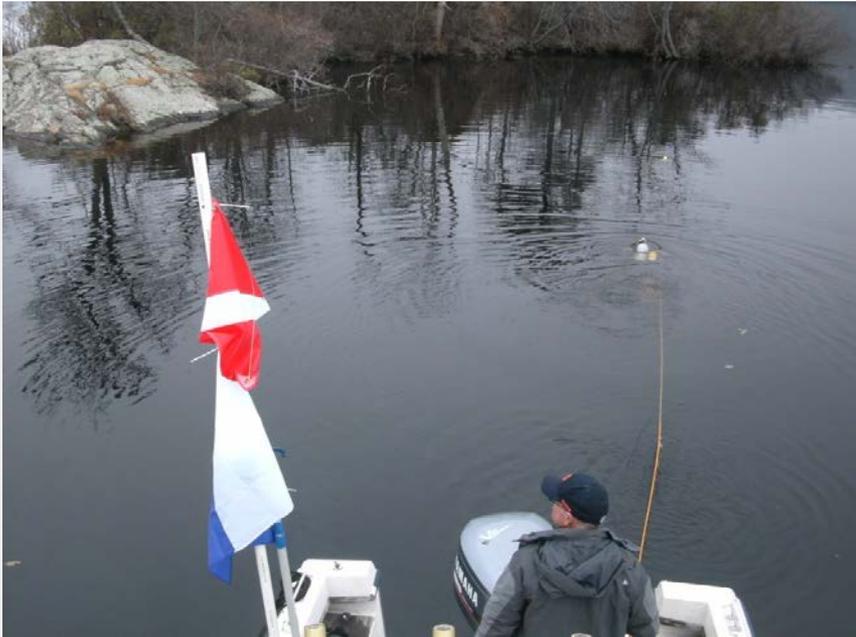
A single clump attached to a buoy line is lowered to the bottom. A second line with knots tied at increments of a specified length is attached to the clump.

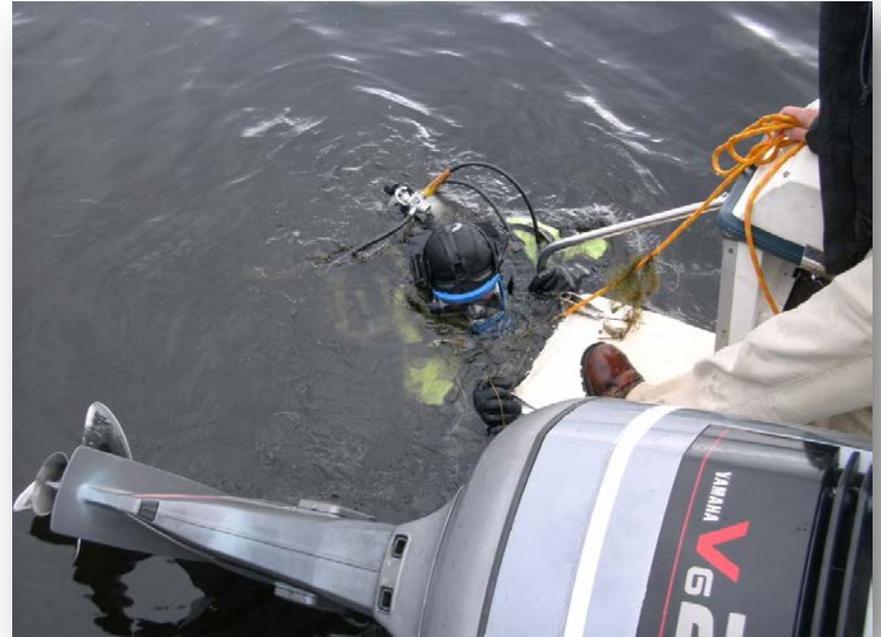
The diver then uses this second line to circle around the clump at increasing or decreasing radii while searching. After one complete circle, the diver moves out or in one knot as required.

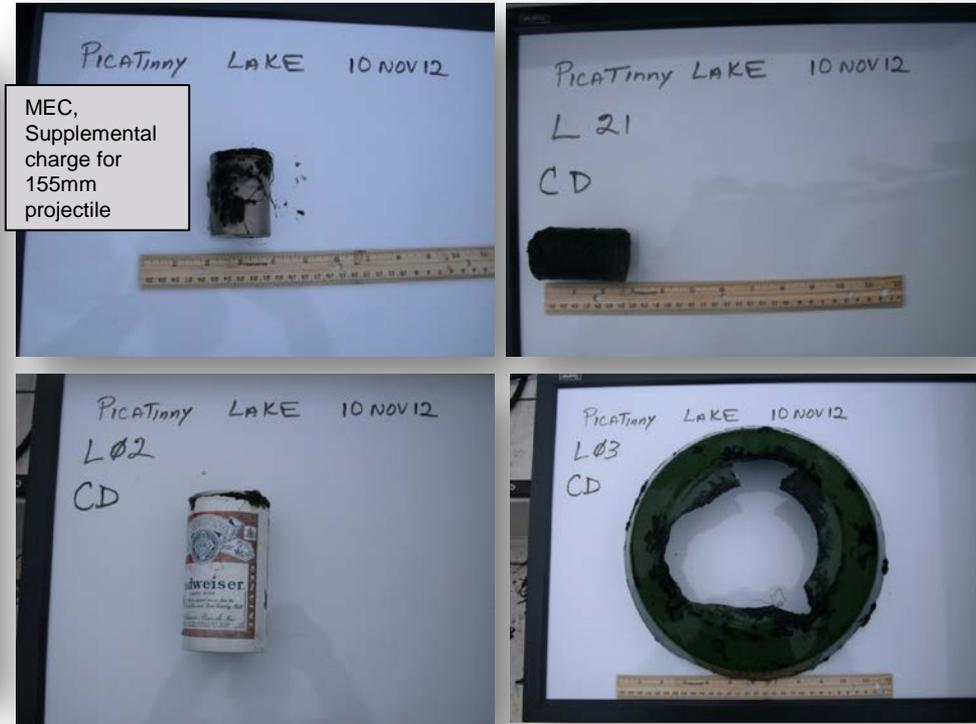
Example items recovered in Picatinny Lake

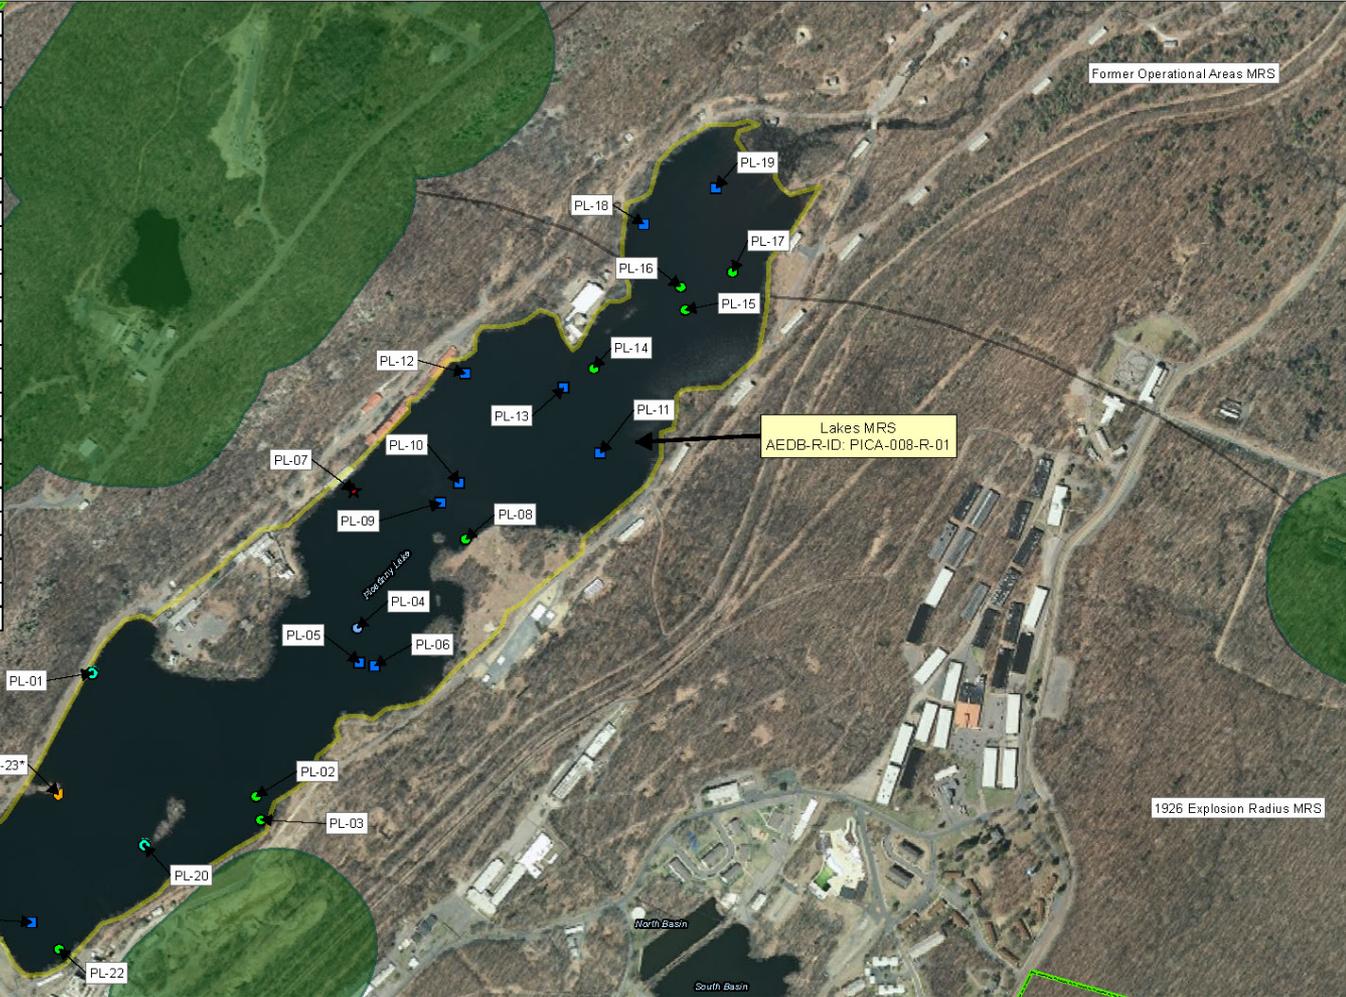
Picatinny Lake Intrusive Investigation Results	
Anomaly ID	Narrative
PL-01	Geologic Item (Hot Rocks)
PL-02	Cultural Debris
PL-03	Cultural Debris
PL-04	No Contact (No audible response)
PL-05	No Find (Audible response, anomaly could not be found)
PL-06	No Find (Audible response, anomaly could not be found)
PL-07	MEC (Supplemental charge for a 155mm)
PL-08	Cultural Debris
PL-09	No Find (Audible response, anomaly could not be found)
PL-10	No Find (Audible response, anomaly could not be found)
PL-11	No Find (Audible response, anomaly could not be found)
PL-12	No Find (Audible response, anomaly could not be found)
PL-13	No Find (Audible response, anomaly could not be found)
PL-14	Cultural Debris
PL-15	Cultural Debris
PL-16	Cultural Debris
PL-17	Cultural Debris
PL-18	No Find (Audible response, anomaly could not be found)
PL-19	No Find (Audible response, anomaly could not be found)
PL-20	Geologic item (Hot Rocks)
PL-21	MD (Expended smoke canister)

PL-22	Cultural Debris
PL-23*	MD (Remnants of flares)
PL-24	No Find (Audible response, anomaly could not be found)

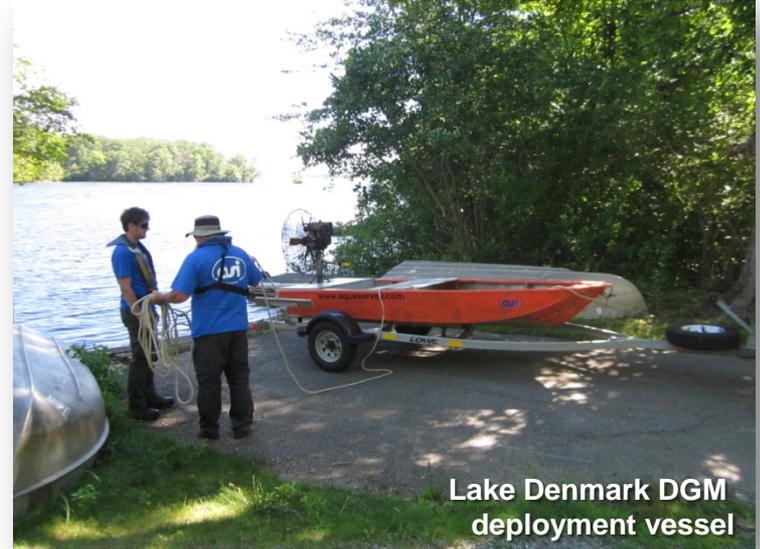
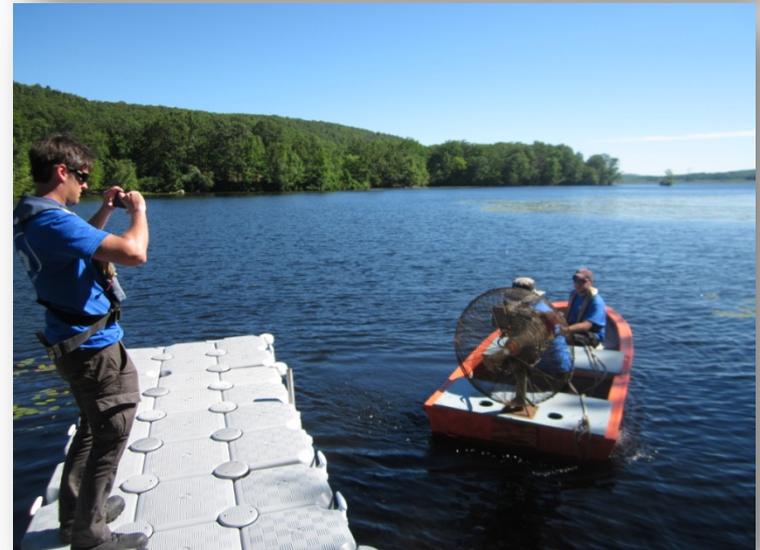
- The northeastern portion of Lake Denmark is shallow water
- Underwater electromagnetic (all metals) geophysical surveys conducted in accessible portions of the lake
 - 3.08 miles of transect surveys (July 2012)
 - 10 anomalies selected from newly collected and preexisting data
- Underwater anomalies reacquired and investigated using dive operations (November 2012)

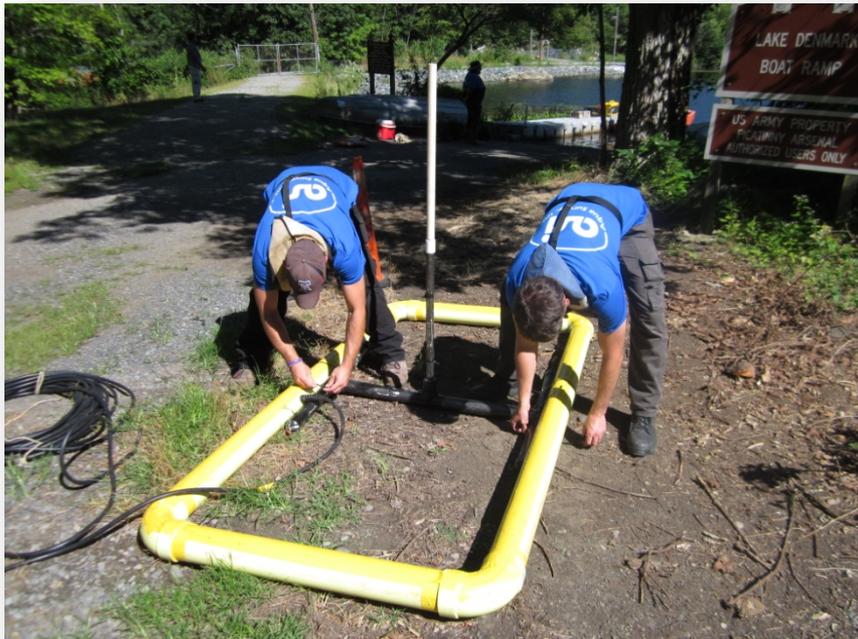
Floatable and waterproof EM61 High Power Sensor

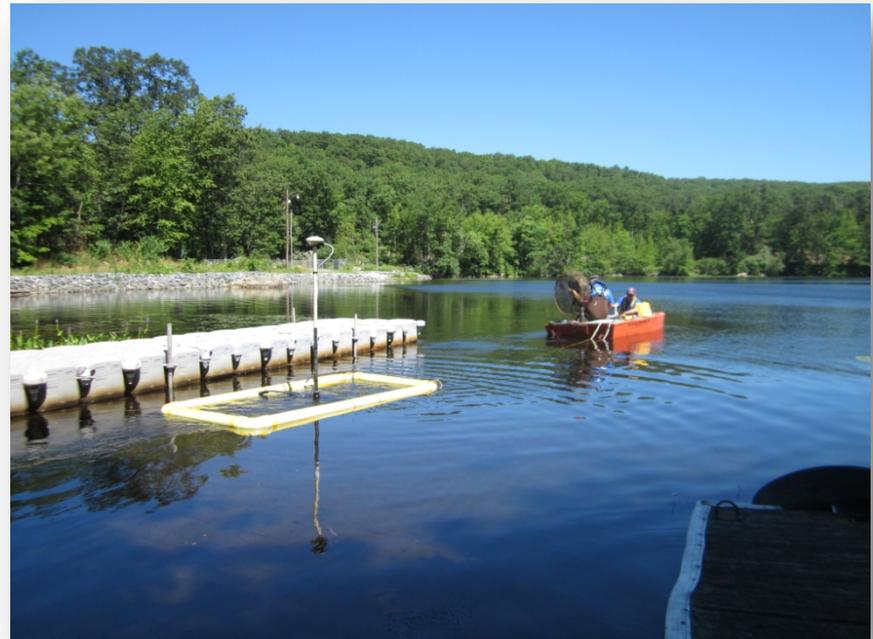
DGM sensor deployment

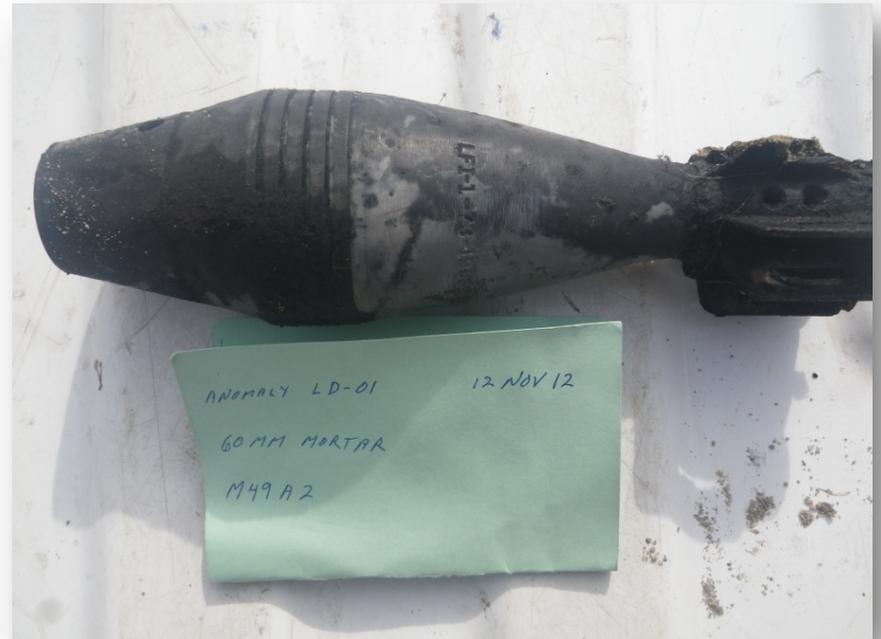
60mm practice mortar recovered in
Lake Denmark

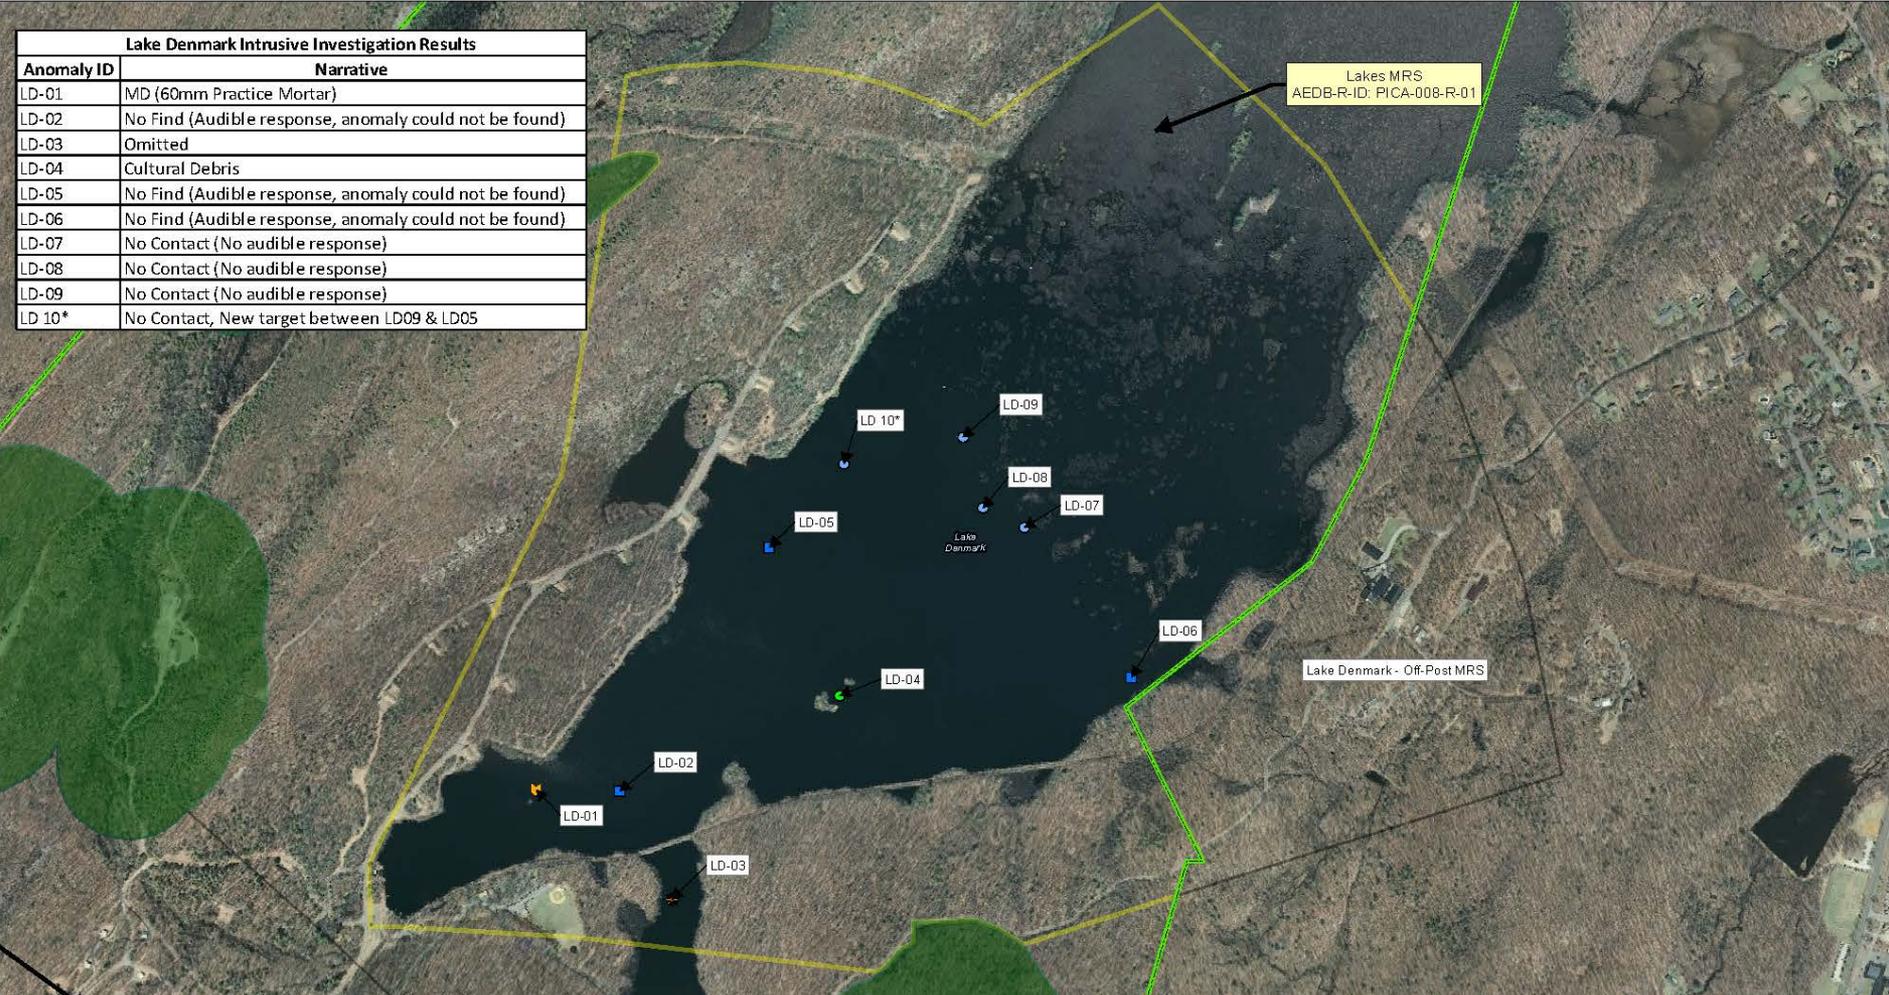
Lake Denmark Intrusive Investigation Results	
Anomaly ID	Narrative
LD-01	MD (60mm Practice Mortar)
LD-02	No Find (Audible response, anomaly could not be found)
LD-03	Omitted
LD-04	Cultural Debris
LD-05	No Find (Audible response, anomaly could not be found)
LD-06	No Find (Audible response, anomaly could not be found)
LD-07	No Contact (No audible response)
LD-08	No Contact (No audible response)
LD-09	No Contact (No audible response)
LD-10*	No Contact, New target between LD09 & LD05

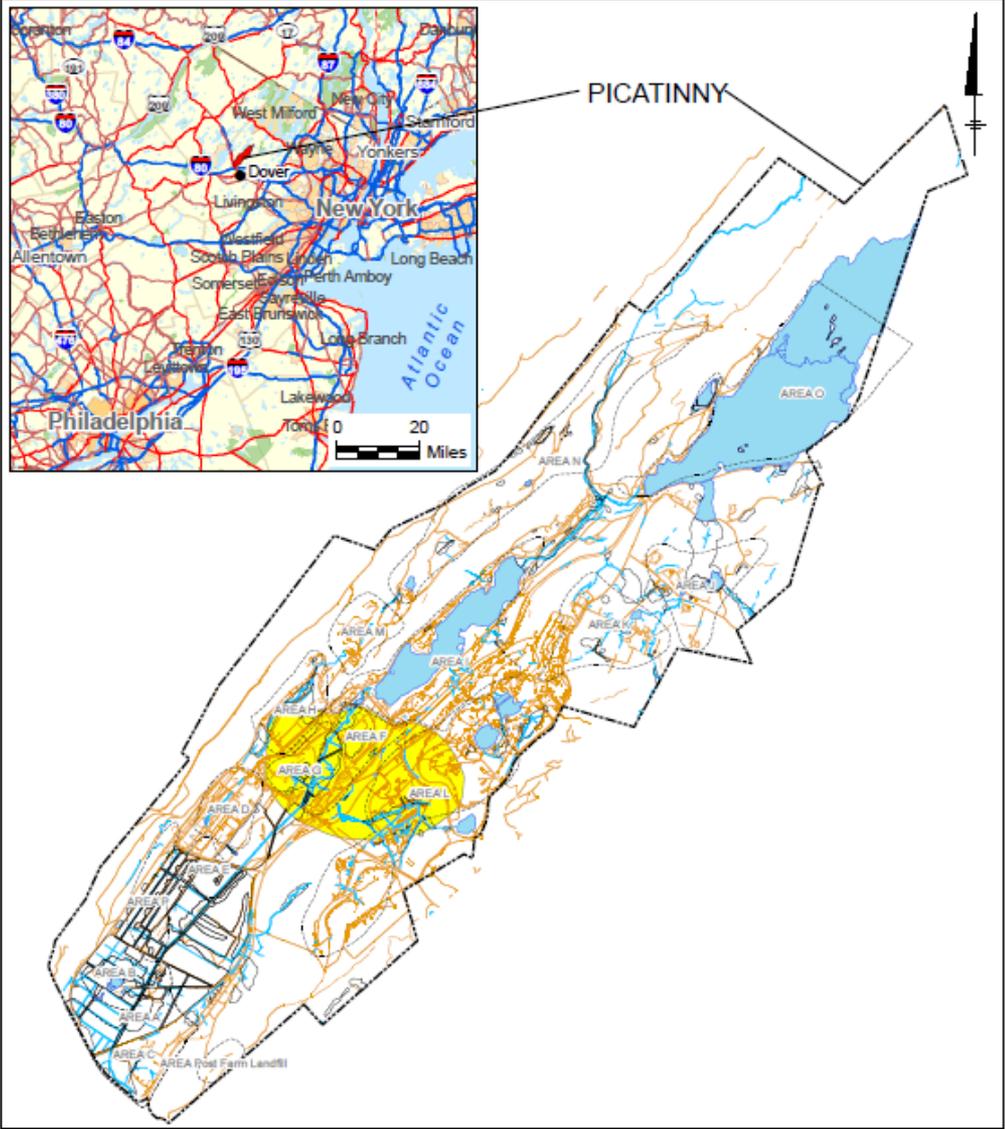
FIGURE
1

**LOCATION OF MID-VALLEY AREA
AND PICATINNY**

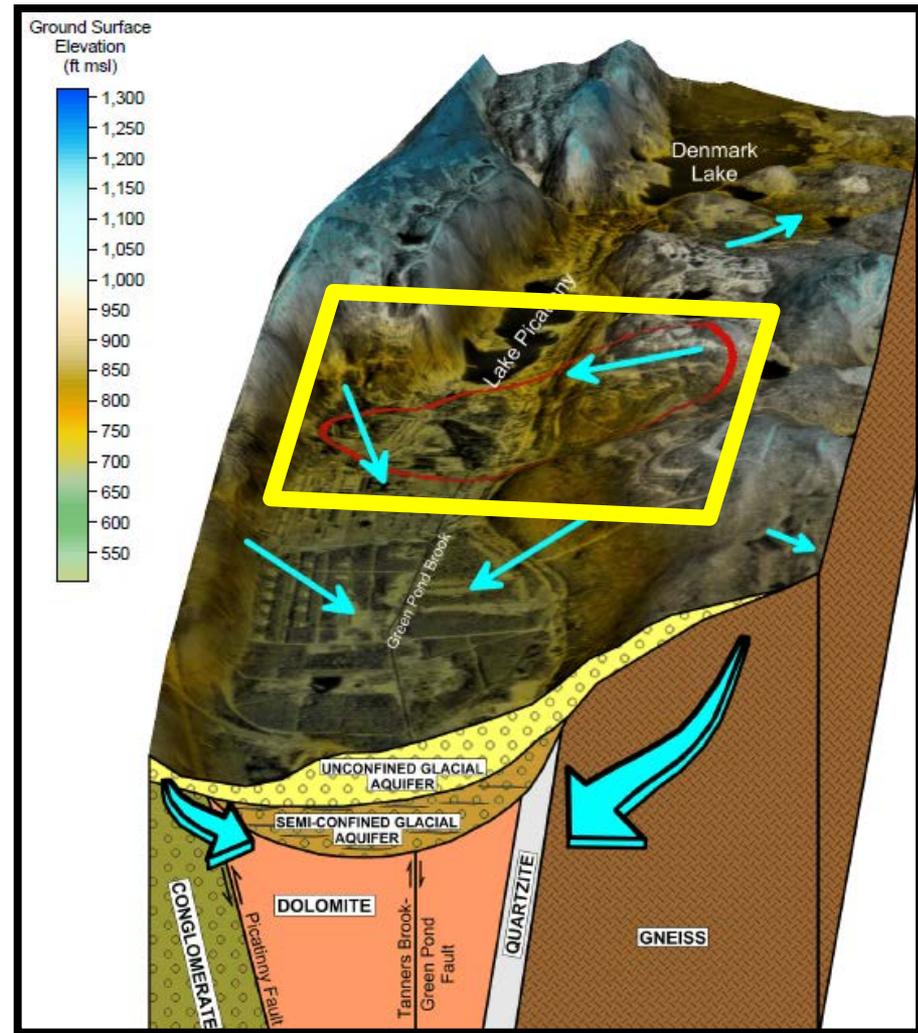
- Glacial valley fill with bedrock uplands
- Surface water bodies present include Robinson Run and Green Pond Brook
- Groundwater flow directions are towards the valley (Green Pond Brook) and locally towards Robinson Run

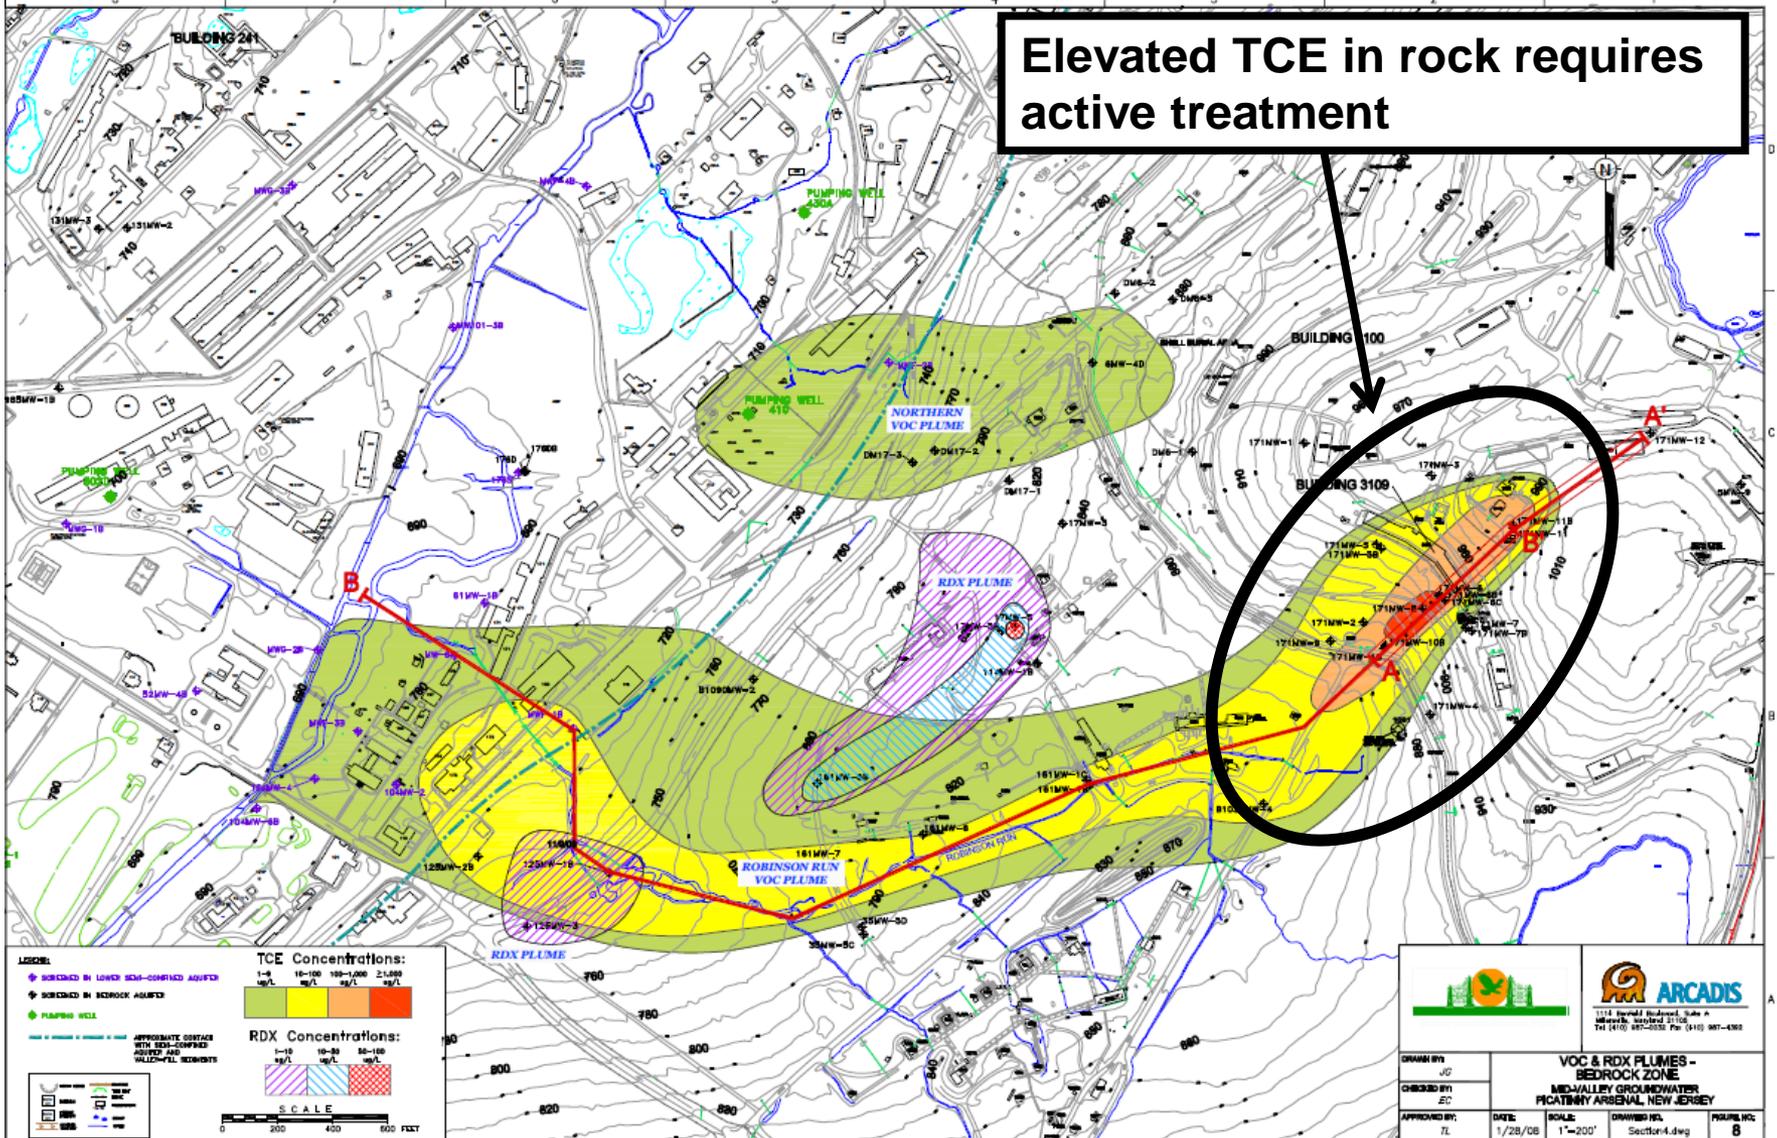
Deeper Groundwater

Elevated TCE in rock requires active treatment

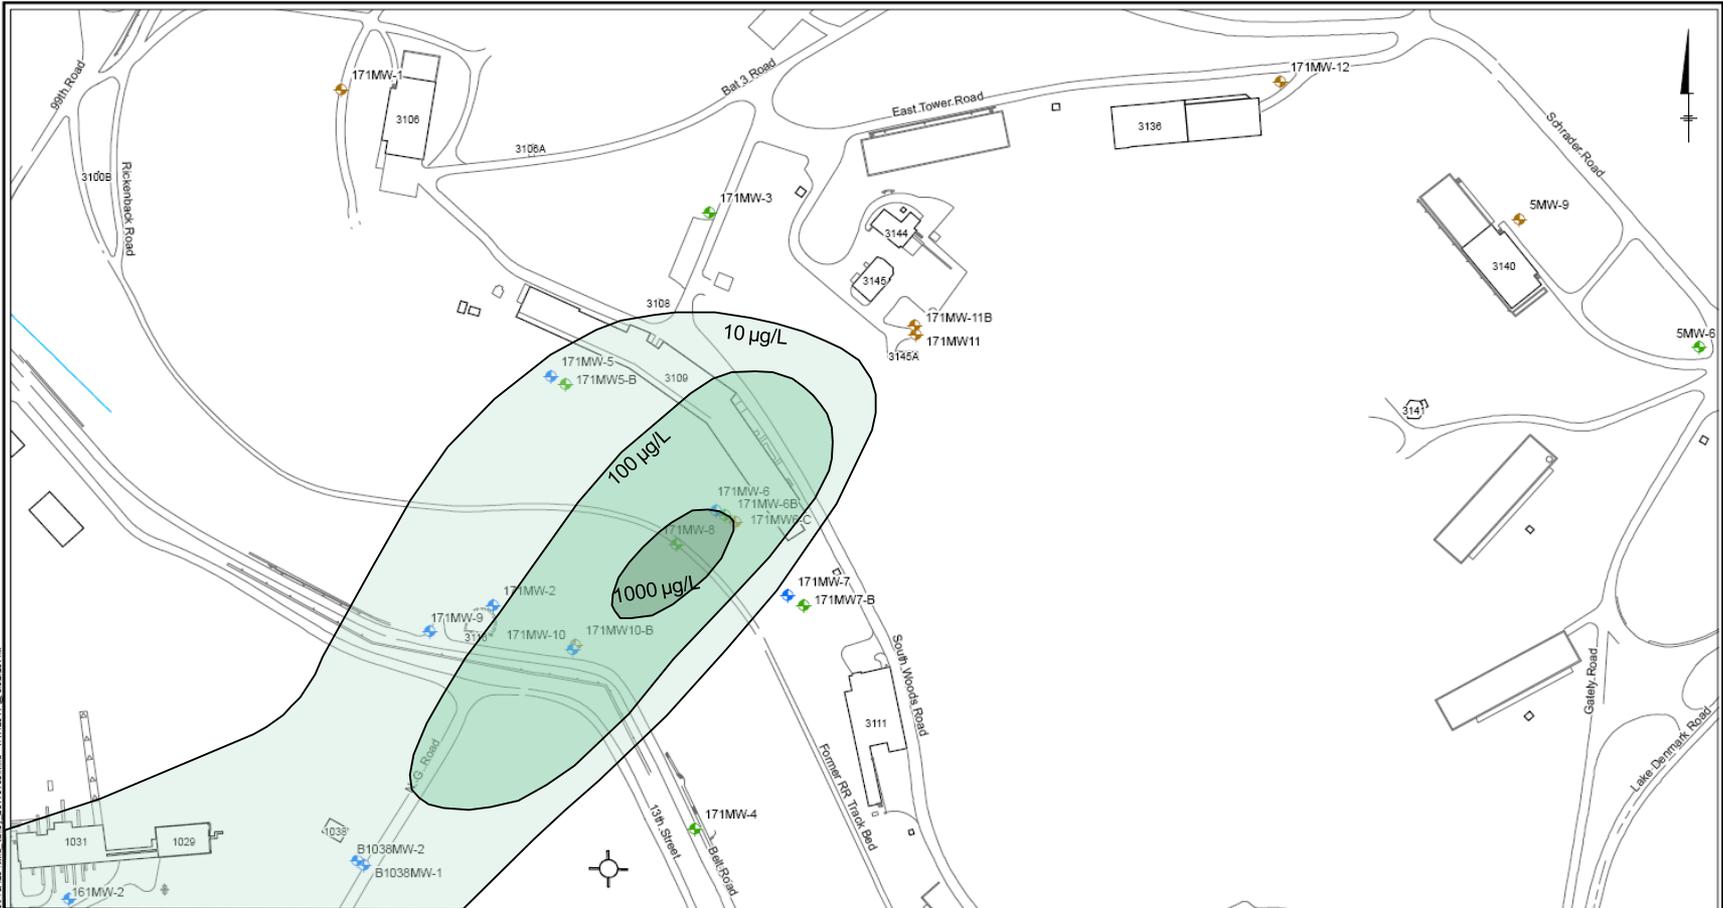
TCE Distribution Building 3109

- LEGEND:
- ◆ SHALLOW BEDROCK WELL, < 65 FT DEPTH BGS
 - ◆ INTERMEDIATE BEDROCK WELL, 65 - 100 FT DEPTH BGS
 - ◆ DEEP BEDROCK WELL, > 100 FT DEPTH BGS
 - ROAD
 - BUILDING

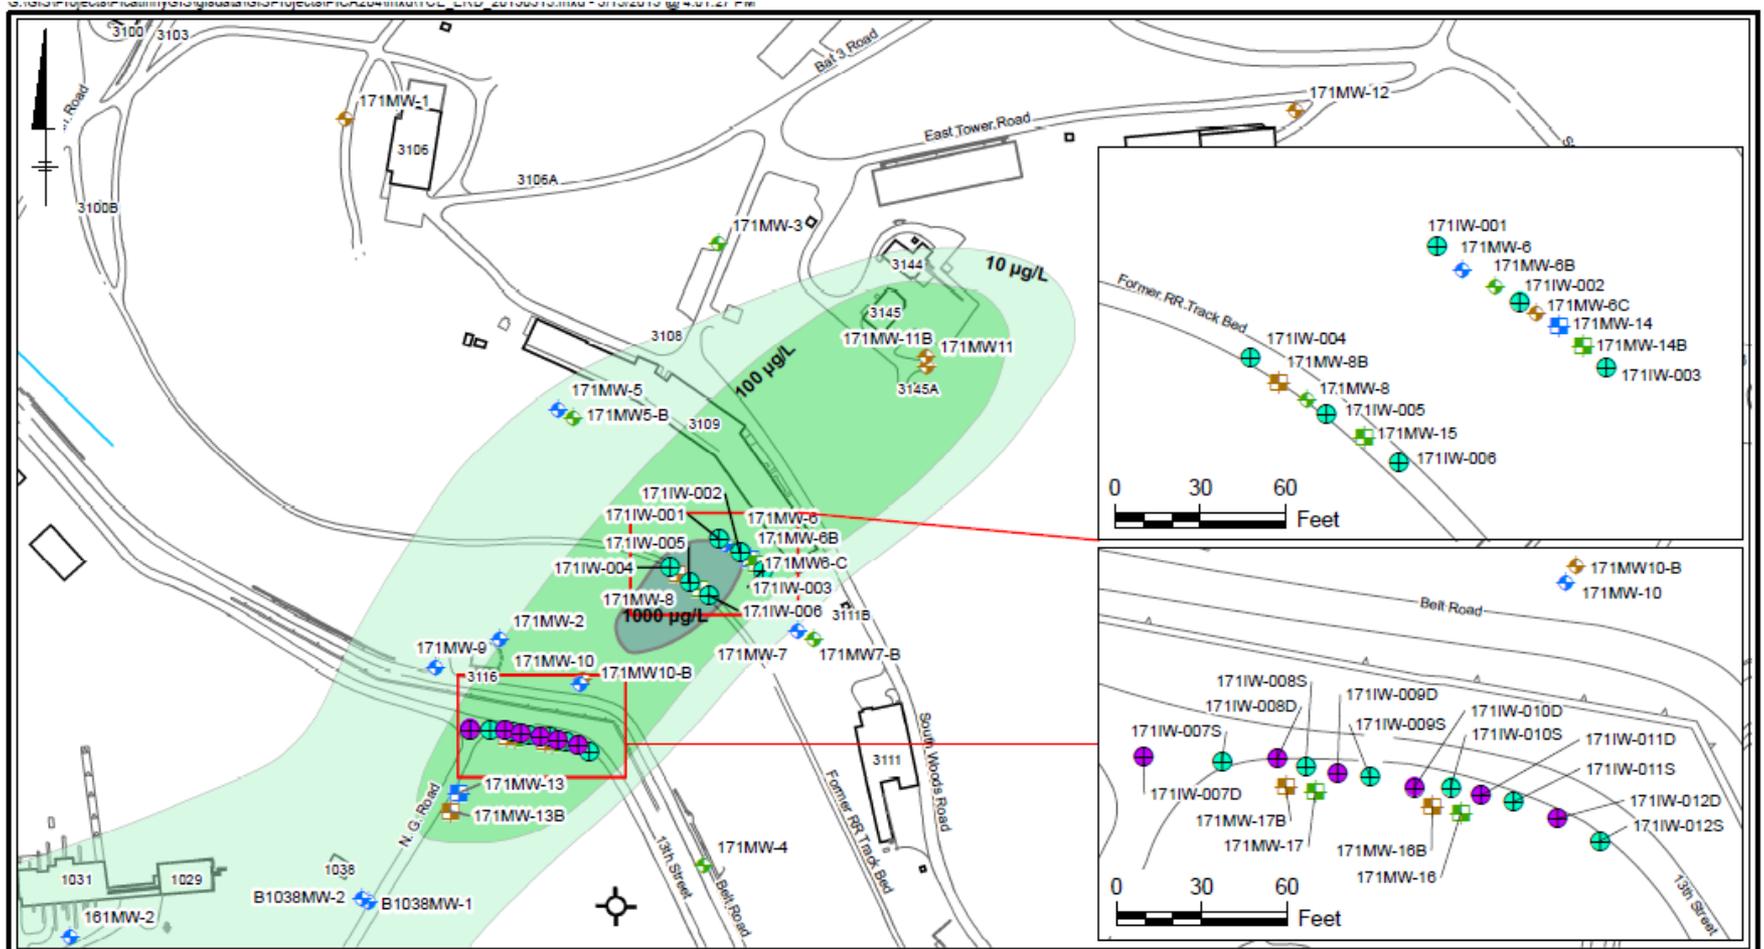
FIGURE **11**

- Injections emulsified vegetable oil (EVO) at head of plume where concentrations are highest
 - 18 injection wells in bedrock
- MNA on downgradient portion of plumes
- Time to achieve remedial goals approximately 35 years
 - Time without treatment 190 years

LAYOUT OF FOCUSED ENHANCED REDUCTIVE DECHLORINATION (ERD) WELL NETWORK
