Agenda for 27 March 2013 Picatinny Arsenal Restoration Advisory Board

Military Munitions Response Program Remedial Investigation

RAB UPDATE

RAB Update

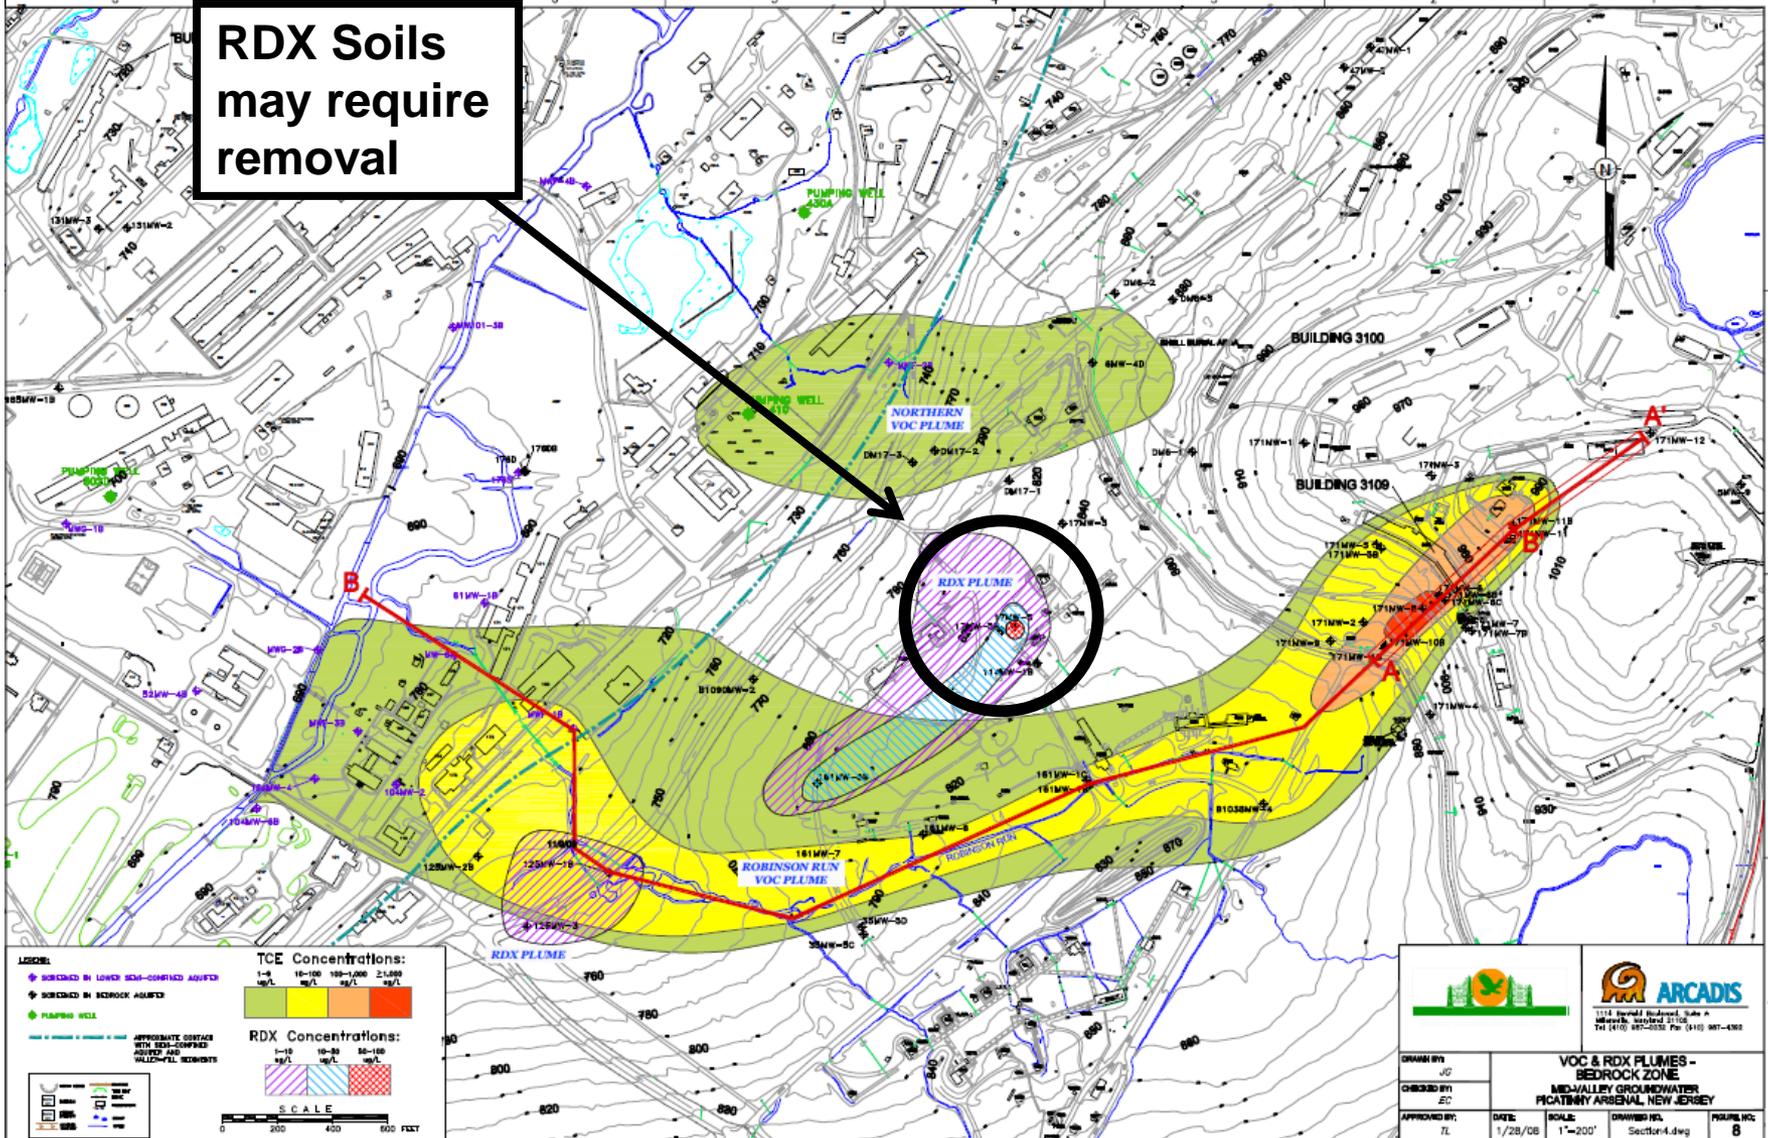
**RDX Soils
may require
removal**

- Continue periodic EVO injections and MNA sampling for groundwater
- Assess extent of RDX contaminated soils and conduct a removal action in 2013, if necessary

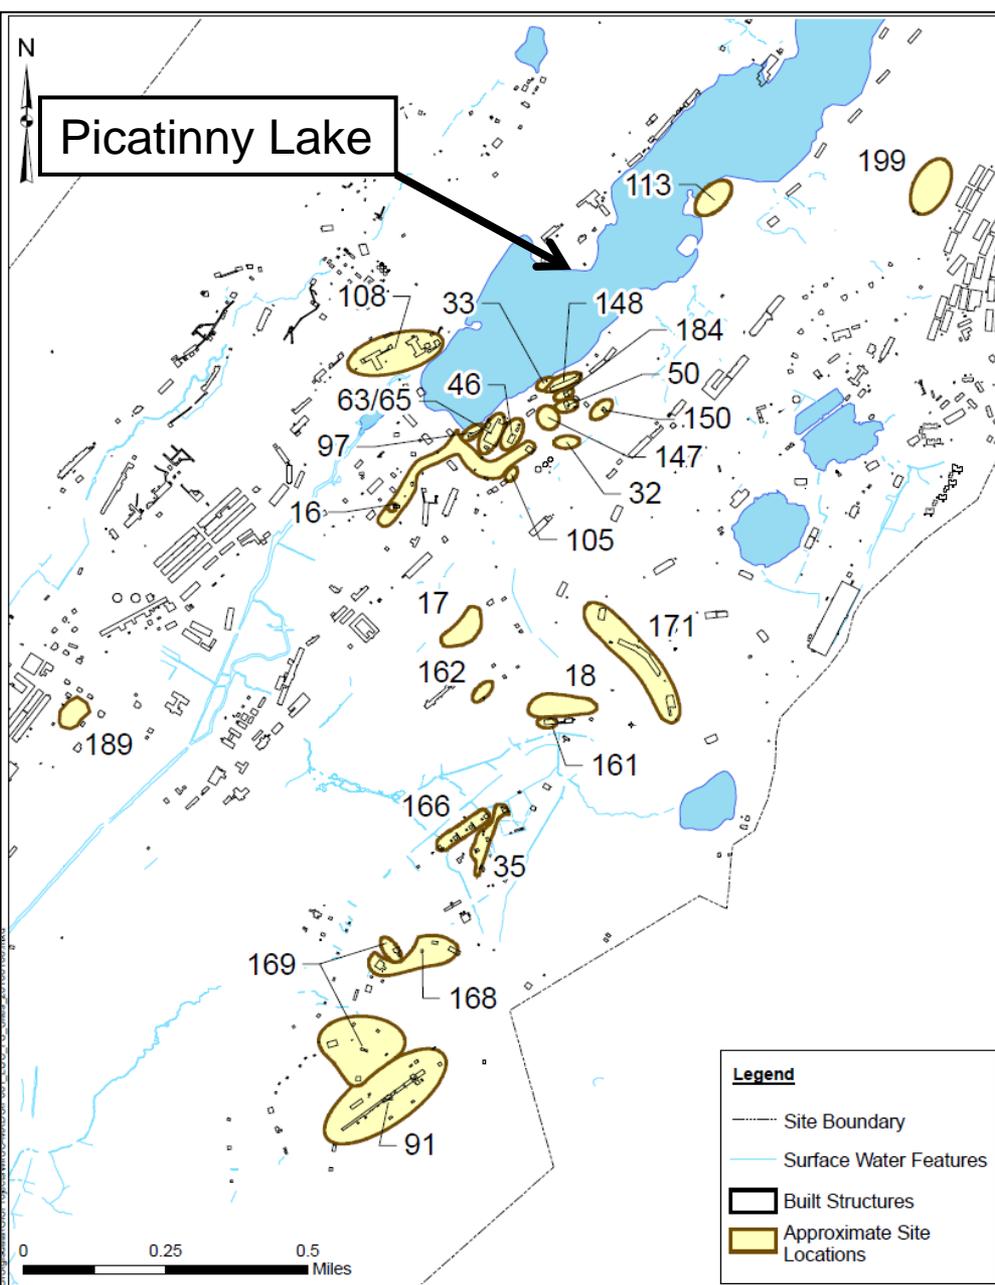
DEPARTMENT MANAGER
 M. NICHIPORIN
 CHECKED
 K. TIPTON
 DRAWING NUMBER
 1

**SITE LOCATIONS
 PICATINNY ARSENAL, NEW JERSEY**
