**HISTORICAL SITE ASSESSMENT  
and  
ADDENDUM TO ENVIRONMENTAL CONDITION OF  
PROPERTY REPORT**

**FORT MONMOUTH  
EATONTOWN, NEW JERSEY**

**January 2007**

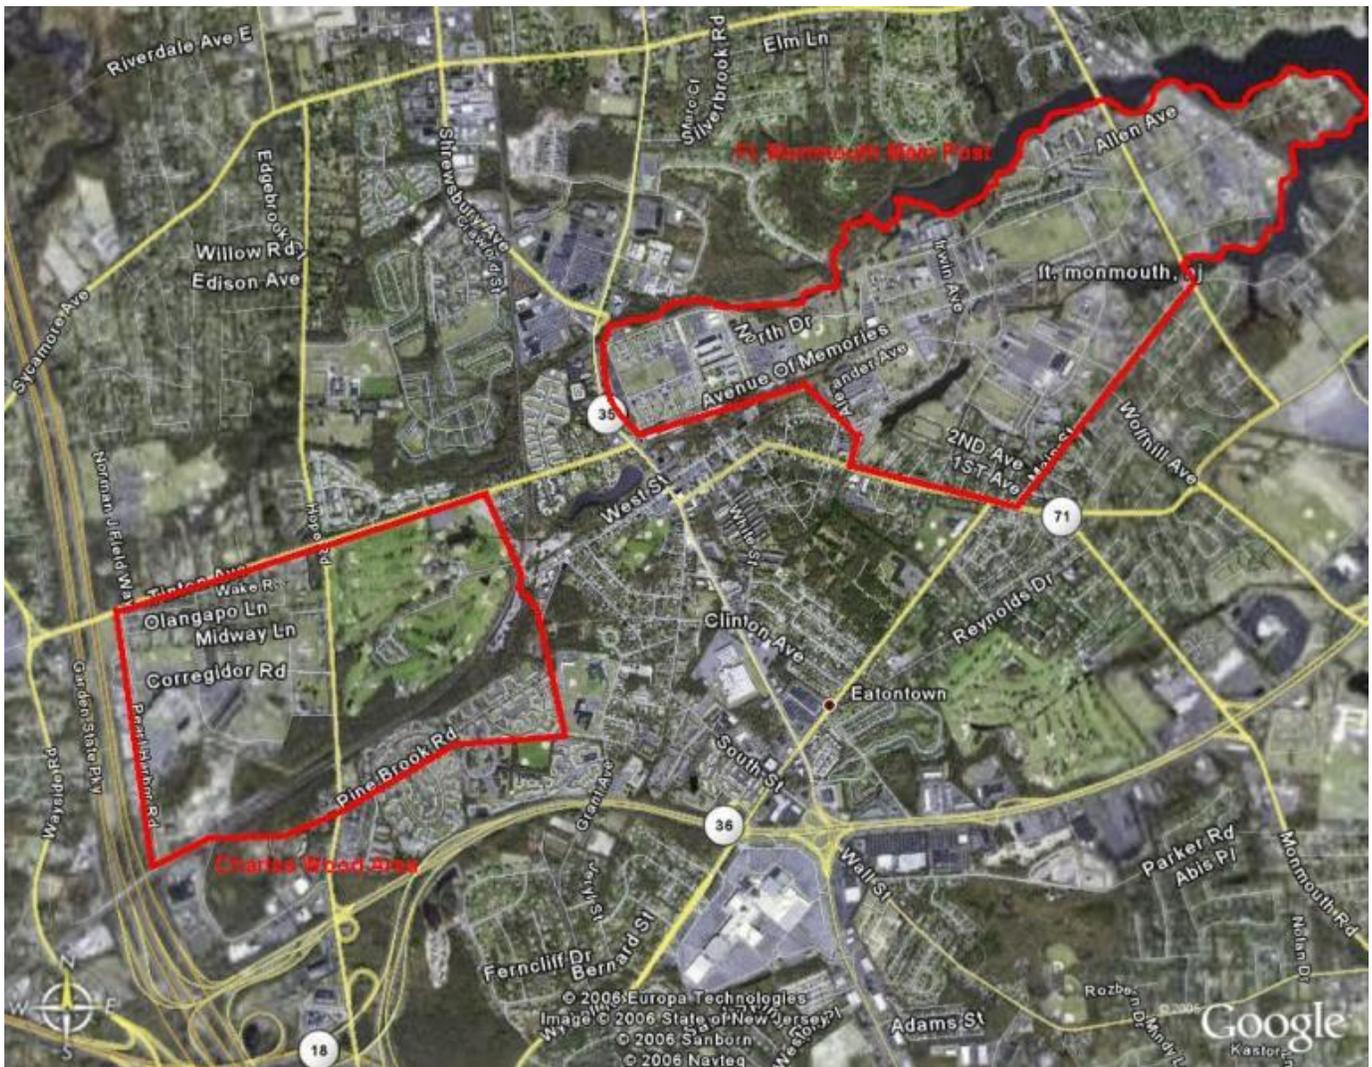
**FIGURE 3-1: AERIAL VIEW OF FORT MONMOUTH**

The Main Post encompasses approximately 630 acres and contains a total of 397 buildings and structures. The Main Post is bounded by State Highway 35 to the west, Parkers Creek to the north, the New Jersey Transit Railroad to the east, and Main Street and State Highway 71 to the south, as shown in the aerial view photograph (Figure 3-1). The Charles Wood Area, located approximately one mile southwest of the Main Post, is composed of approximately 511 acres and contains a total of 241 buildings and structures (Figure 3-1). This area is bounded by the Garden State Parkway to the west, Tinton Avenue to the north, Maxwell Place and the New Jersey Transit Railroad to the east, and Pine Brook Road to the south.

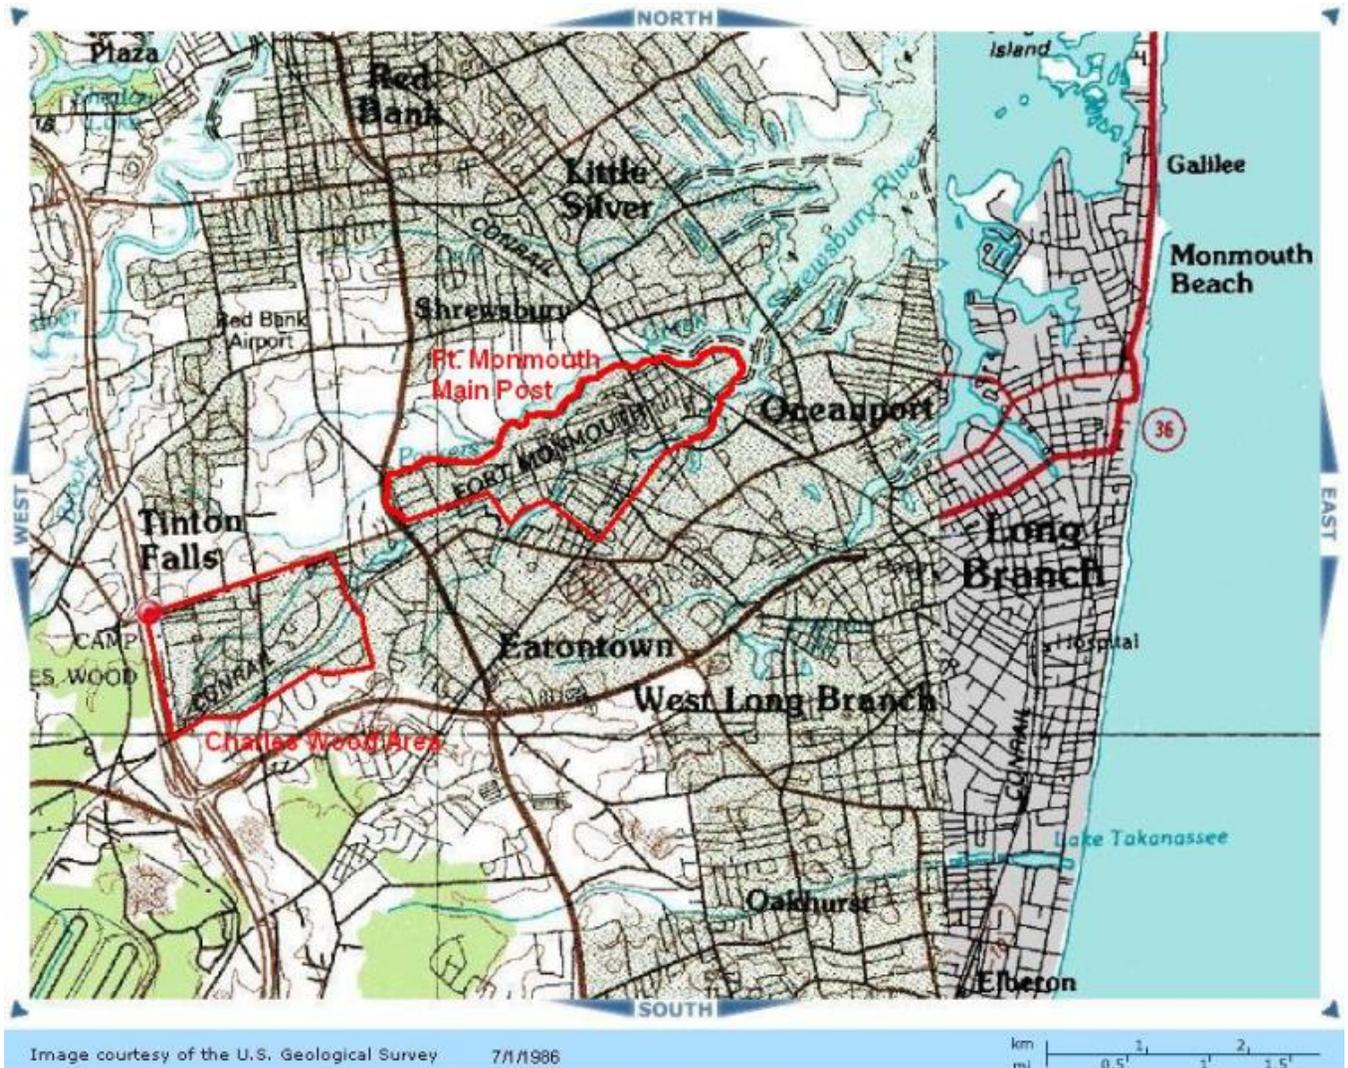
**FIGURE 3-2: TOPOGRAPHIC DETAIL OF FORT MONMOUTH AND SURROUNDING AREA**

Topography at both the Main Post and Charles Wood areas is characterized generally by low relief. Elevations above mean sea level range from 5-34 feet and 26-60 feet, respectively, with regional slope generally towards the Atlantic Ocean (i.e., towards the east). Figure 3-2 provides the U.S. Geological Survey (USGS) topographic map for Fort Monmouth and the surrounding areas. Over the past 80 years, the natural topography of Fort Monmouth has been altered by excavation and filling activities by the military. The dominant topographic feature affecting contaminant transport and fate is the network of tributaries throughout Fort Monmouth that drain to the Shrewsbury River. The drainage network is discussed in detail in Section 3.2.3. (Ref. 068)

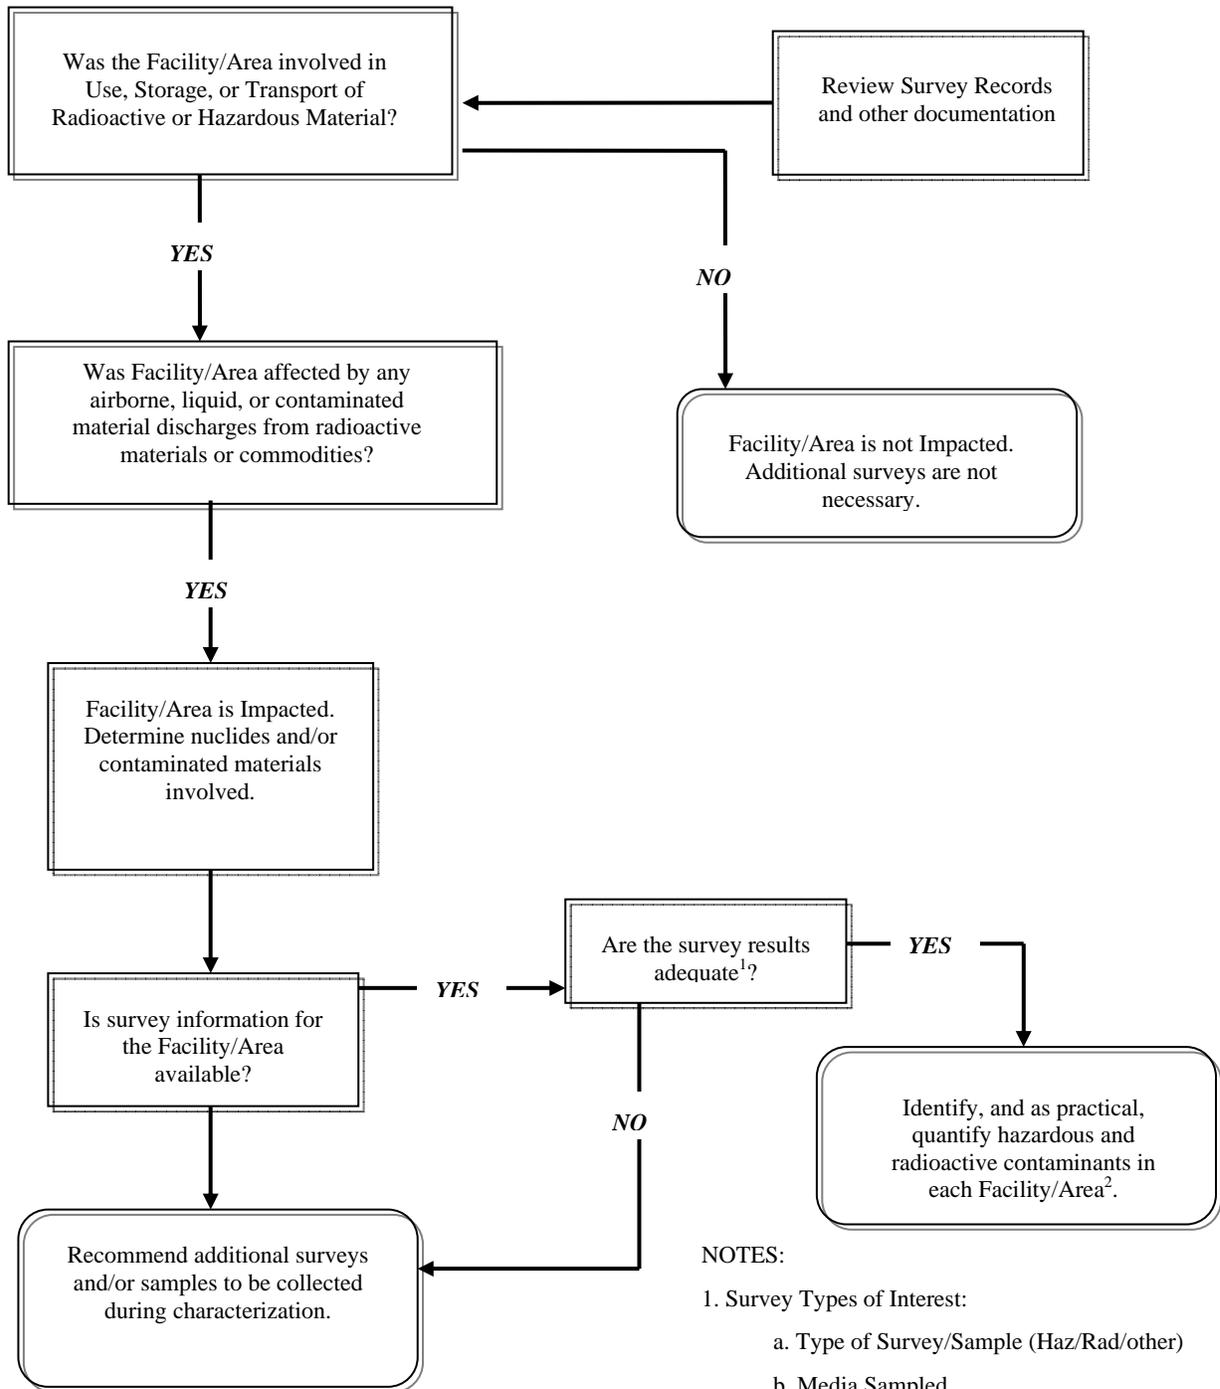
The HSA also evaluates potential migration of contamination in the environment and makes recommendations for future surveys. To achieve this goal, a systematic approach was developed for screening the Fort Monmouth facilities, as outlined in Figure 4-1.

1. Survey Types of Interest:
  - a. Type of Survey/Sample (Haz/Rad/other)
  - b. Media Sampled
  - c. Depth and extent/number
  - d. Post-Survey Contamination Potential
2. If a Facility/Area has been demolished or removed, consider a survey of the site of the former building, as appropriate.

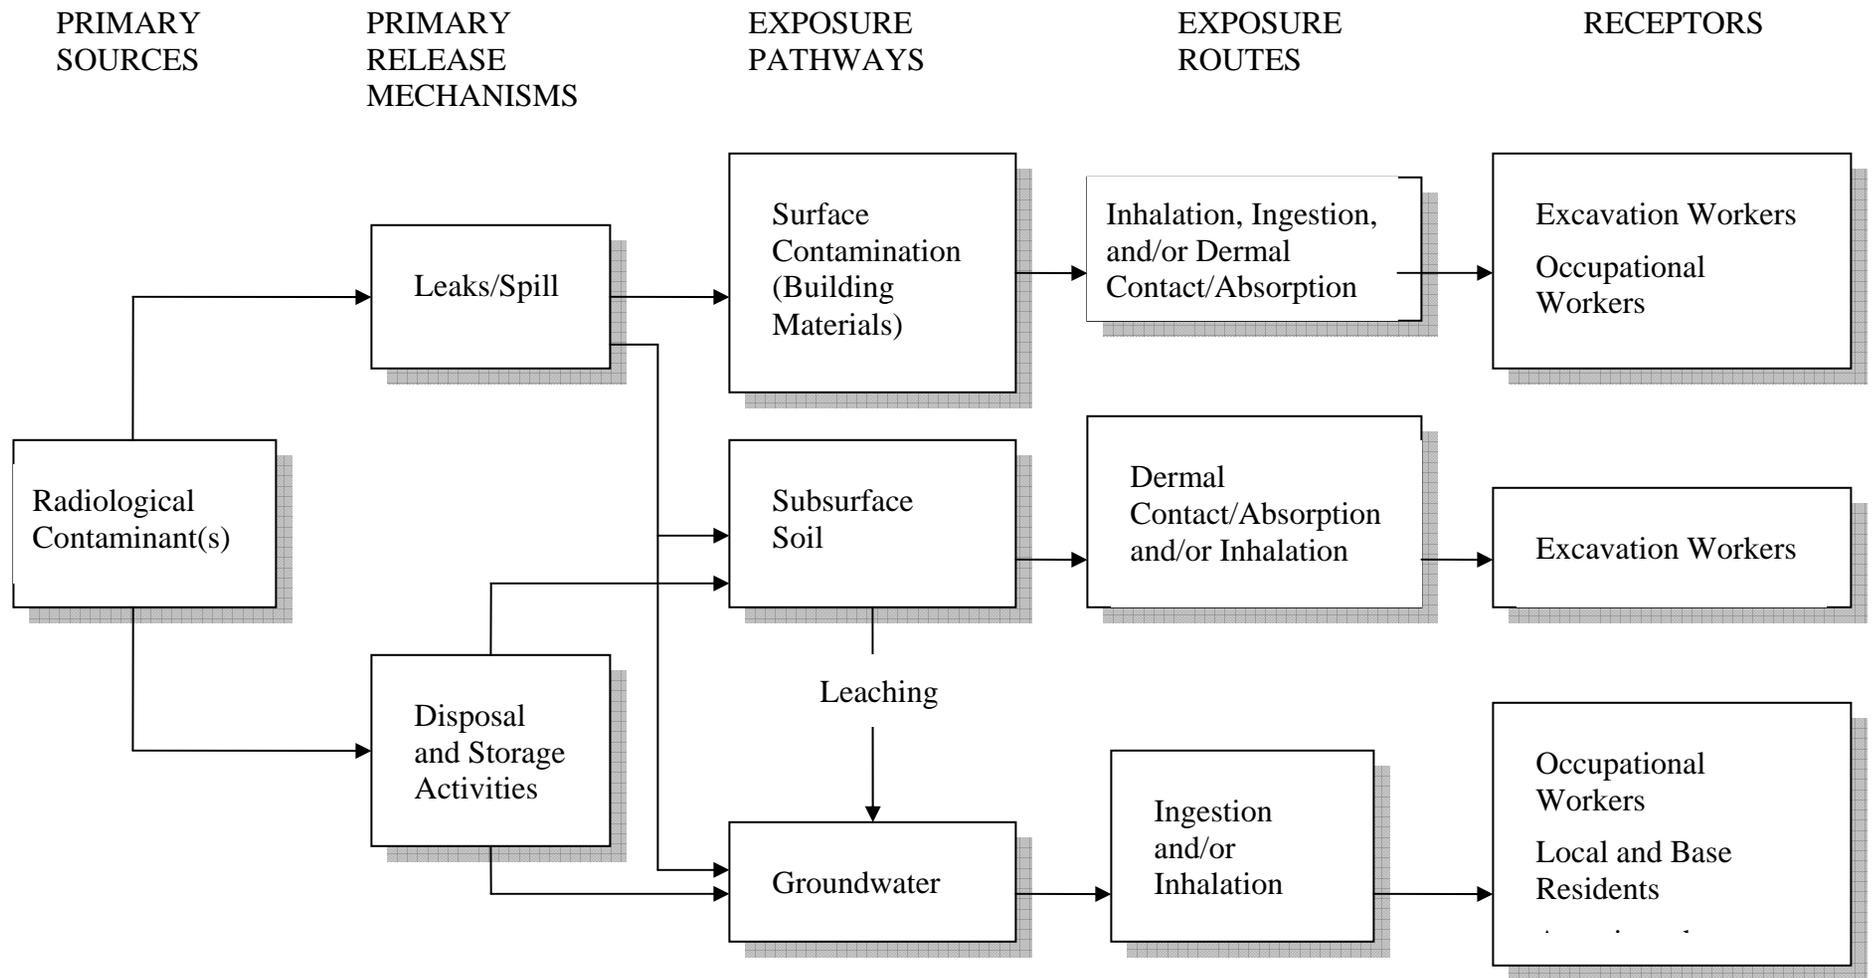
**FIGURE 7-1: CONCEPTUAL SITE MODEL (CSM) FOR FORT MONMOUTH**

Surface contamination of building materials (work surfaces, shelves, floors, walls, ceilings, etc.) is considered a primary transport mechanism. A secondary mechanism may be contaminants leaching from soil or from leaky drain/sewer systems to groundwater. This could occur through the network of tributaries throughout Fort Monmouth and shallow aquifers that ultimately drain into the Shrewsbury River.

- Inhalation, ingestion, and/or dermal contact with contaminants found on building materials and/or transfer of contamination following dermal contact to other materials;
- Dermal contact/absorption and/or inhalation with subsurface soils during excavation activities or with building materials during demolition activities;
- Ingestion and/or inhalation of leachate in surface water and sediment downgradient of contaminated soil areas;
- Inhalation, ingestion, and/or dermal contact with or absorption of groundwater downgradient of contamination sources.

Human receptors potentially include Fort Monmouth occupational workers who are in daily contact with radiological materials or work in and around potentially contaminated buildings. In addition, any excavation workers on the base who are involved in soil excavation or building demolition activities would be potential receptors. Base and off-site local residents are potentially impacted via transfer of contamination obtained through contact with commodities or building materials, as well as contact with contaminated groundwater. Ecological receptors potentially include aquatic wildlife and terrestrial plants and wildlife in and around the base area, which also can translate to human receptors through activities such as game hunting or fishing. The likelihood of impact to any of these receptors is minimal.
