**AMMENDMENT TO THE FINDING OF SUITABILITY TO LEASE  
FORT MONMOUTH NEW JERSEY,  
FORT MONMOUTH MARINA  
APRIL 2014**

**Project Title:** Amendment to the Finding of Suitability to Lease (FOSL) Fort Monmouth New Jersey, Fort Monmouth Marina, dated June 2013

# Asbestos Survey and Assessment

## U.S. Army Fort Monmouth, Building 450 Tinton Falls, New Jersey

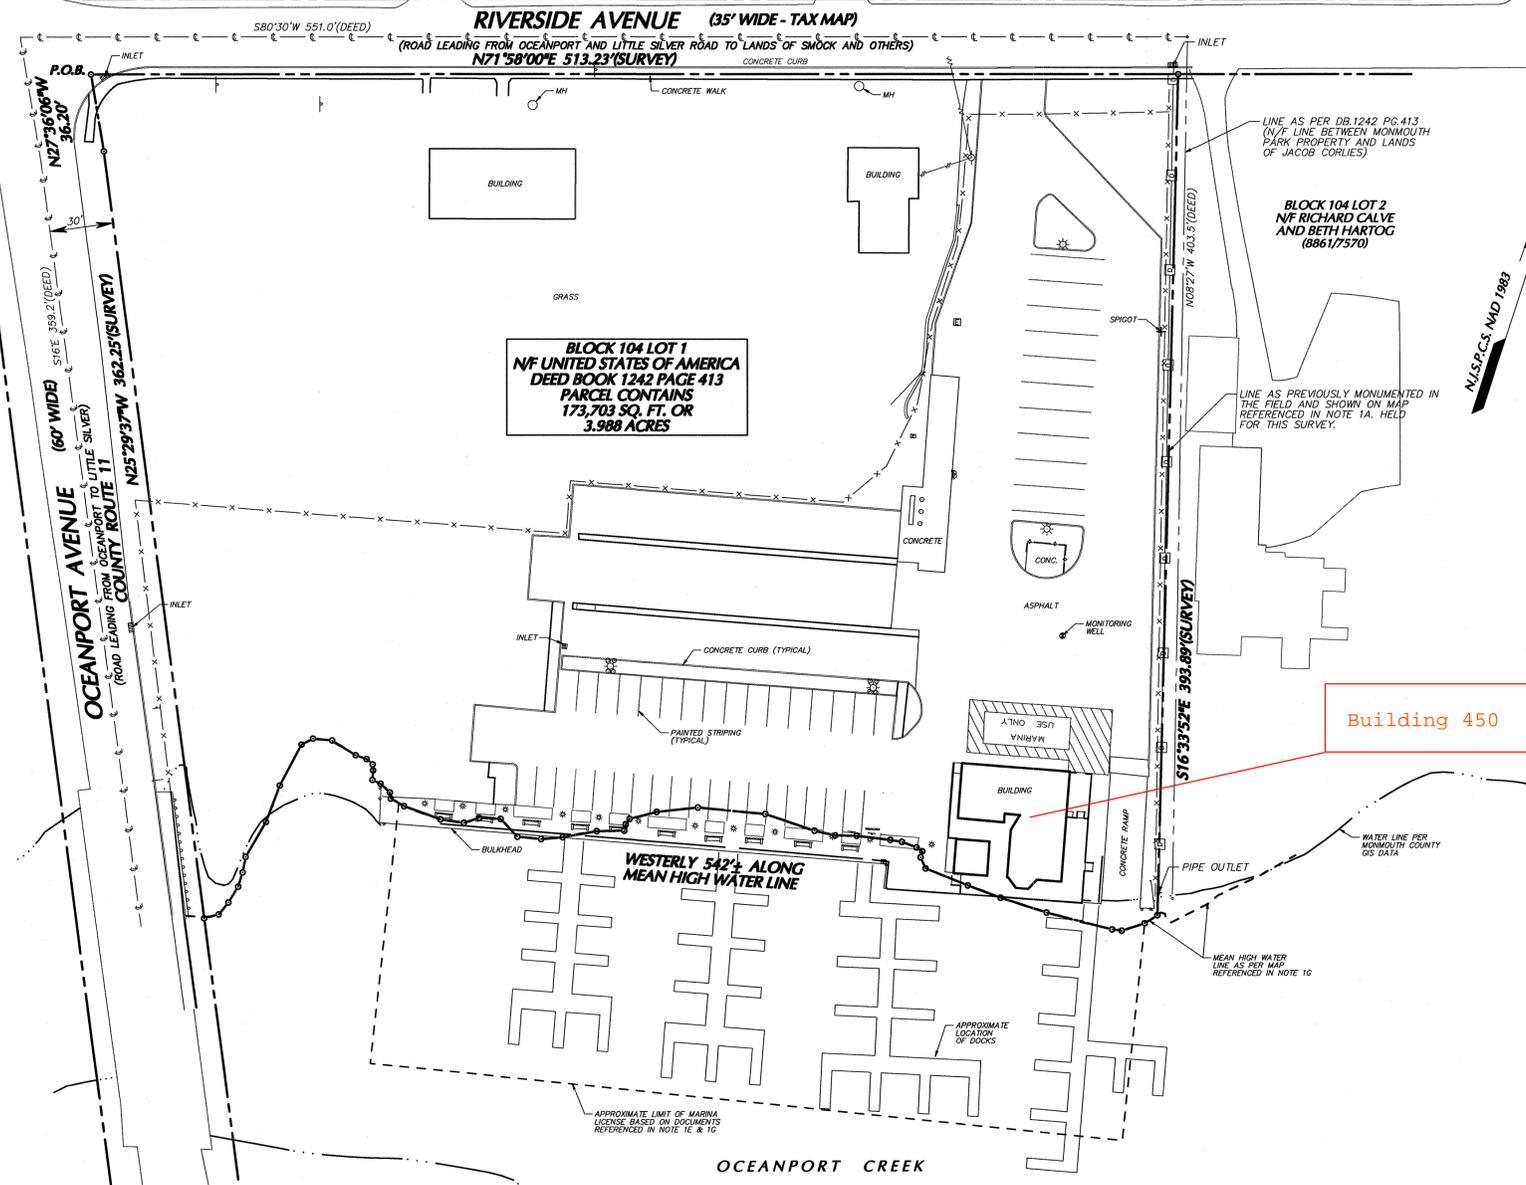
Drawing Title  
**ALTA/ACSM LAND TITLE SURVEY**  
 BLOCK 104, LOT 1

5. PLANIMETRIC INFORMATION SHOWN HEREON ALONG THE OUTBOUND LIMITS OF THE PARCEL AND WITHIN THE MARINA AREA HAS BEEN OBTAINED FROM GROUND SURVEYS BY LANGAN ENGINEERING AND ENVIRONMENTAL SERVICES, INC. DURING NOVEMBER 2012.

10. PARCEL AREA IS BASED ON THE FOLLOWING:
  - OCEANPORT AVENUE BEING 60 FEET WIDE AS PER TAX MAP, MONMOUTH COUNTY ROAD PLAN AND MAP REFERENCED IN NOTES 1A & 1B. RIGHT OF WAY DEPICTED ON MAP REFERENCED IN NOTE 1A WAS HELD.

- RIVERSIDE AVENUE BEING 35 FEET WIDE AS PER TAX MAP. ALIGNMENT SHOWN IS BASED ON PHYSICAL LOCATION OF ROADWAY. NO OTHER DOCUMENTS OR EVIDENCE HAVE BEEN FOUND WHICH WOULD HELP DETERMINE THE INTENDED ALIGNMENT. DEEDS LISTED IN NOTE 1F PROVIDE CONFLICTING DATA IN REGARDS TO CENTERLINE OF RIVERSIDE AVENUE AND ALSO LOT LINES.

- EASTERLY LINE SHOWN IS BASED ON MAP REFERENCED IN NOTE 1A. THIS LINE FOLLOWS EXISTING SITE CONDITIONS. DEED FOR PROPERTY IN QUESTION AND ADJOINING DEEDS PROVIDE CONFLICTING DATA FOR LOT LINES AND DO NOT MATCH EXISTING CONDITIONS. ALTHOUGH PROPERTY CORNER MARKERS WERE NOT FOUND FOR THIS SURVEY, THE REFERENCED 1969 SURVEY, WHICH WAS HELD, INDICATES THAT NUMEROUS PROPERTY MARKERS WERE SET AT THAT TIME. BASED ON THE CONFIGURATION OF EXISTING CONDITIONS ALONG THIS BOUNDARY LINE, IT APPEARS THEY WERE CONSTRUCTED USING THE PROPERTY MARKERS SHOWN ON THAT SURVEY.

- SOUTHERLY LINE SHOWN IS BASED ON TIDELANDS MAP REFERENCED IN NOTE 1G. BOUNDARY FOLLOWS LINE OF LANDS NOW OR FORMERLY FLOWED BY MEAN HIGH WATER AS DIGITIZED FROM SAID MAP. ALL PROPERTY WATERWARD OF THIS LINE IS OWNED BY THE STATE OF NEW JERSEY.

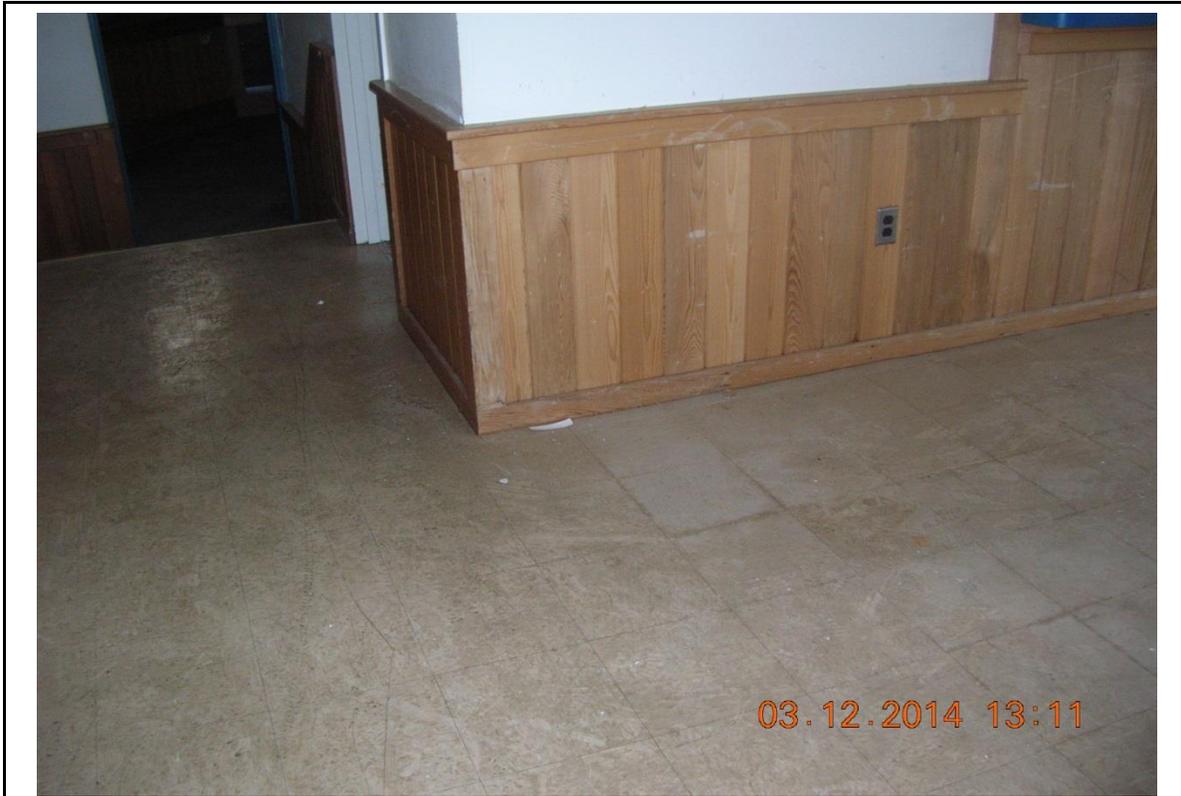
<b>PHOTO NO. 1</b>	<b>HA-1 Diner Eating Area – Beige Floor Tile</b>
<b>DESCRIPTION:</b>

- HA-1 Beige, 12-inch-by-12-inch, Vinyl Composite (Floor) Tile (VCT);
- HA-2 Tan/Yellow Glue associated with HA-1;
- HA-3 Blue/Grey, 12-inch-by-12-inch, Vinyl Composite (Floor) Tile (VCT);
- HA-4 Tan Glue associated with HA-3;
- HA-5 4-inch, Off-White, Vinyl base cove molding;
- HA-6 Yellow/Tan Mastic associated with HA-5;
- HA-7 Off-white, pitted, 2-foot-by- 2-foot, Ceiling Tile;
- HA-8 Wallboard;
- HA-9 Joint Compound associated with HA-8;
- HA-10 Grey, 1-inch –by- 1-inch Ceramic Floor Tile;
- HA-11 Cream-color Mortar associated with HA-10;
- HA-12 Gray Grout associated with HA-10;
- HA-13 Light Brown Ceramic Base Cove Molding;
- HA-14 Gray Grout associated with HA-13;
- HA-15 Cream-color Mortar associated with HA-13;

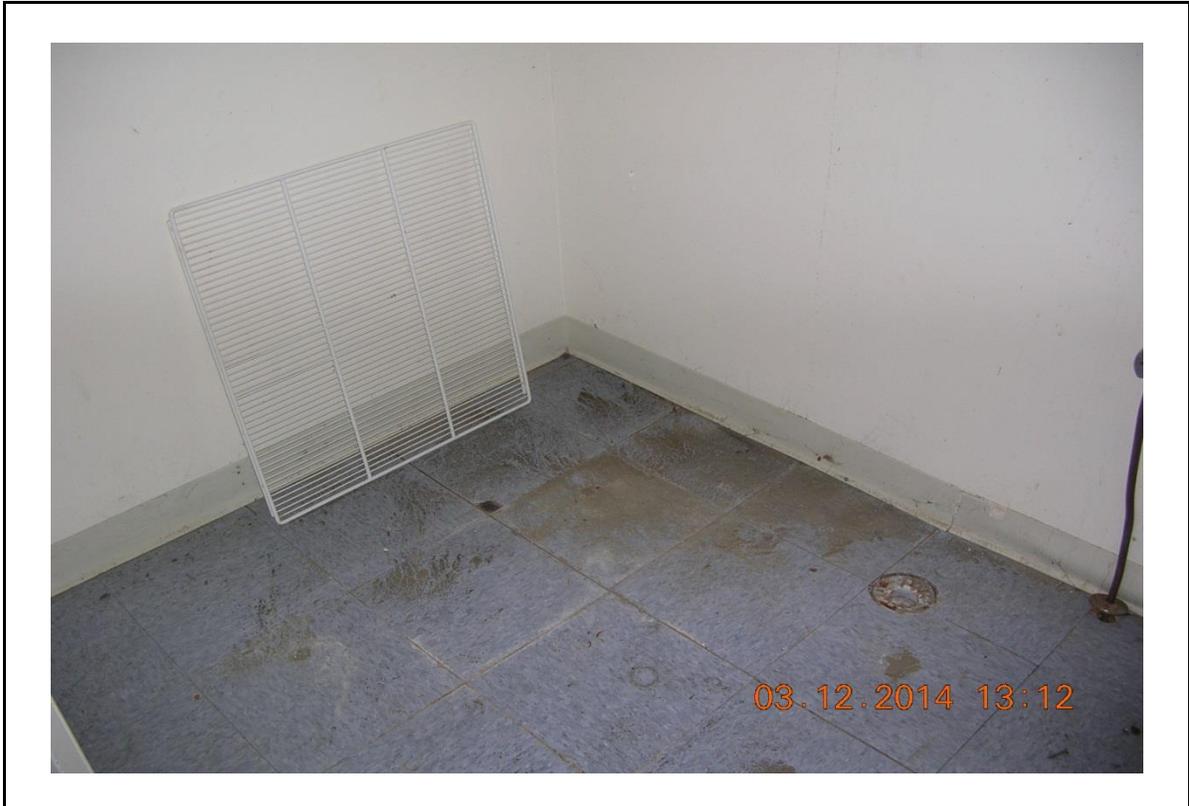
<b>PHOTO NO. 3</b>	<b>DESCRIPTION:</b>
	HA-3 Blue 12"x12" VCT – HA-5 Off white 4" Vinyl base cove molding

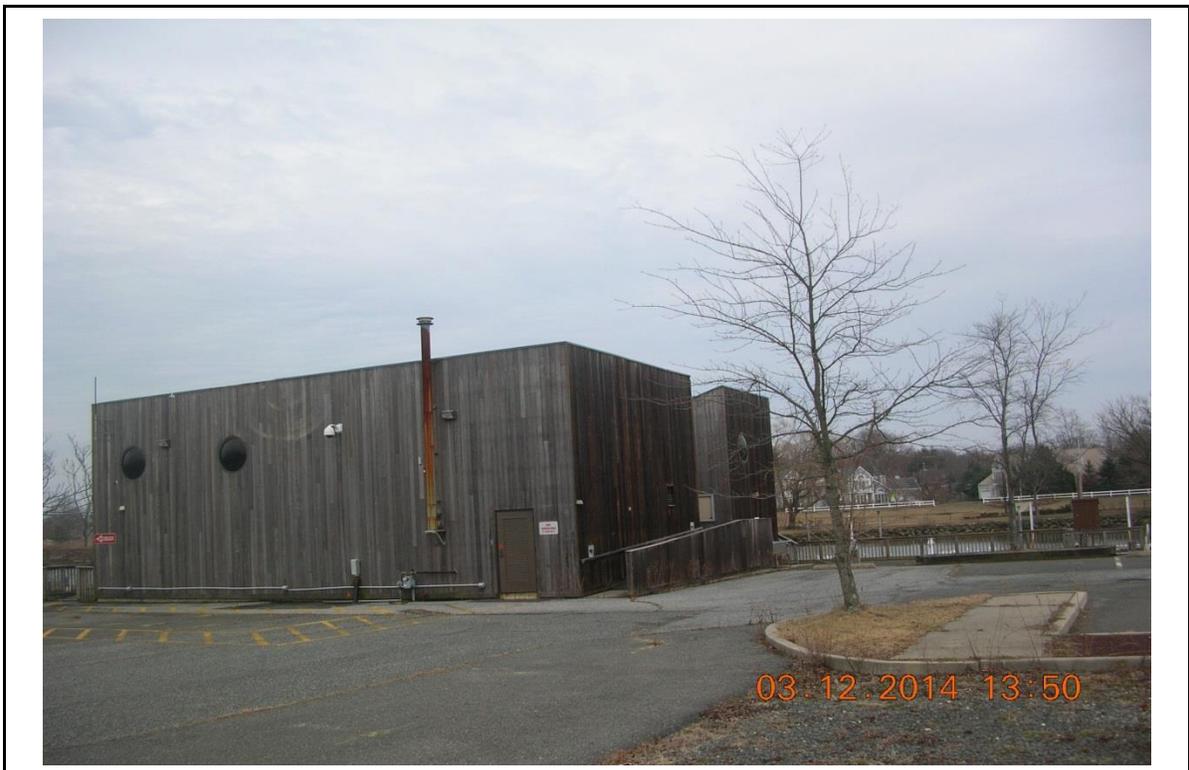
Building 450, located within the U.S. Army Fort Monmouth in Tinton Falls, New Jersey is an abandoned marina/diner that was completely flooded during Super Storm Sandy. The building is a single story, approximately 5,000 square foot structure, with open deck area. The floor is a concrete slab. The walls are sheetrock and wood. The building exterior is wood. The slope roofing consists of two (2) layers of roofing shingles and a layer of roof felt. No records of asbestos related activities at Building 450 were available to BVNA at the time of inspection.

<b>PHOTO NO. 4</b>	<b>DESCRIPTION:</b>
	Exterior of Building 450, North and West side

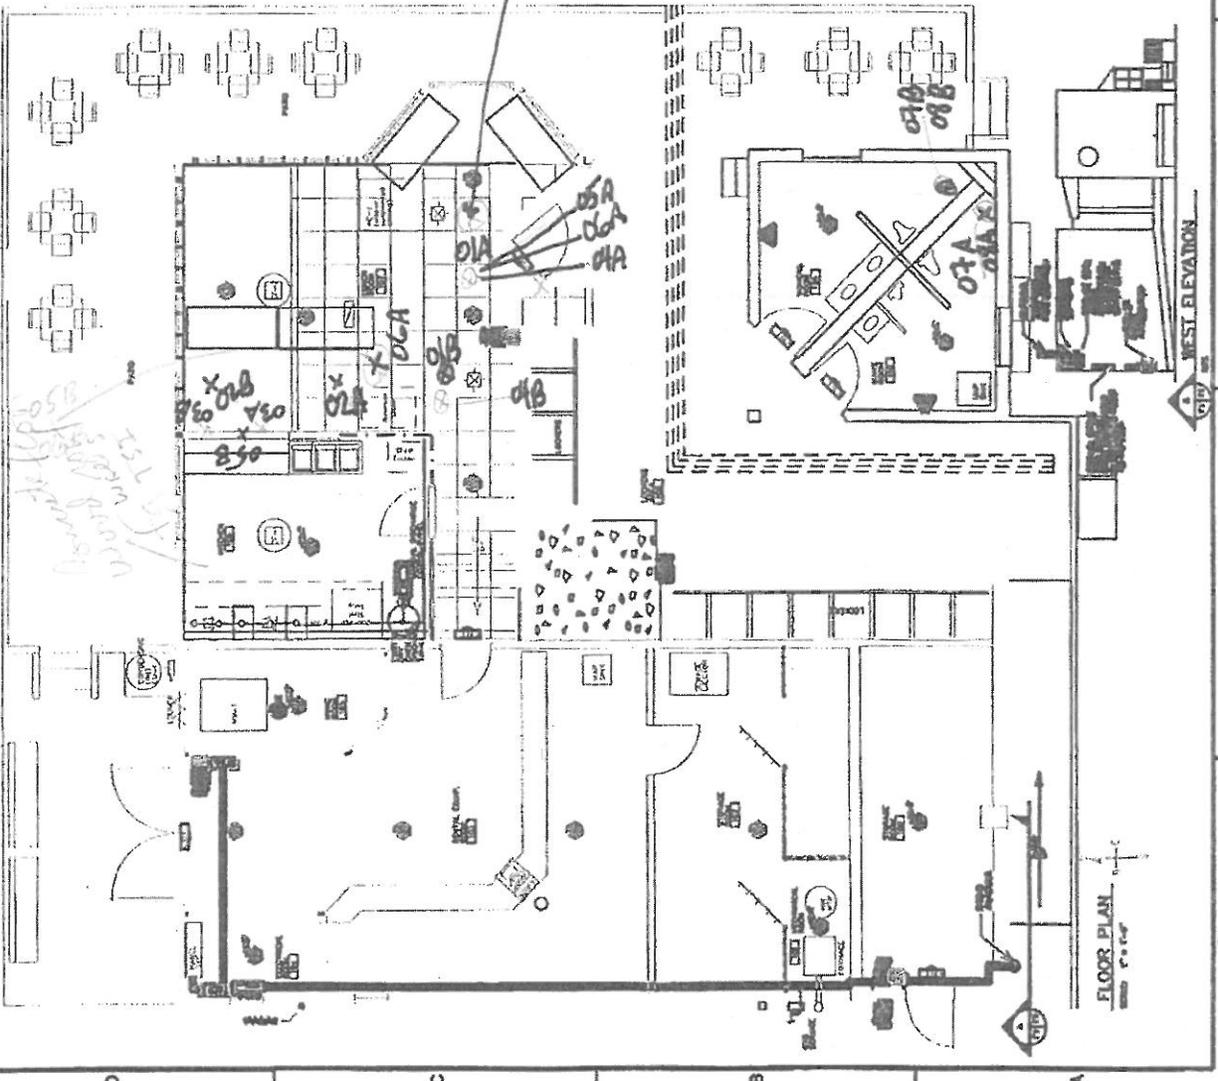
FLOOR PLAN

FM-031214-450-01A
