**ENVIRONMENTAL CONDITION OF
PROPERTY UPDATE REPORT**

**FORT MONMOUTH
ENVIRONMENTAL CONDITION OF PROPERTY PARCEL 14**

**U.S. Army
Base Realignment and Closure Office**

JUNE 2012

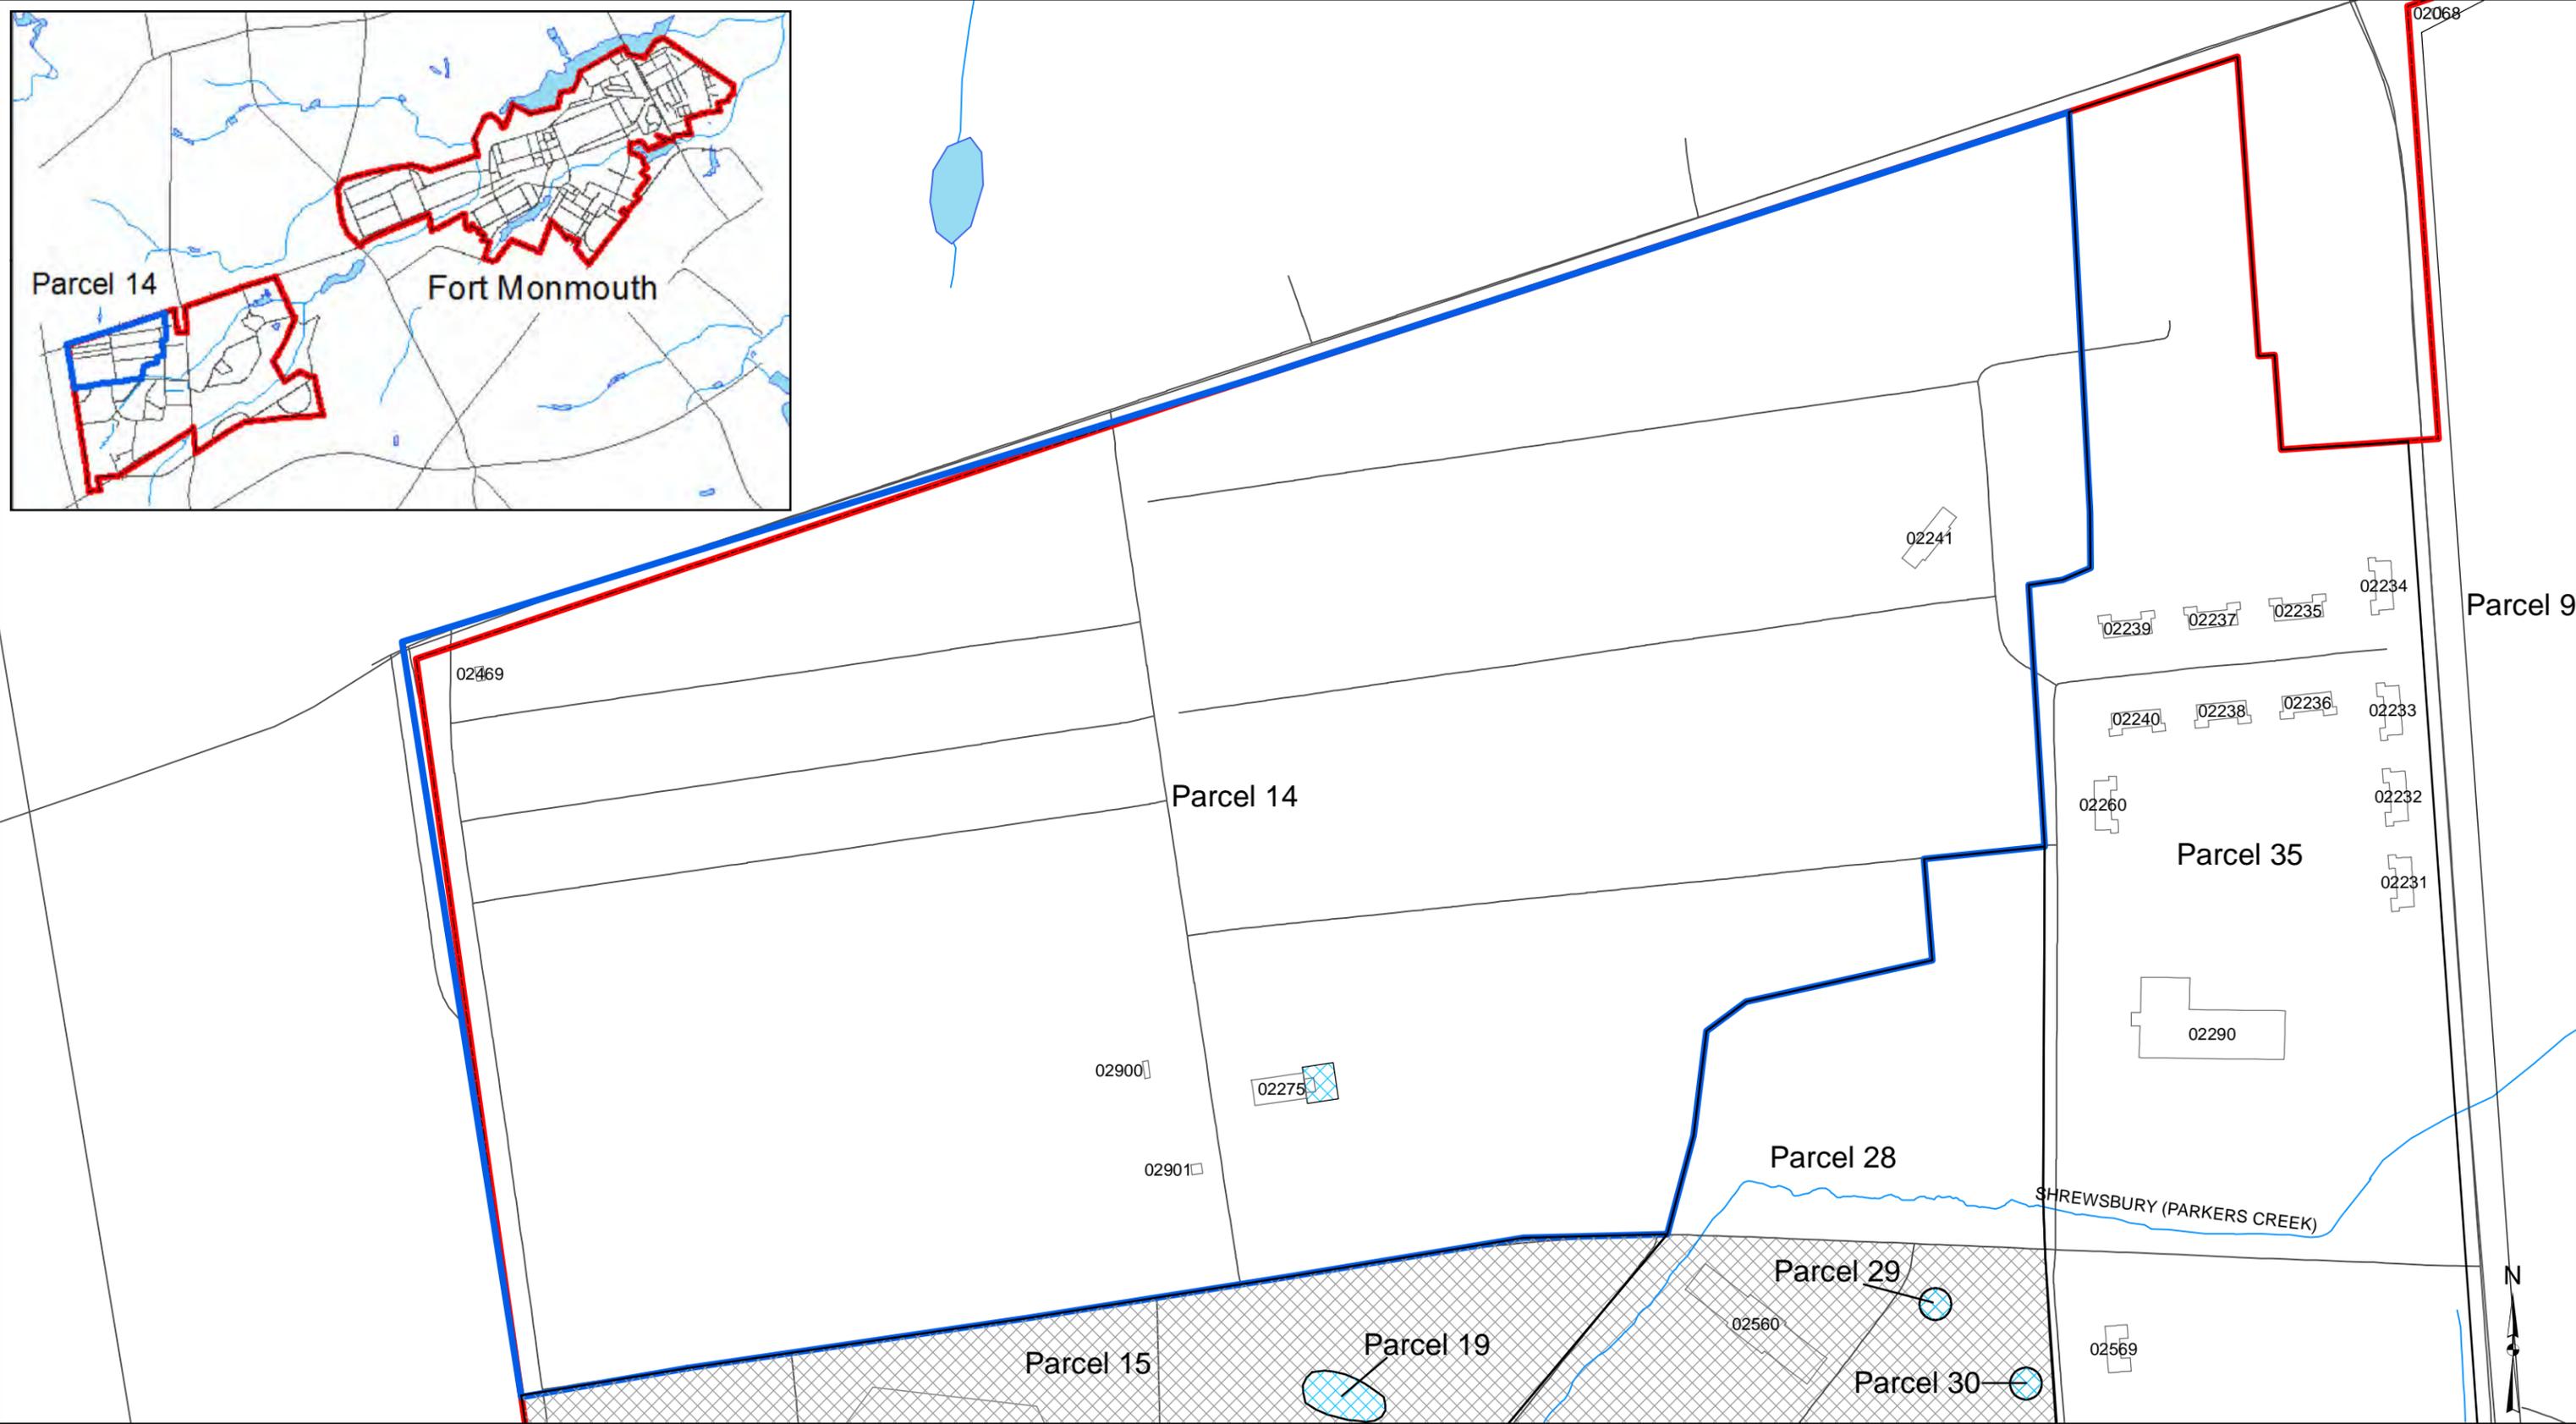
FIGURE 2
Environmental Condition of Property
Parcel 14
Updated Property Categories

The area of the site covered by this ECP Update is approximately 77.5 acres in the northeast corner of the Charles Wood Area of Fort Monmouth (see Figure 2). It should be noted that for purposes of organization and reporting in the original ECP, the property was divided into Parcels designated with numbers.

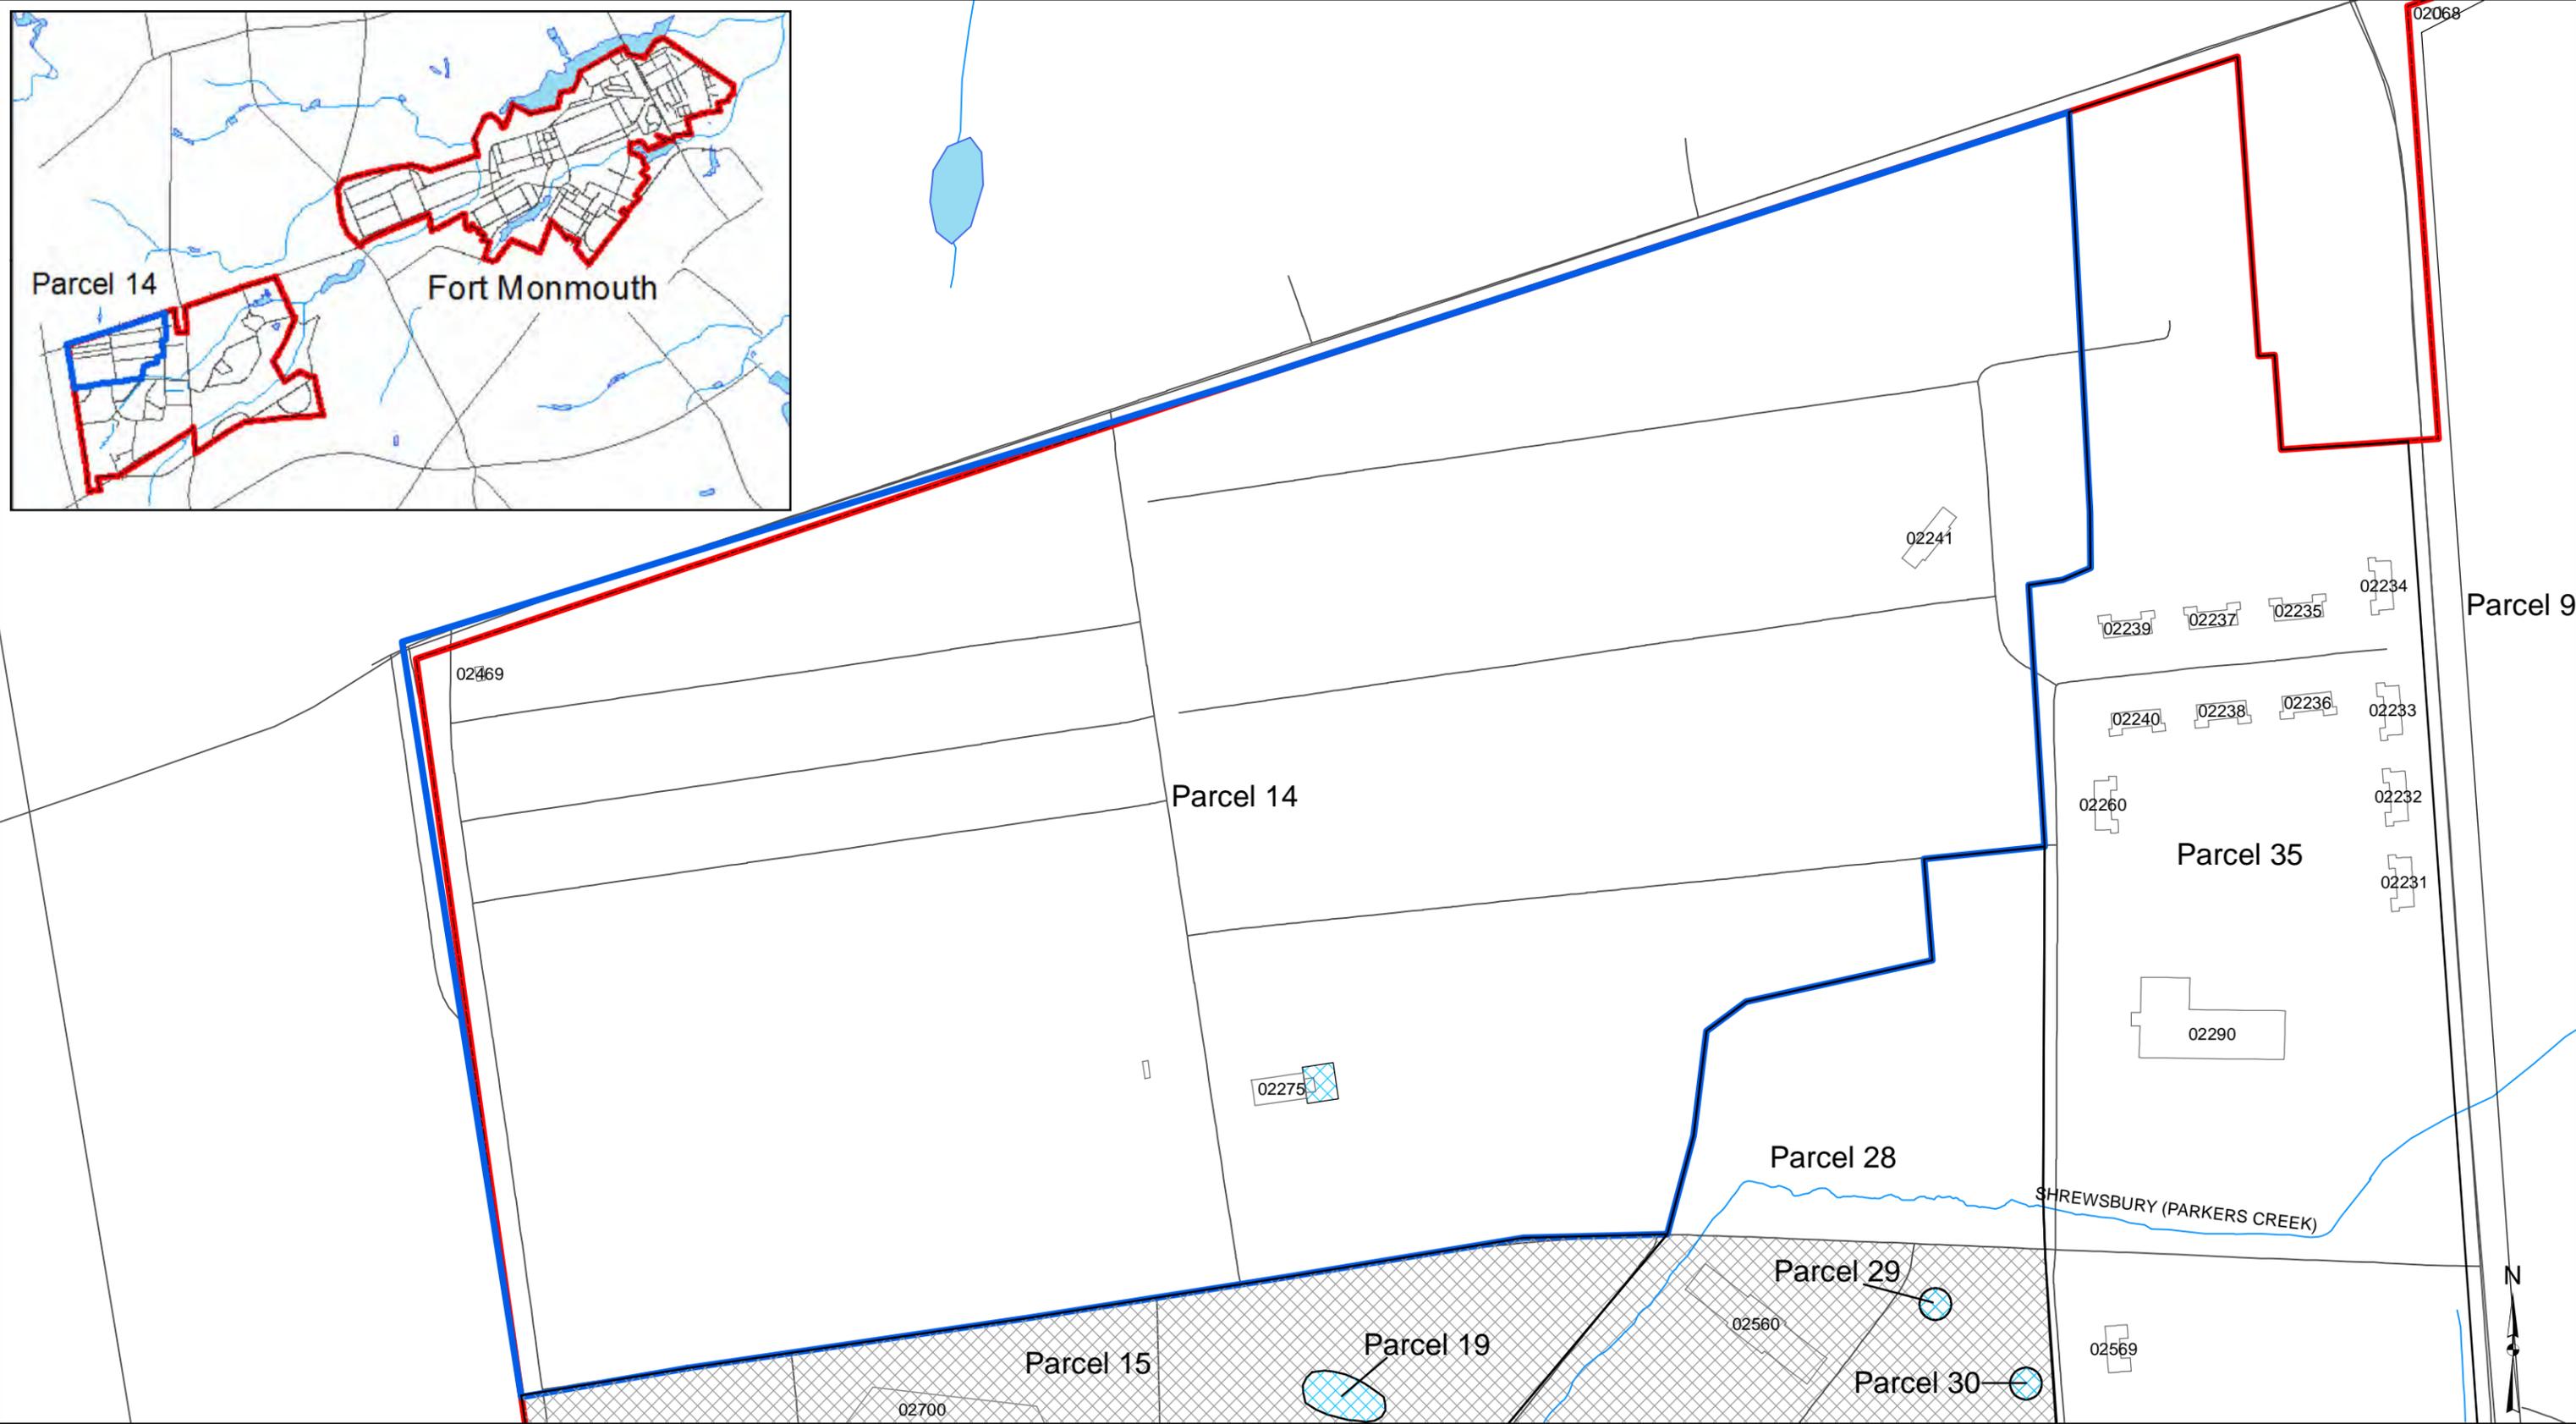
FIGURE 1
Environmental Condition of Property
Parcel 14
Updated Property Categories

In order to support the property transfer the Army is proposing to change the property classification for the majority of Parcel 14 from a Category 2, "Areas where only release or disposal of petroleum products has occurred" to a Category 1, "Areas in which no release or disposal of hazardous substances or petroleum products have occurred (including no migration of such substances from adjacent areas) and a visual inspection indicates that both the land and the buildings are uncontaminated." The one small area where the UST was removed from Building 2275 will remain a Category 2. The Army requests NJDEP's concurrence in the Category 1 designation for this area.

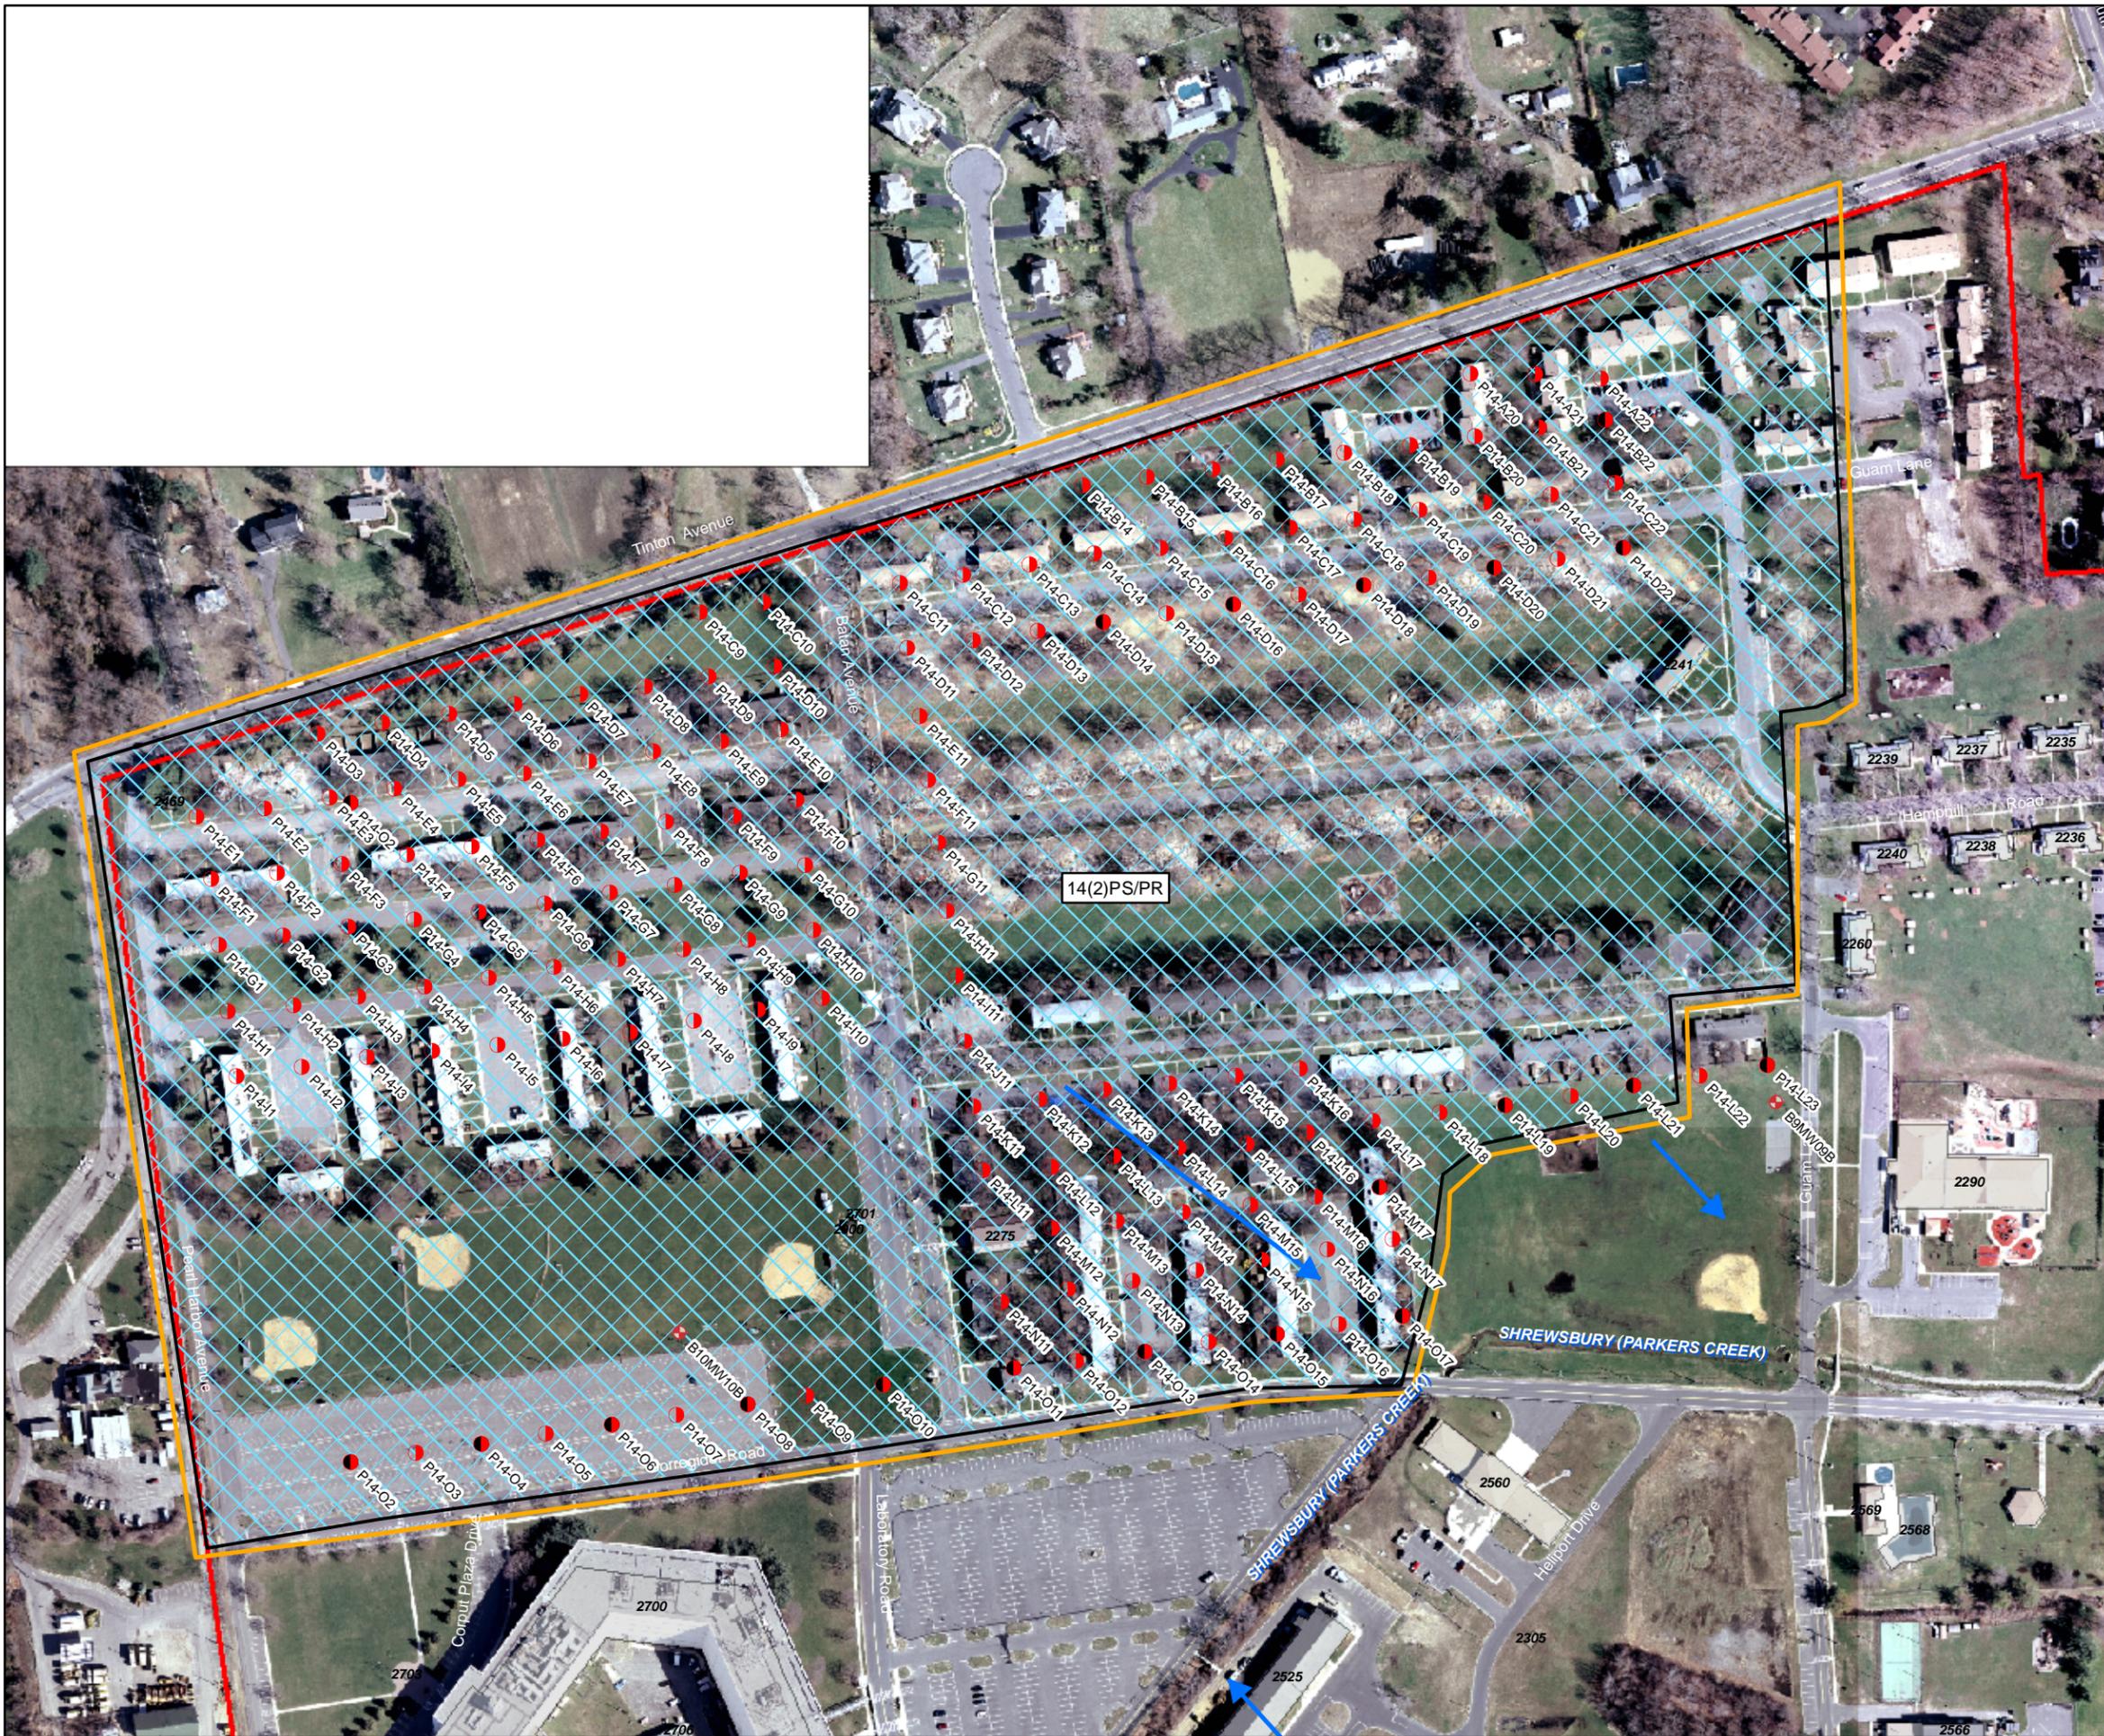
FIGURE 3.2-1
FORT MONMOUTH ECP
SITE INVESTIGATION
PARCEL 14 SAMPLE LOCATIONS
 CHARLES WOOD AREA
 FORT MONMOUTH
 NEW JERSEY

One suspected UST, near former Building 2116, was identified from the geophysical investigation conducted at Parcel 14. No COCs were identified above applicable NJDEP criteria in soil or ground water. Soil and groundwater analytical results indicated that no release had occurred. The location of the potential tank at former Building 2116 was investigated with test pitting to determine if the tank existed but no tank was found and only remnants of water, gas and sewer piping were identified.

In light of the absence of evidence of a release to the environment, NFA for soil, groundwater, and the suspected UST in Parcel 14 was recommended.

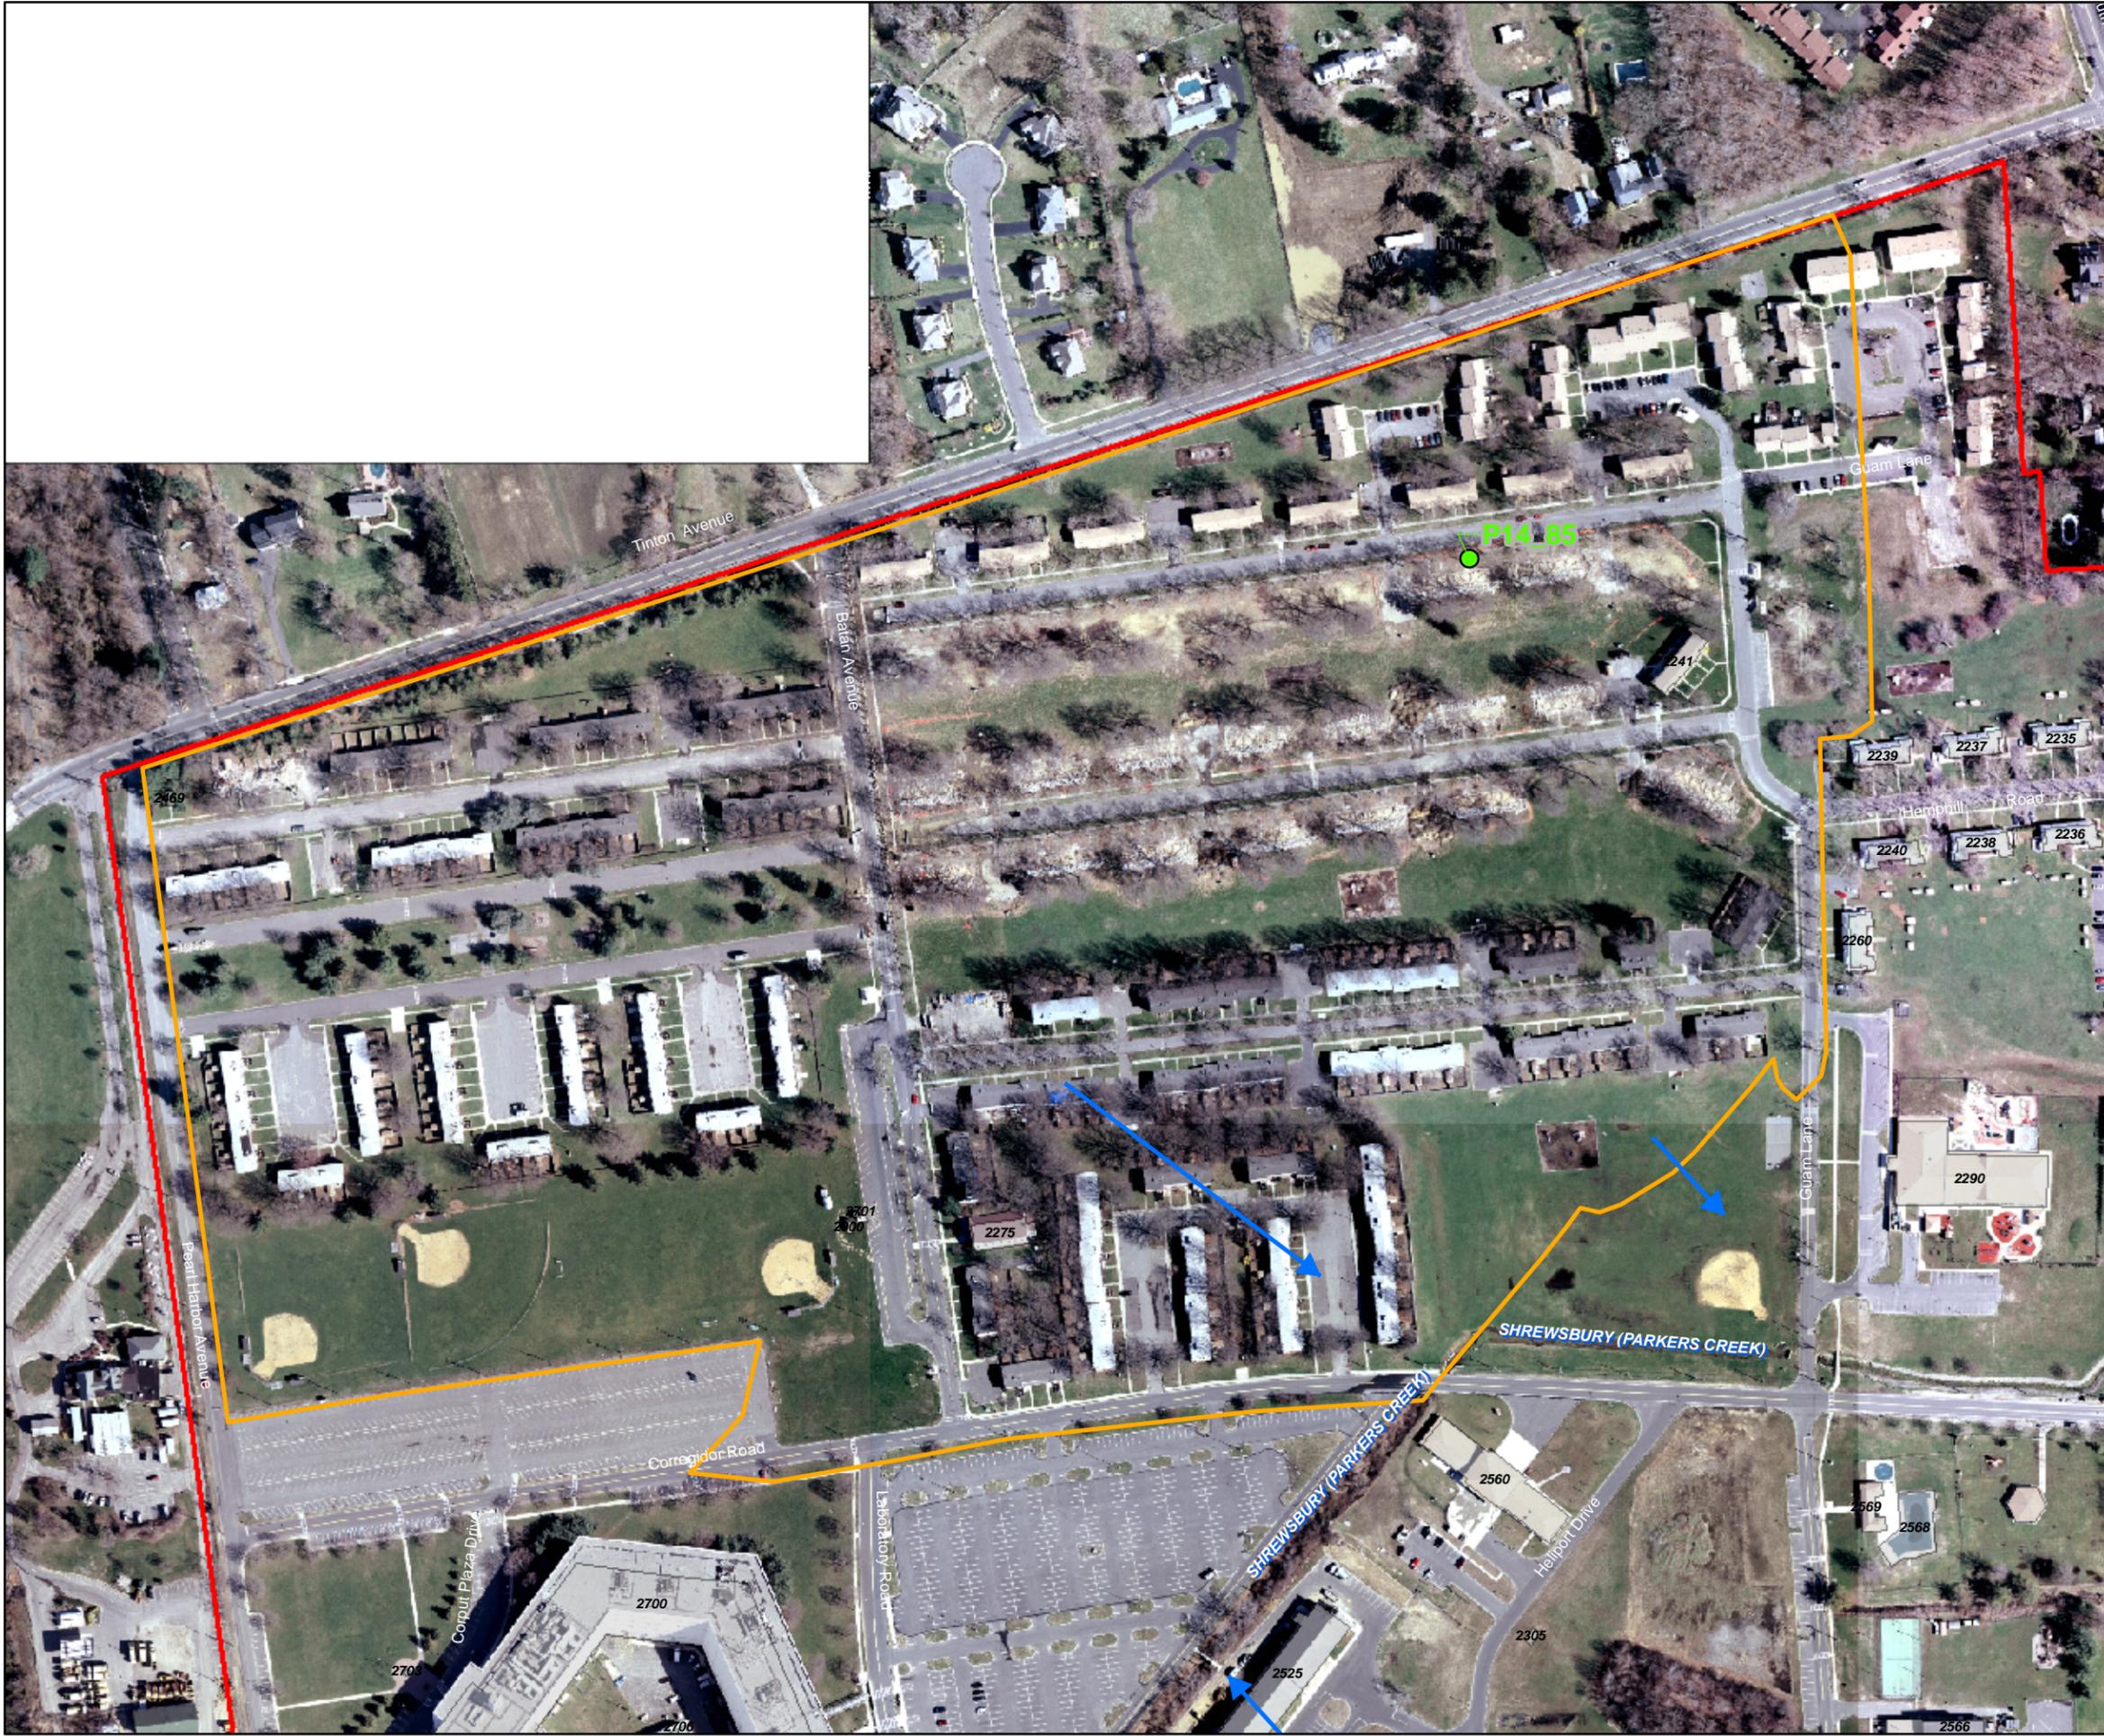
Table 3.2-1 presents a summary of field activities, and sample locations are provided on **Figure 3.2-1**. An analytical summary of soil and groundwater sampling activities, including sample IDs, collection dates, analytical parameters, and methods of analysis, are provided in **Table 3.2-2**.

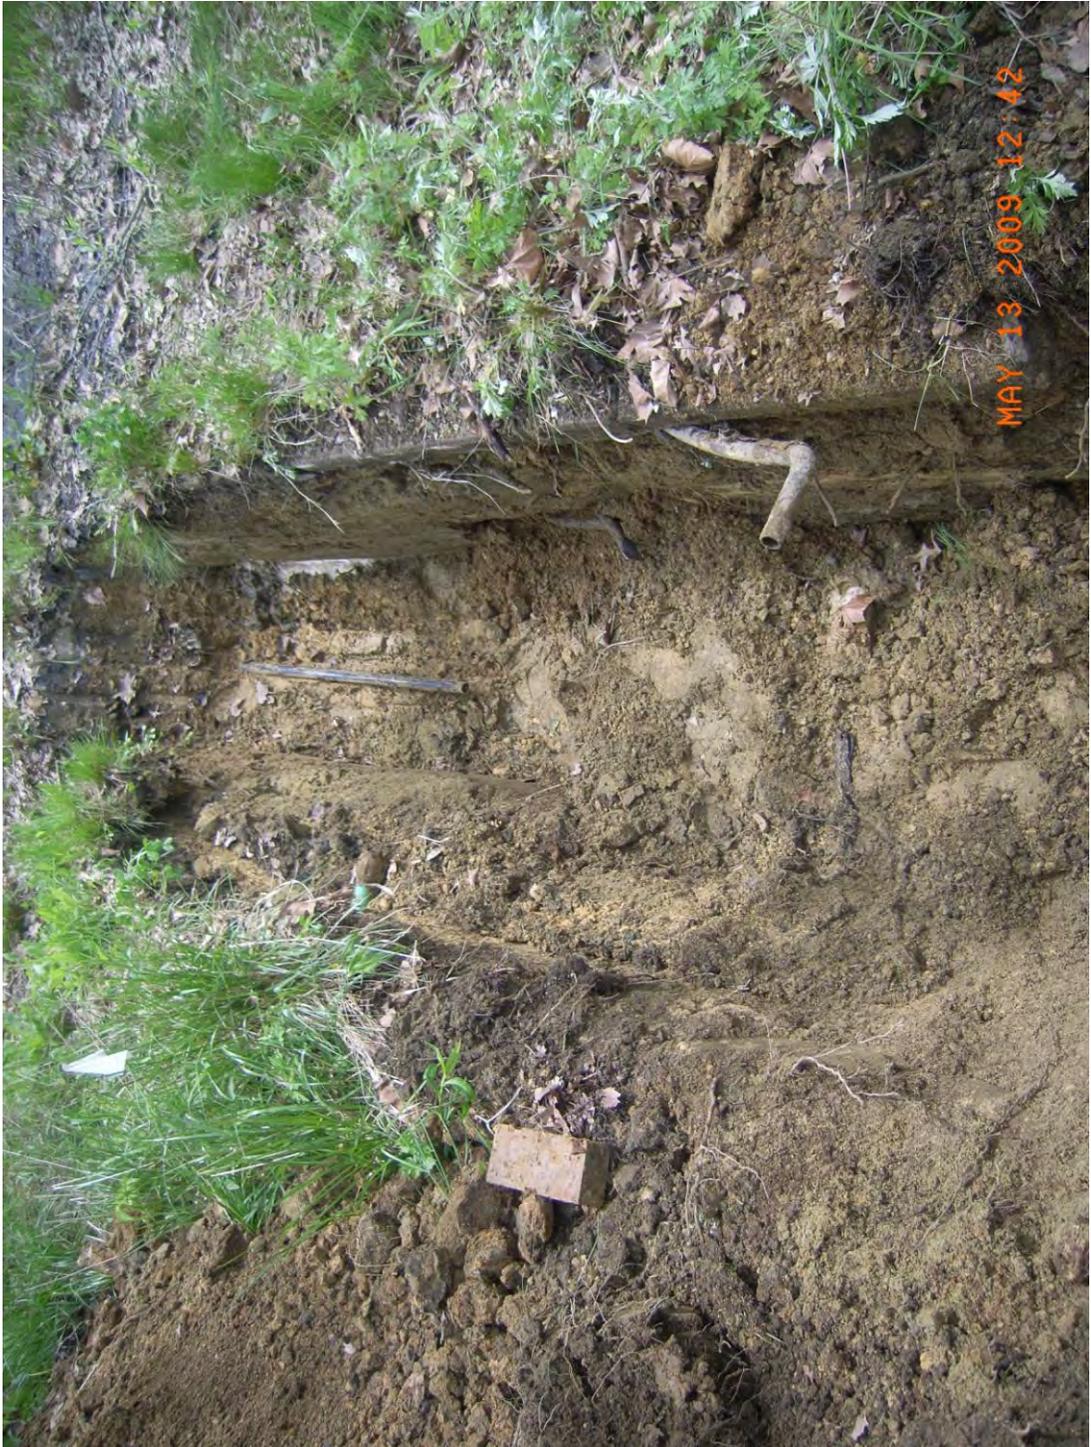
NO TANK WAS LOCATED IN TEST PIT, JUST ALOT OF
ABANDONED PIPES (WATER, NAT. GAS, SEWER)
