Thiokol Propulsion

19mm Twin Screw Extruder Incidents Briefing

Presented by:
Mike Rose

May 1, 2001

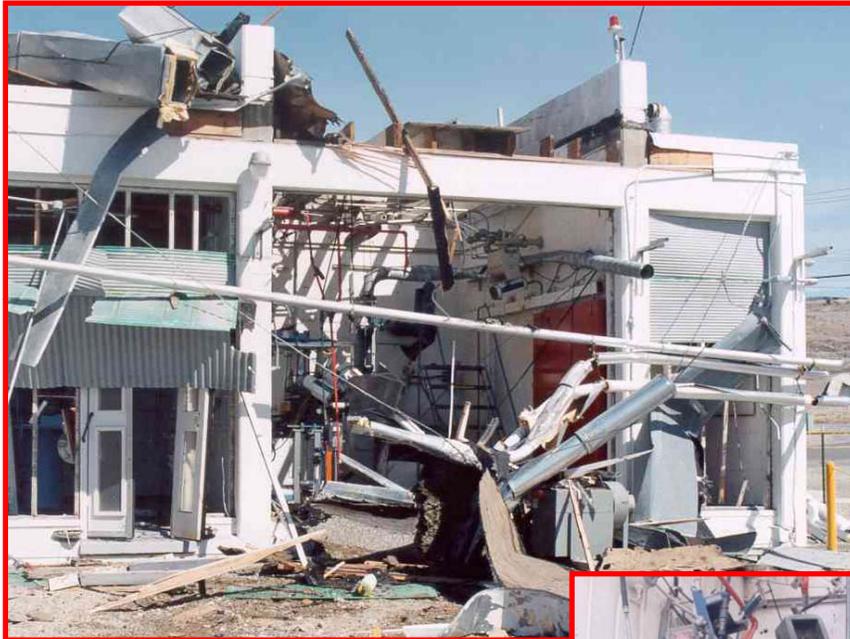
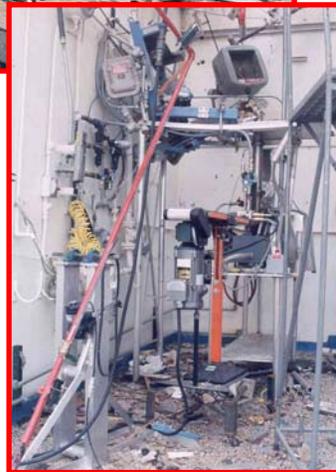
M-56 Facility

- Roof and blowout wall completely destroyed
- Significant damage to ducting and utilities

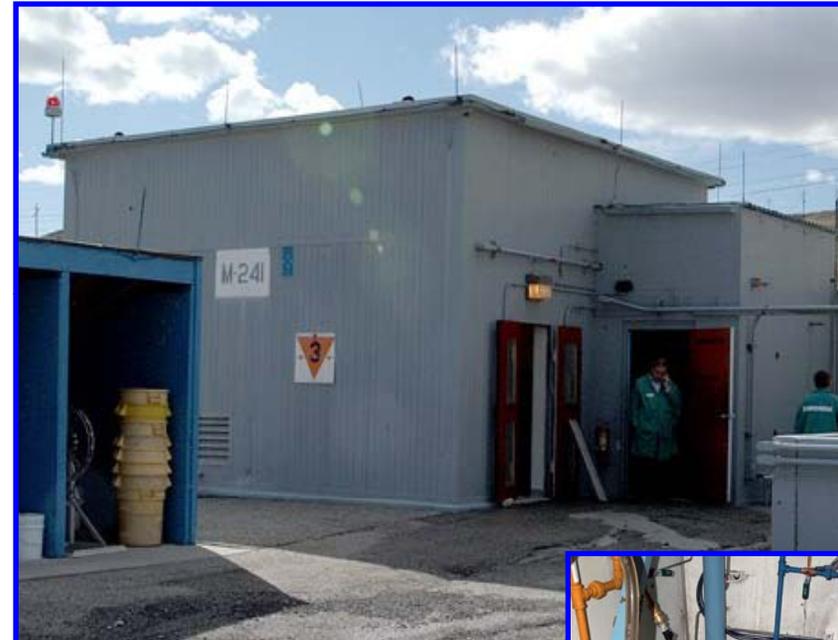
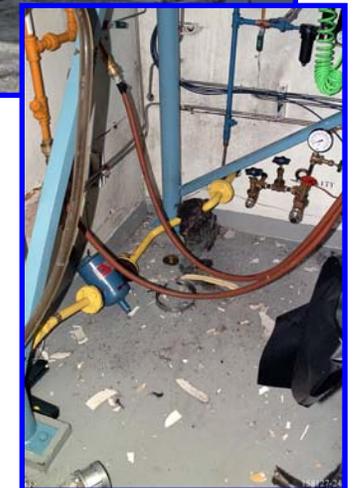
M-241 Facility

- Building structure not damaged
- Minor damage to vacuum line piping

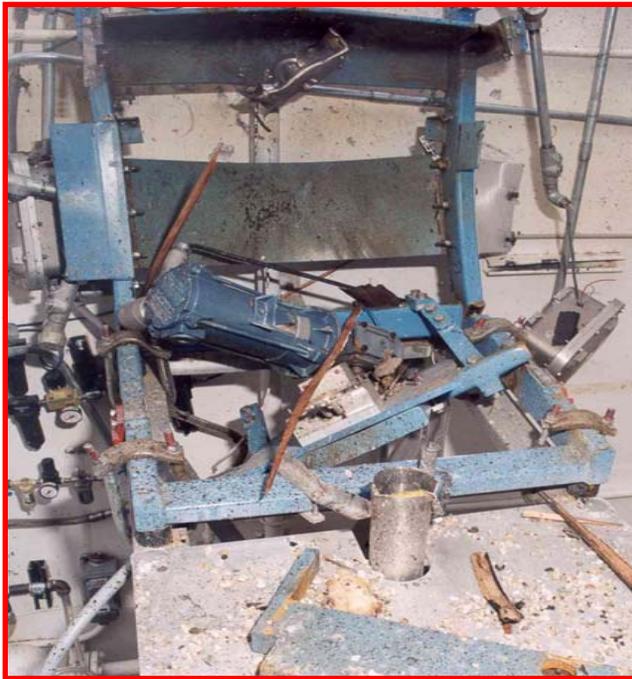
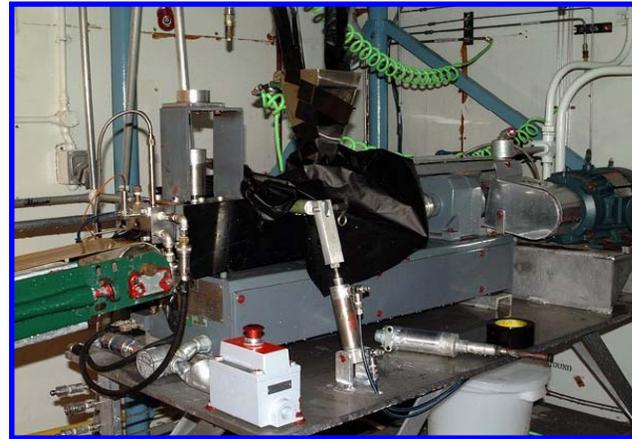
M-56 Equipment

- LIW feeder destroyed
- Screw shafts and elements ruined
- Minor damage to extruder

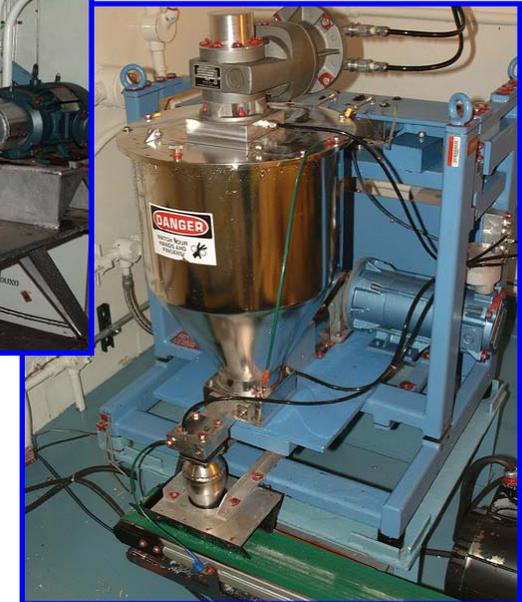
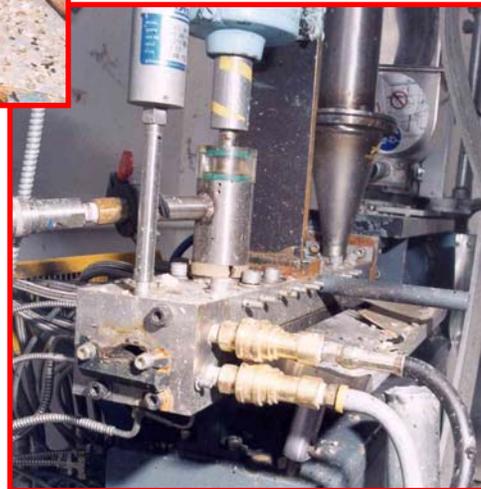
M-241 Equipment

- No damage to LIW feeder
- Screw shafts and elements ruined
- Minor damage to extruder

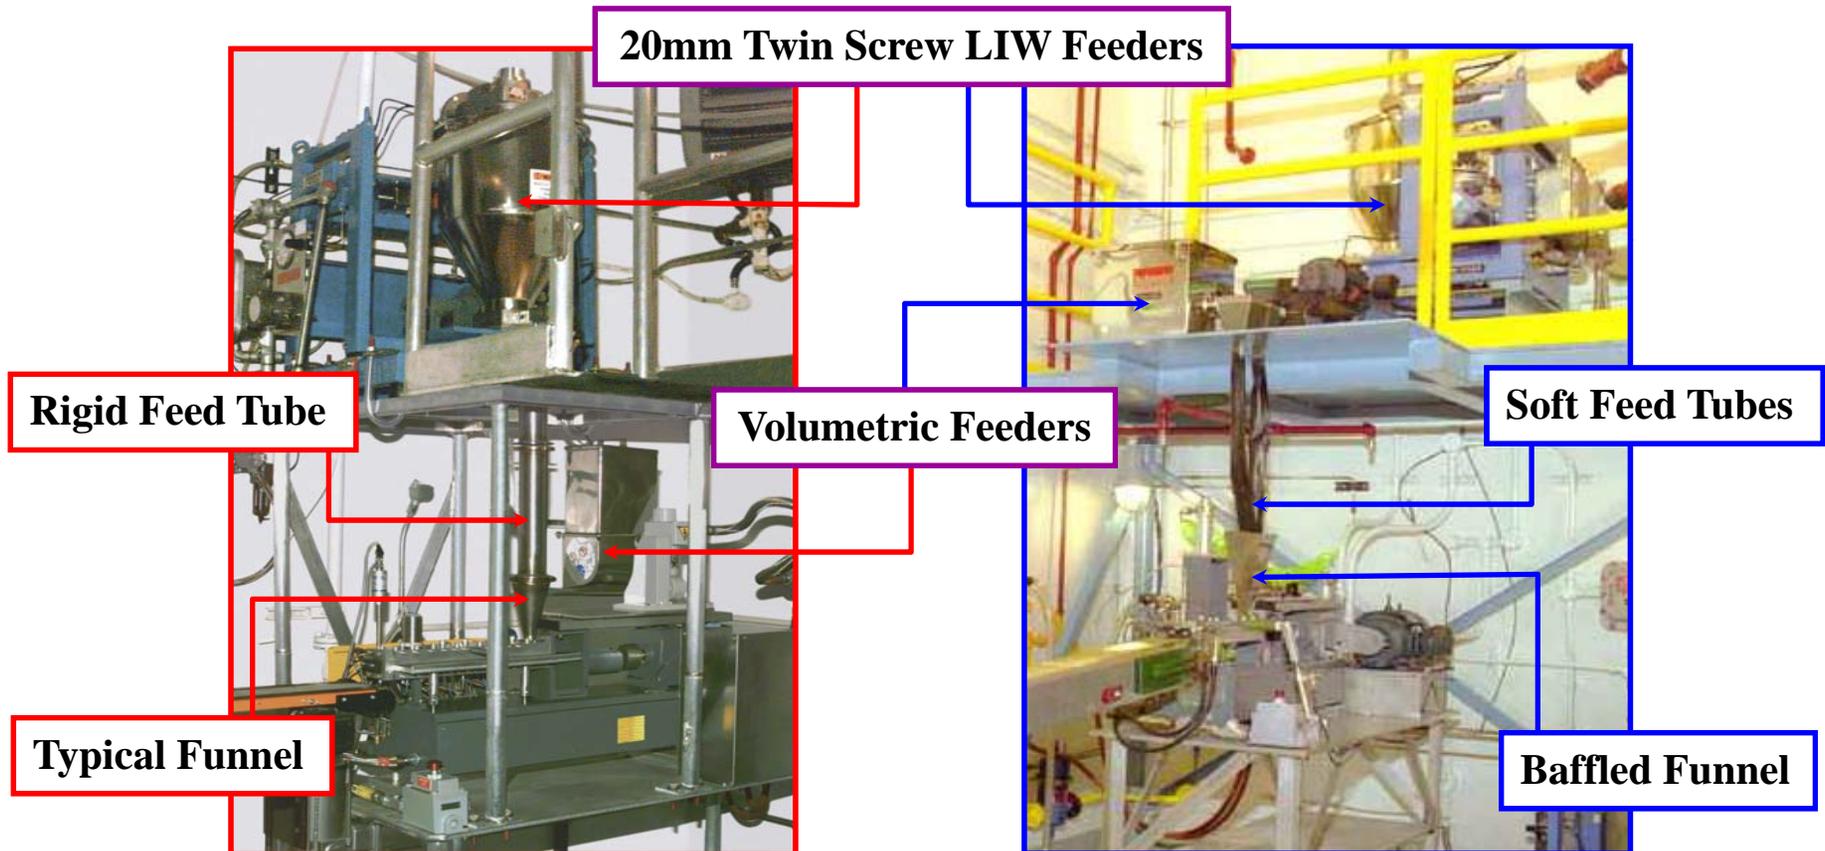
19mm TSE Process Modifications

Installation @ M-56

Installation @ M-241

- The M-56 incident revealed gross inadequacies regarding flame propagation
- Installation of isolation system requisite before energetic extrusion could continue
 - Many different systems were examined for effectiveness
 - All of the systems examined required a discrete amount of time for sensing and system activation
 - Propagation happens very rapidly (milliseconds) limiting the usefulness of these types of systems
- Thiokol designed, fabricated, and implemented an isolation system that is not time dependant
- The system involves a baffled feed funnel, pliable conductive feed tubes, and conveyor belts
 - Each device within the system provides additional protection against propagation

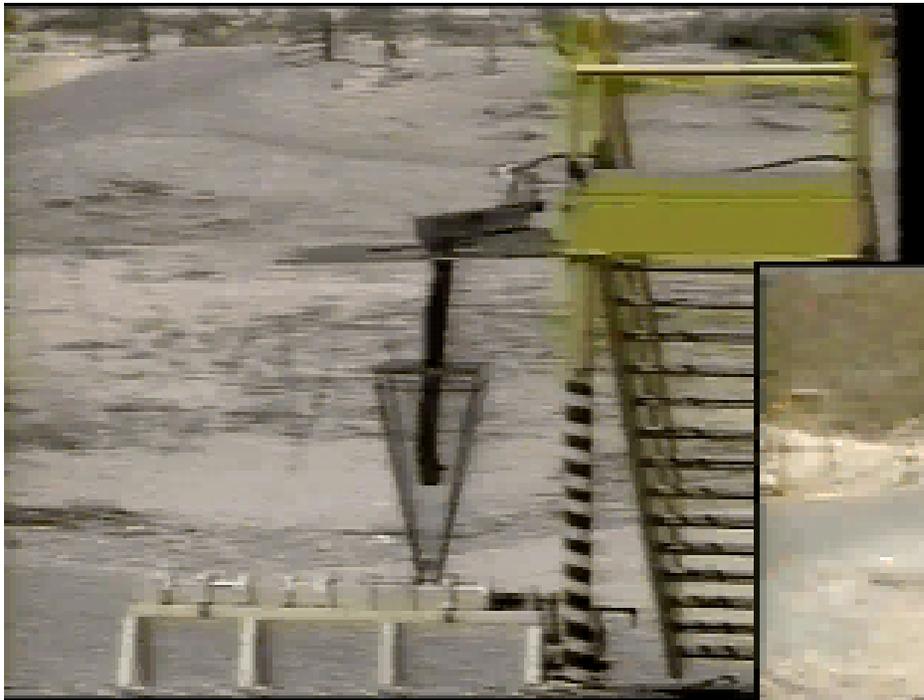
Typical Funnel Design

Test Comparison For Funnel Design
