**U.S. Army Garrison Fort Monmouth
Restoration Advisory Board (RAB)
July 12, 2012 ~ 7:00 p.m.**

MINUTES

Heavy Metal Impacts on Wampum Lake

U.S. ARMY FORT MONMOUTH RAB TOUR AND TERRAIN WALK MAY 2, 2012

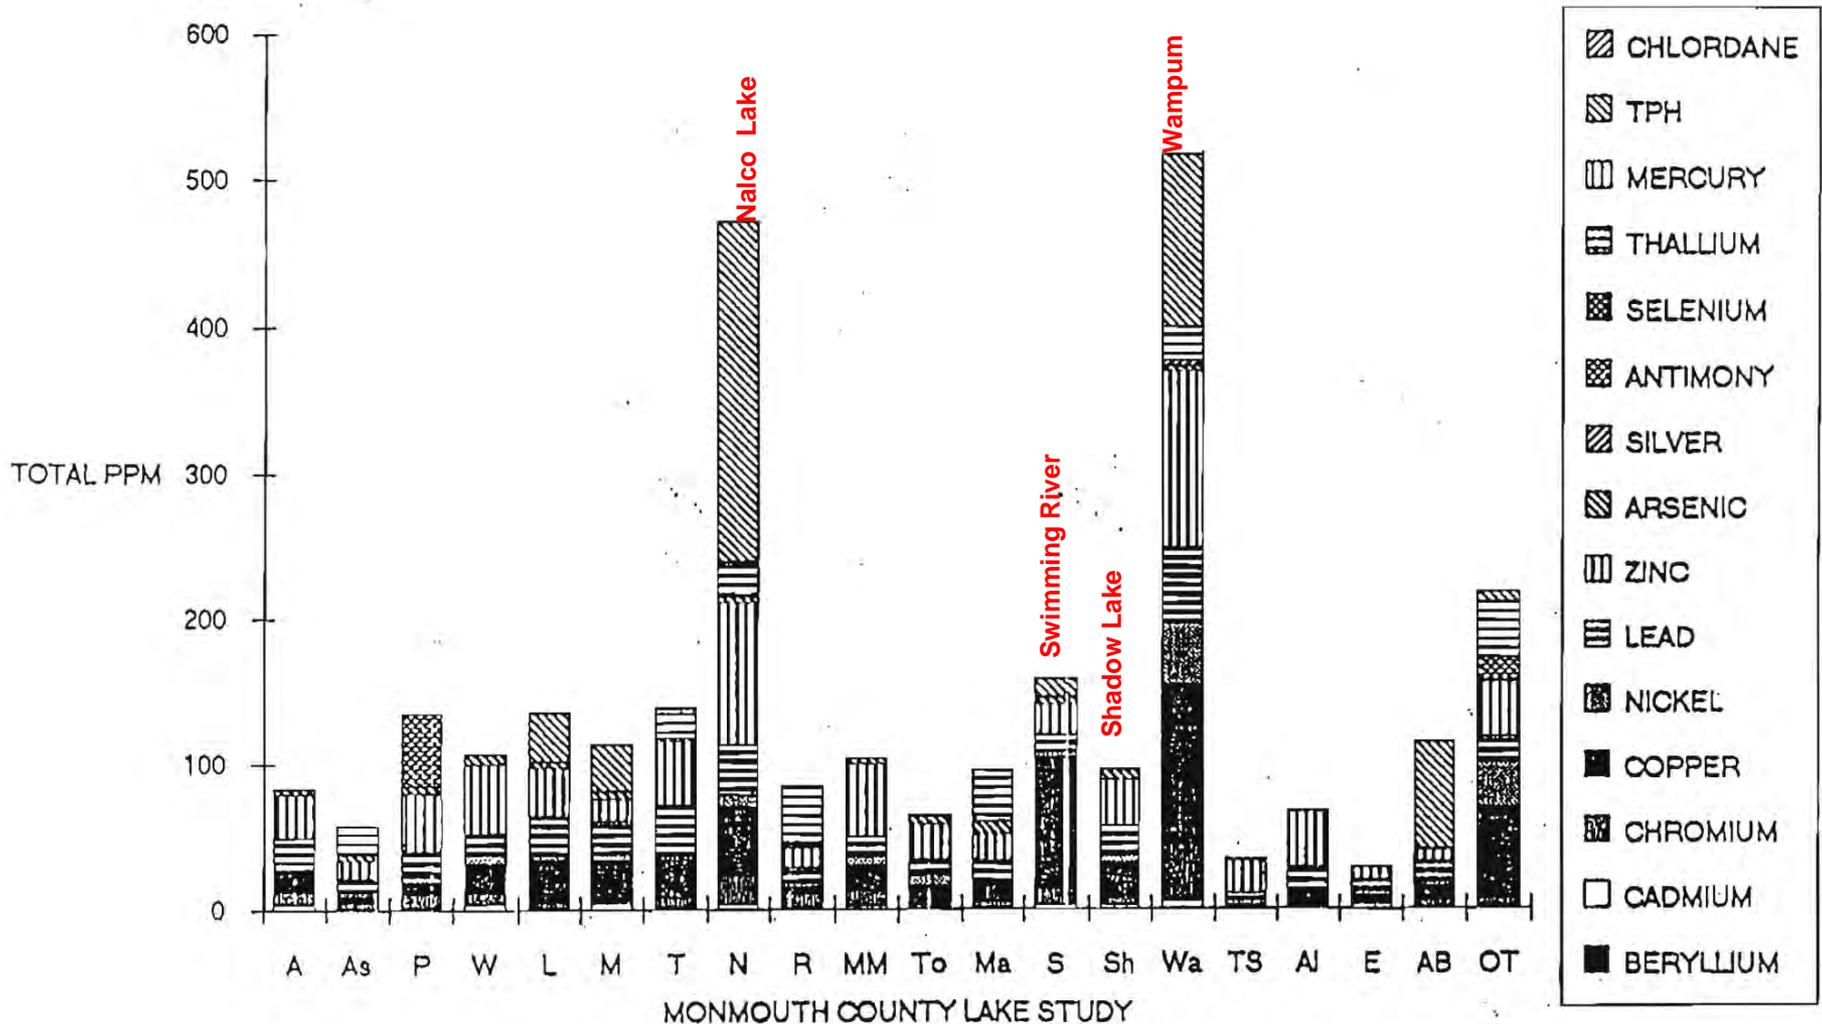
Wampum 1st Among County Lakes

Wampum did not have the highest level for every contaminant in the County lakes, its cumulative record puts it in first place. We know from reading the report that Chlordane pesticide was also found.

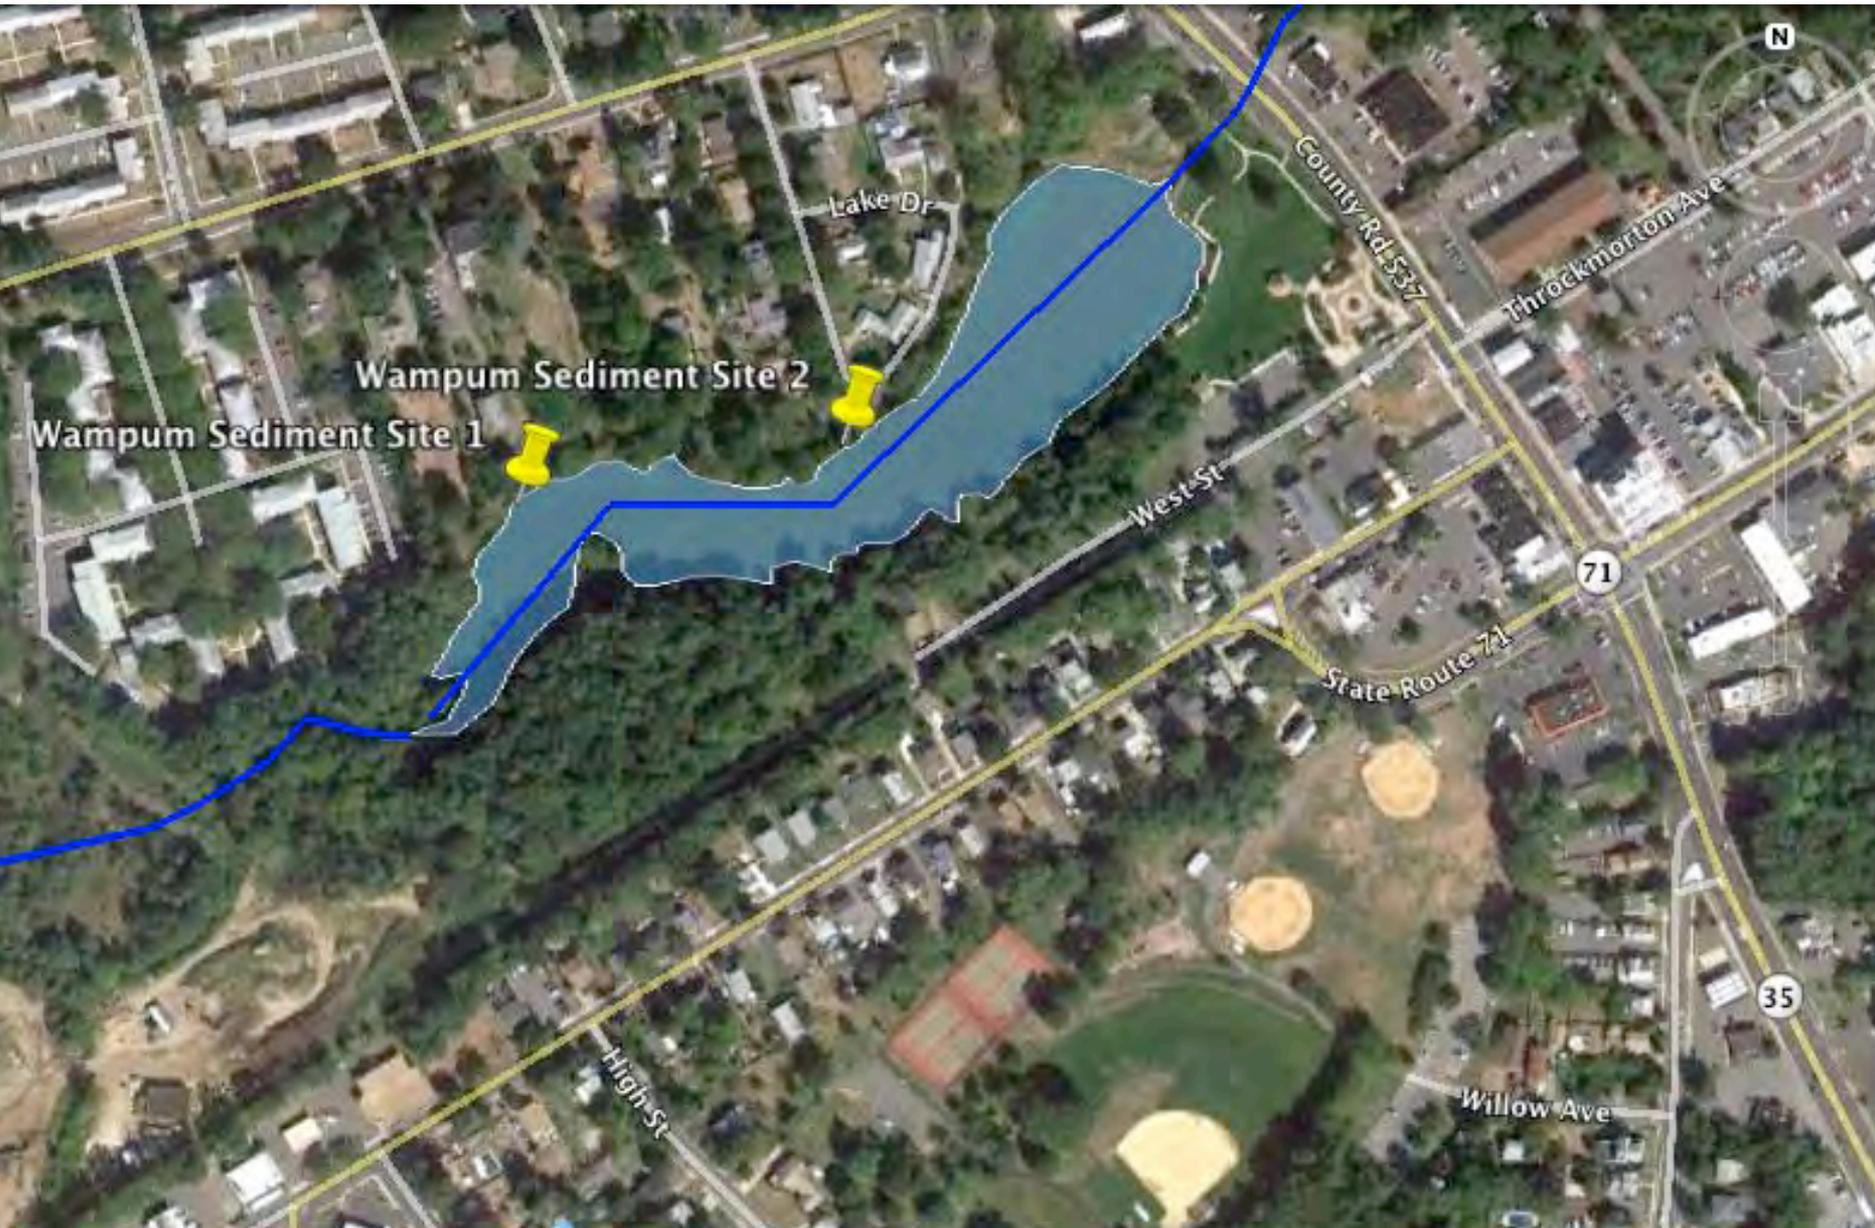
MCHD Wampum Sediment Sample Sites

- In 1990, Monmouth County Health Department (MCHD) conducted a significant test of all the chief lakes in Monmouth County.
- Among these lakes was Wampum Lake, which lies 0.2 mile east of the Charles Woods Area (CWA) of Fort Monmouth.
- Impact and scope of its findings and possible sources may not have been fully realized at the time.
- We know that MCHD tested for the same contaminants--Antimony, Arsenic, Beryllium, Cadmium, Chromium, Copper, Lead, Mercury, Nickel, Selenium, Silver, Thallium, and Zinc--in all the lakes and was not targeted on Wampum.

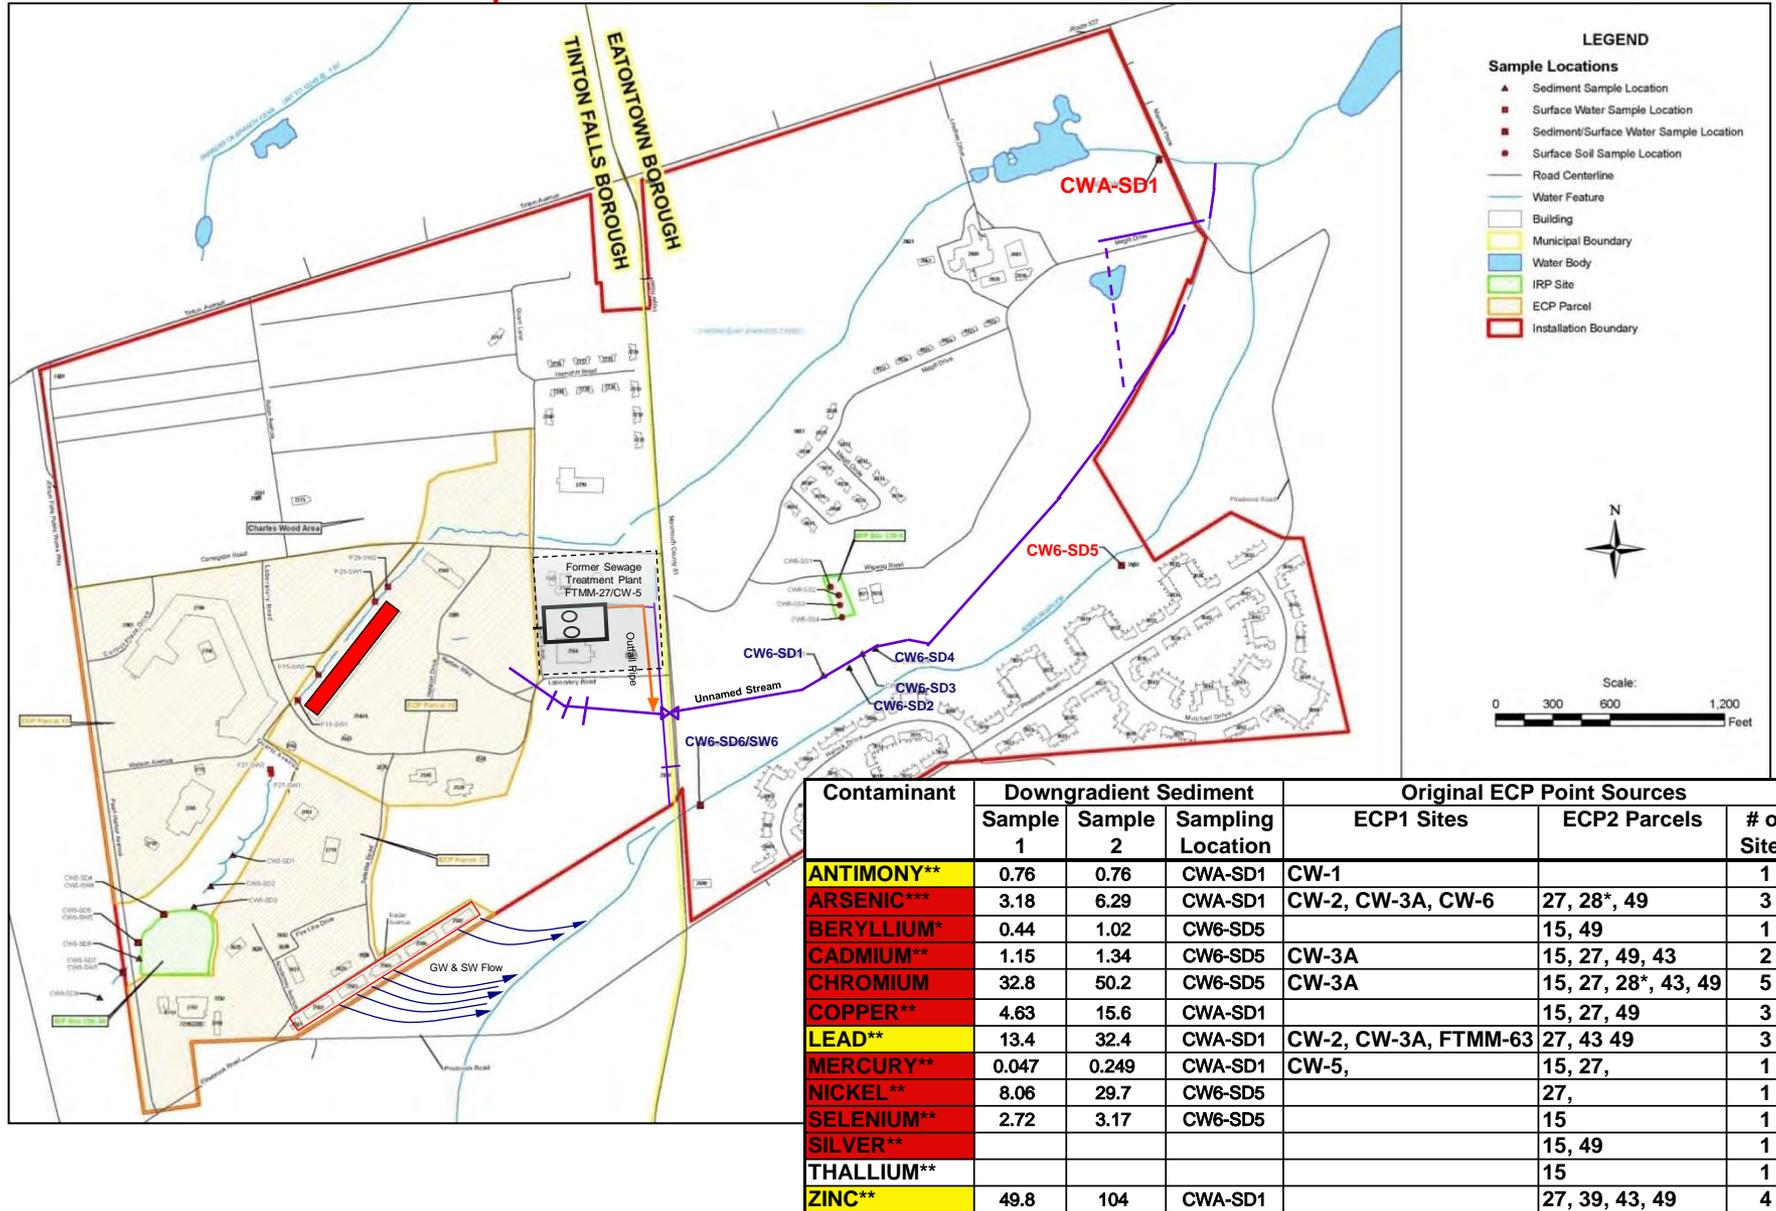
New Sediment Sample Sites Still Show Lake's Contaminants After 21 Years!

Sediment samples were collected from 2 new test locations downgradient [i.e., at the CWA eastern border] of the CWA activities. One [CWA-SD1] was collected from North Branch and one [CW6-SD5] was collected from South Branch of Wampum Brook. The 2 sample sites were placed on the branches only after insistence of this author.

- ✓ **Metals.** A total of 21 metals were detected in sediment from CWA downgradient samples: aluminum, antimony, **arsenic**, barium, **beryllium**, **cadmium**, calcium, **chromium**, cobalt, **copper**, iron, **lead**, magnesium, manganese, **mercury**, **nickel**, potassium, **selenium**, **silver**, sodium, vanadium, and **zinc**. Seven of the metals with applicable freshwater or saltwater sediment criteria were found at concentrations in one or more sediment sample exceeding the criteria: **cadmium, chromium, and selenium in both** samples; **arsenic, mercury, and lead in North** Branch and **nickel in South** Branch of Wampum Brook.

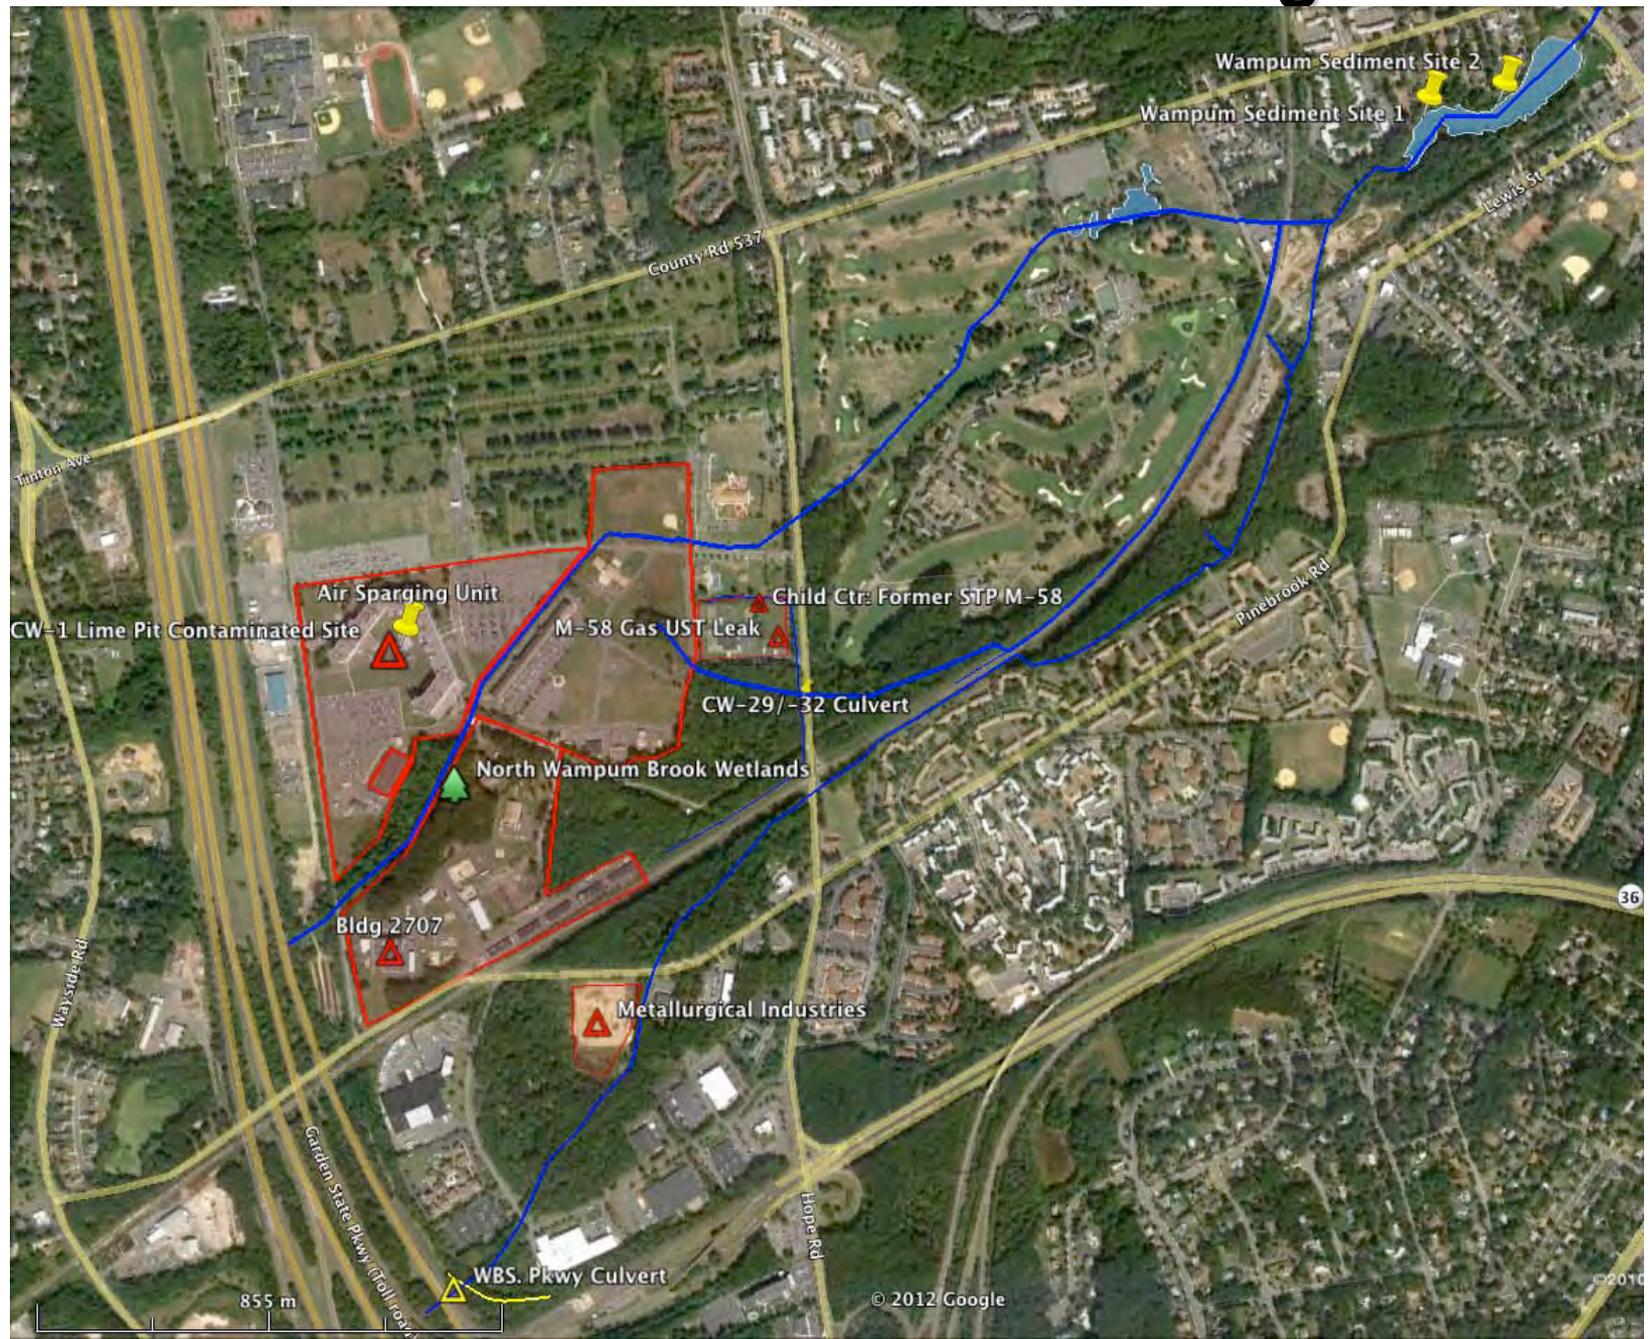
The Un-Named Stream: A Missing Link

6. About 150' further, it empties into the "Shrewsbury Brook" (the northern branch of Wampum Brook) before the combined flow goes eastward through a culvert under the RR Tracks where it meets up with the southern branch of the Wampum Brook and into the Wampum Lake. See the purple line representing the un-named stream in the attached map.

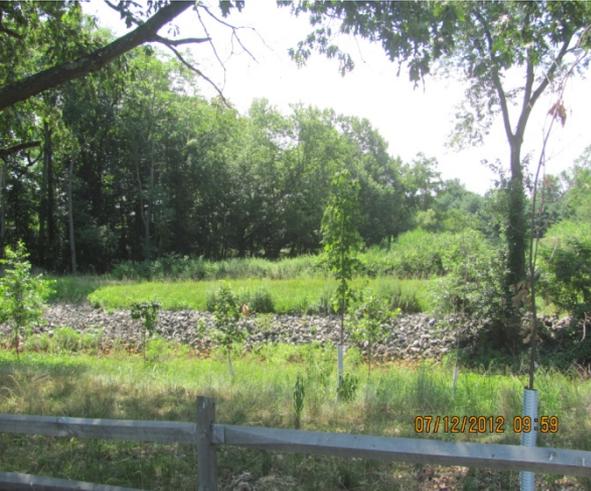
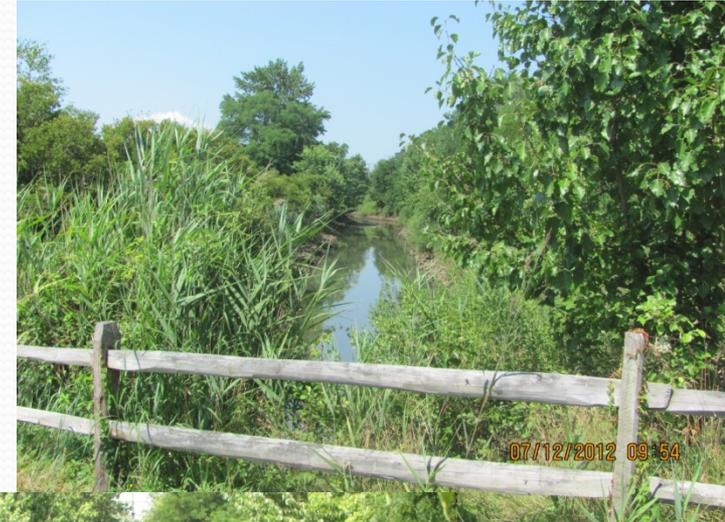
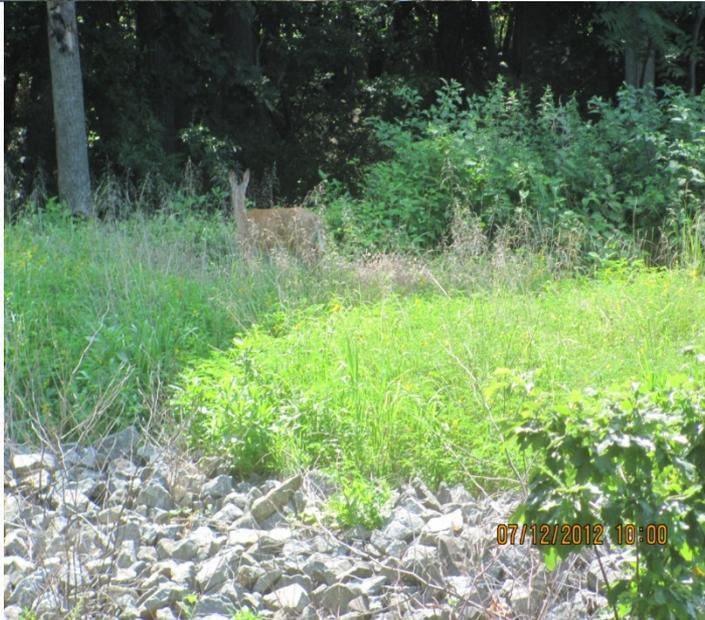
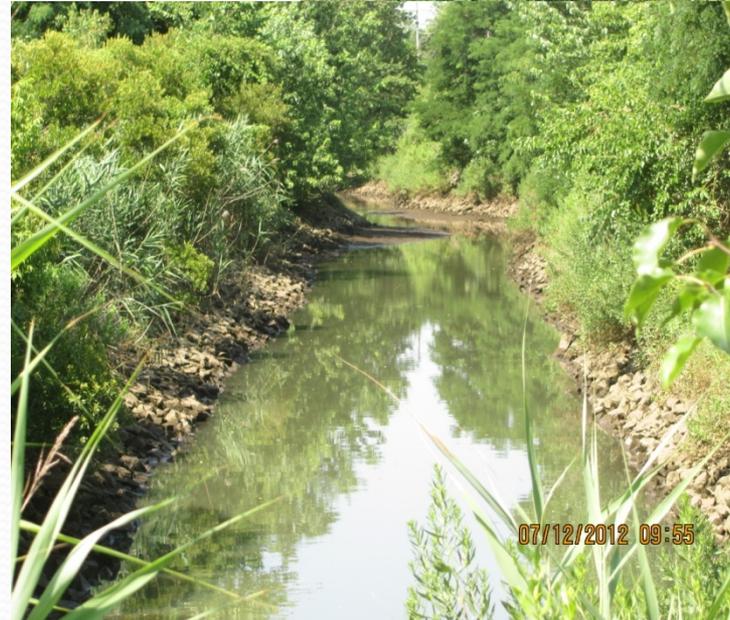
Tour of Main Post and Charles Wood Area IRP Sites

- All IRP sites are well maintained
- The Stream Bank Stabilization is still structurally sound at each landfill

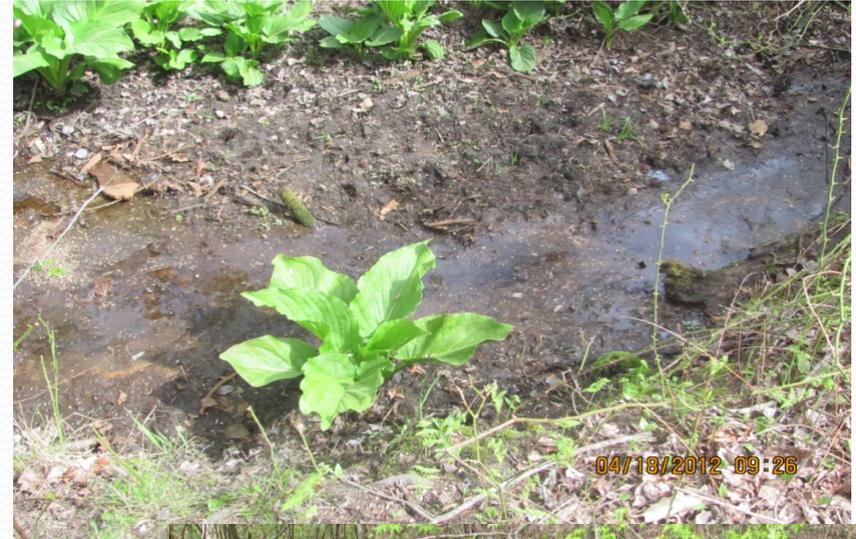
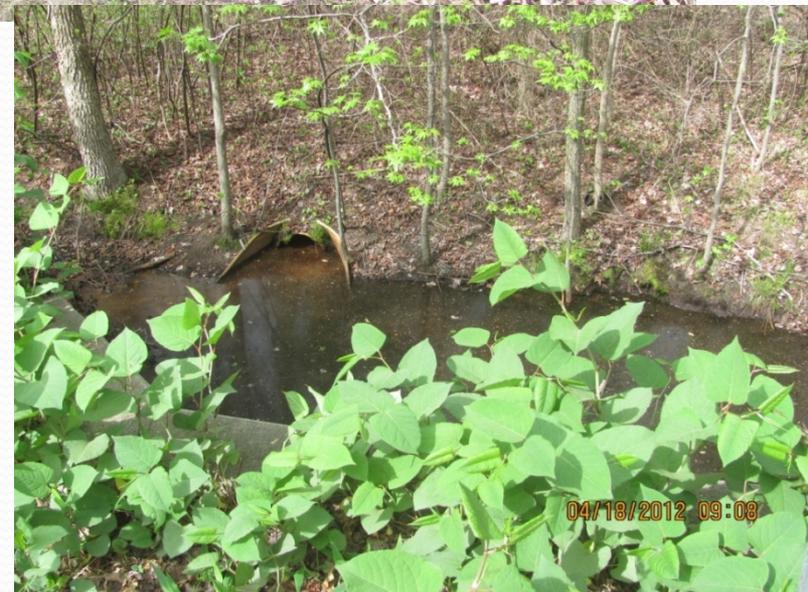
Followed Southern and Northern Tributaries Leading to Wampum Lake

- **Former STP was located in building 2566 current site**
- **During the STP operation, the discharge created a stream leading to the southern tributary to Wampum Lake**
- **STP was closed in 1975. The stream area is now a ditch that has flowing water during a heavy rain event.**
- **A drainage ditch north of building 2567 connects with the ditch that led from the STP site.**

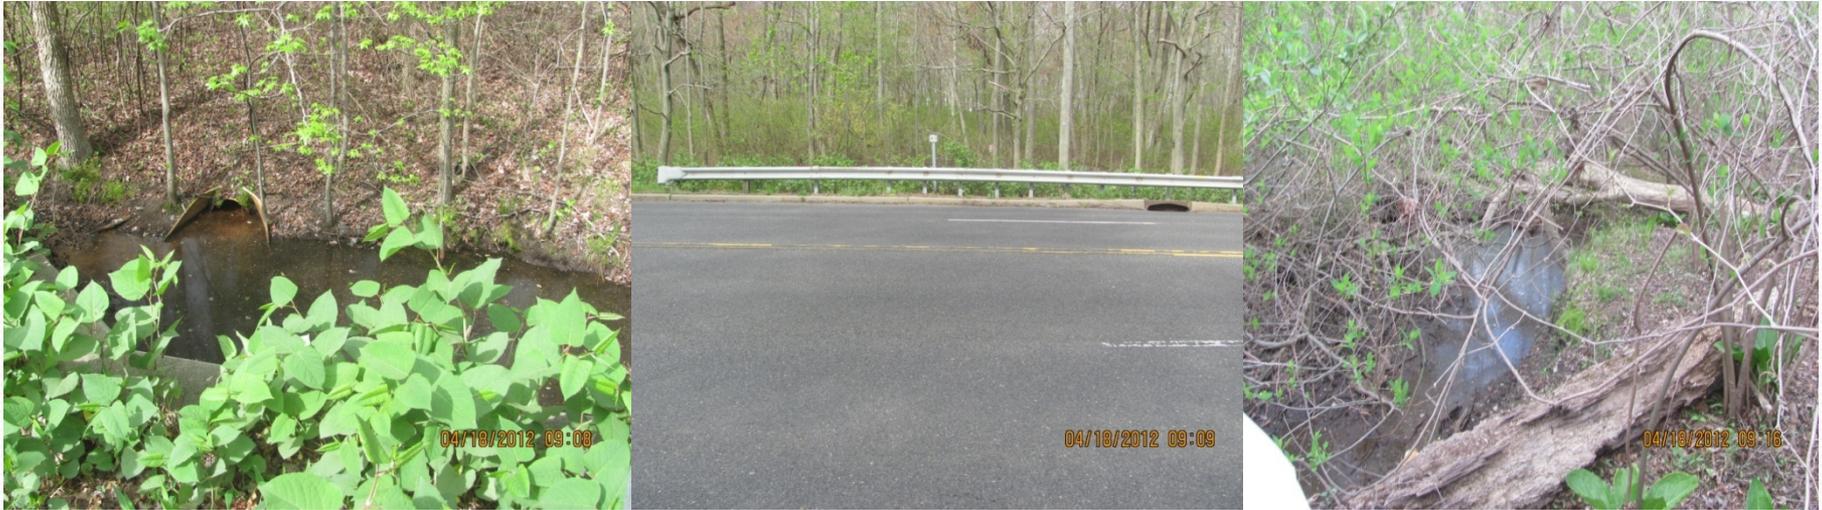
Followed the Southern Tributary Leading to Wampum

- The drainage ditch created a stream that started the southern tributary to Wampum Lake.
- The RAB members followed the water flow under Hope Road and across the street.
- The water flows through the woods adjacent to the golf course and then along the NJ Transit railroad tracks.
- The southern tributary ended, approximately $\frac{3}{4}$ of the way between Hope Road and Maxwell Road.
- During a heavy rain event, the water would flow further.

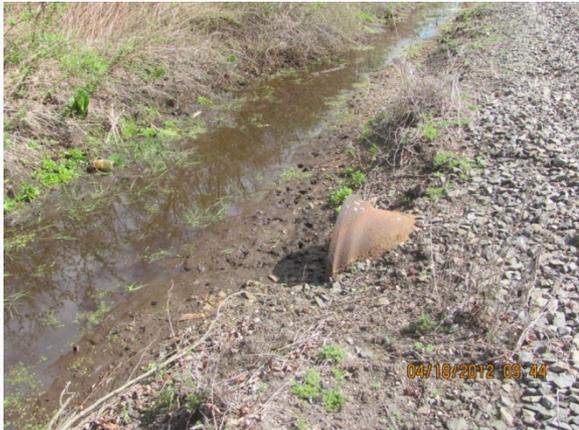
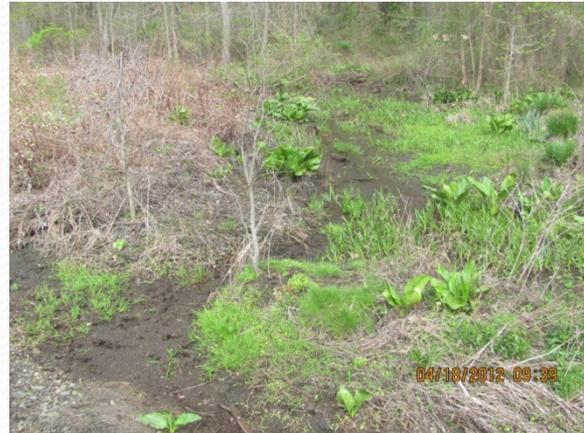
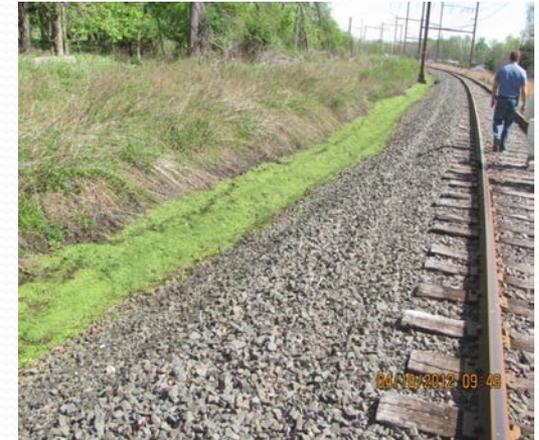
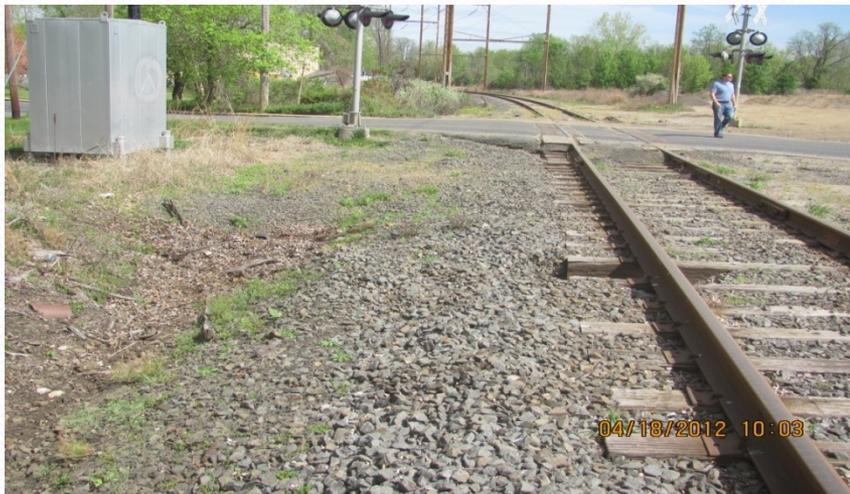
Followed the Southern Tributary Leading to Wampum

- Southern tributary ends before Maxwell Road

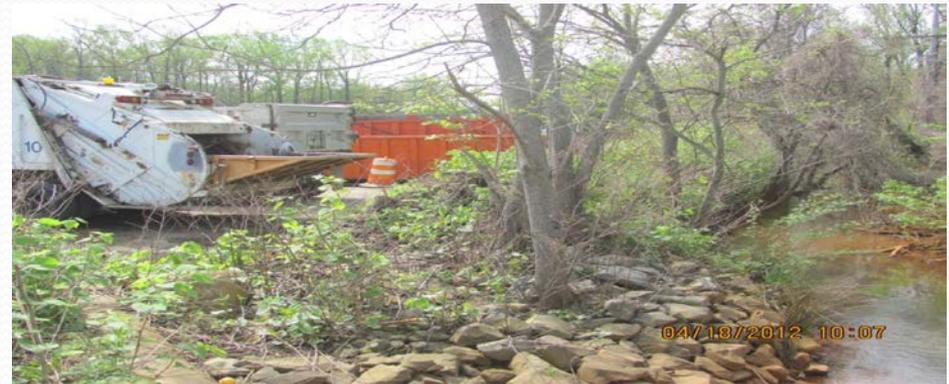
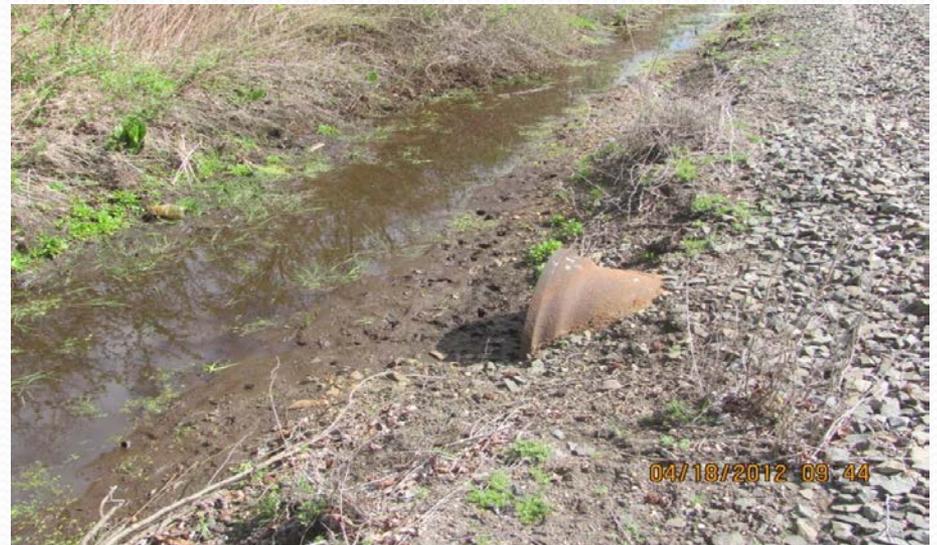
Followed Southern and Northern Tributaries Leading to Wampum Lake

- **The northern tributary begins in CWA and flows under Maxwell Road**
- **The water flows behind Fiore Paving Company**
- **The water then flows along the NJ Transit railroad tracks and ends before Wampum**
- **During a rain event, the water may continue to the lake**

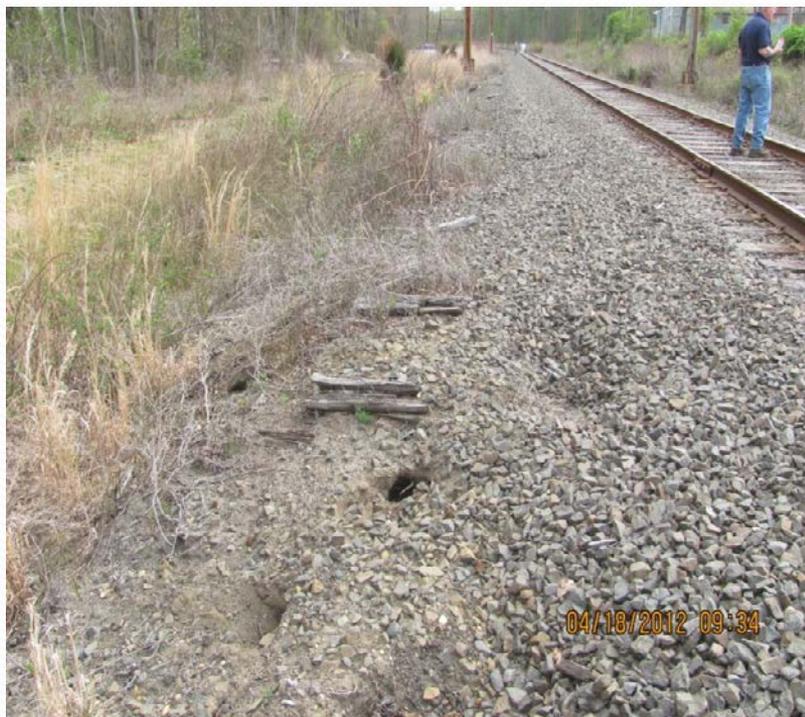
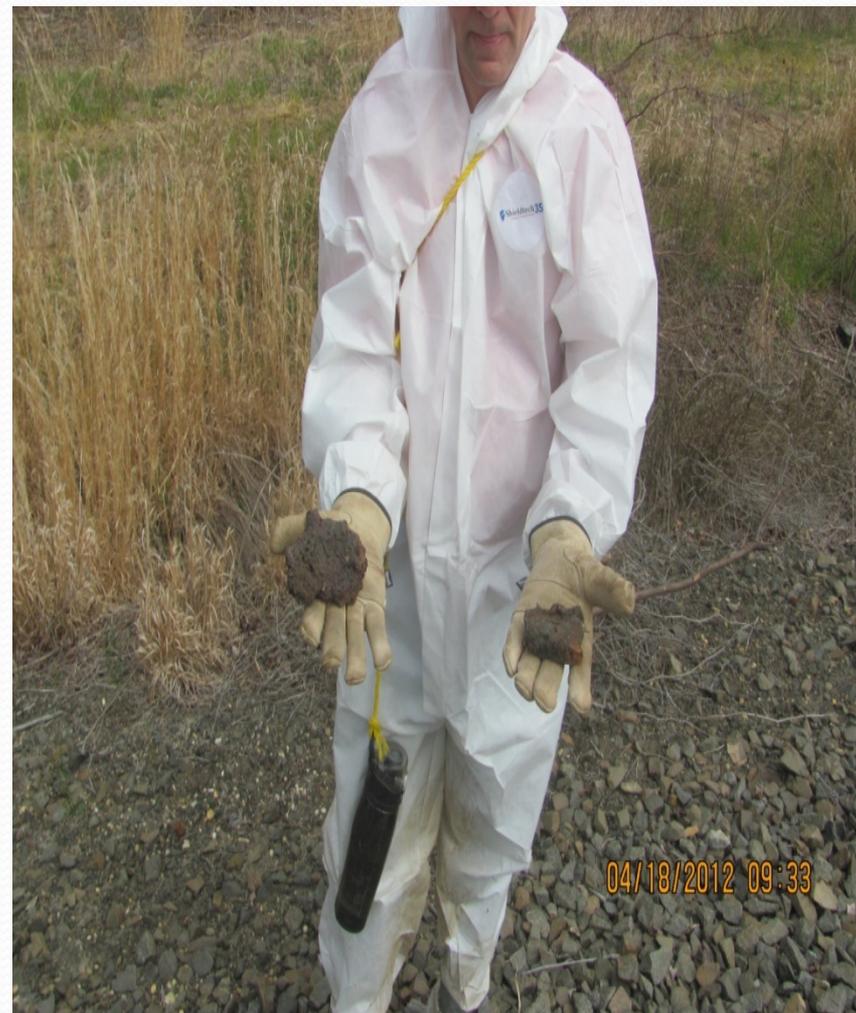
- Coal slag found along the NJ railroad line

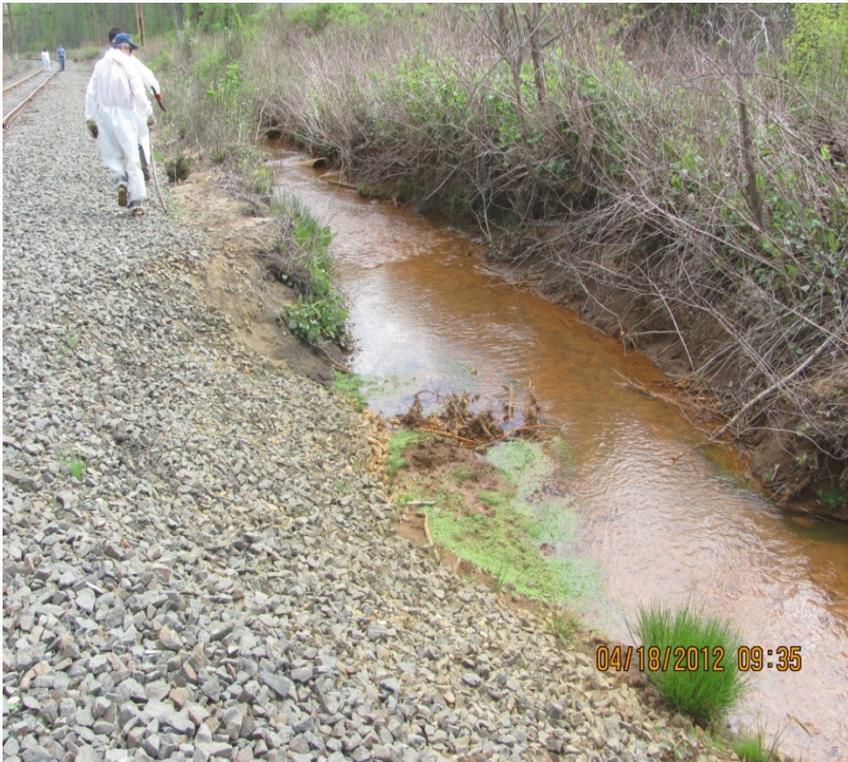
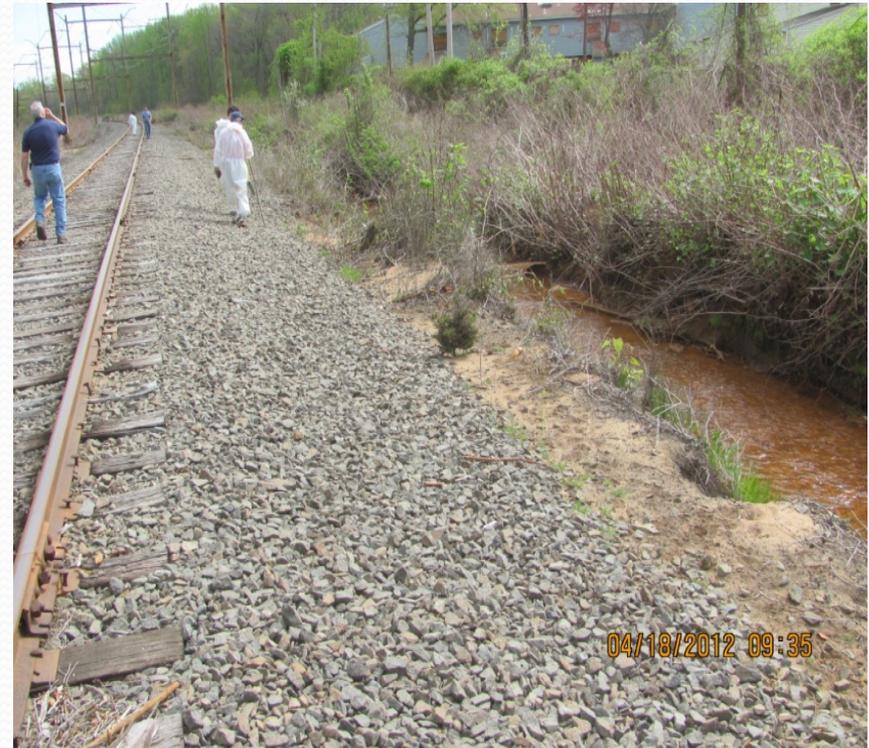
- Stream coming from Metallurgical area, and flowing behind Pinebrook housing

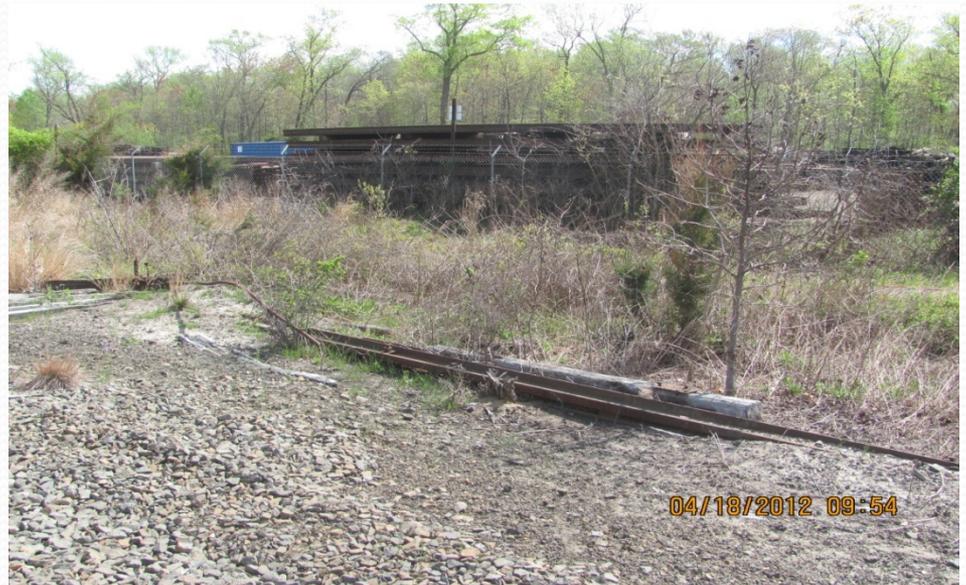
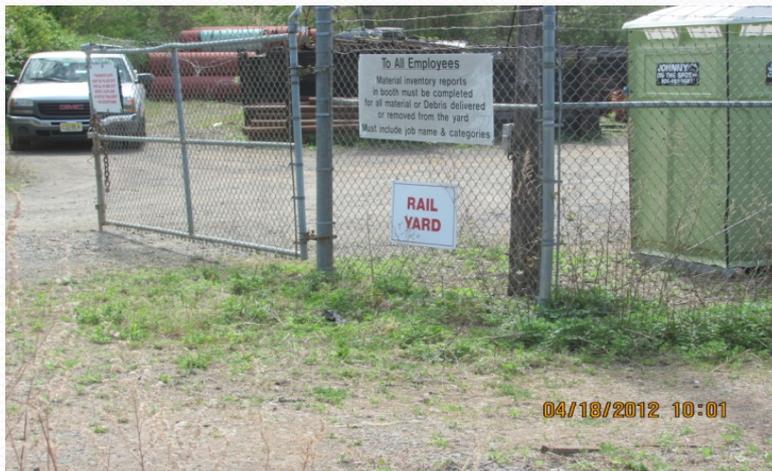
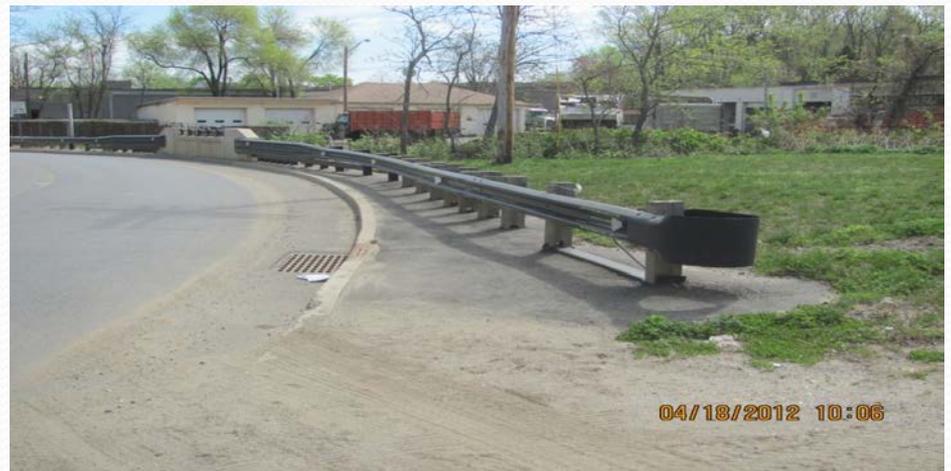
- Railroad storage area with rusting rails, next to NJ rail line
- Railroad storage ends at Maxwell Road
- The stream coming from the Metallurgical property, flows behind the railroad storage area.

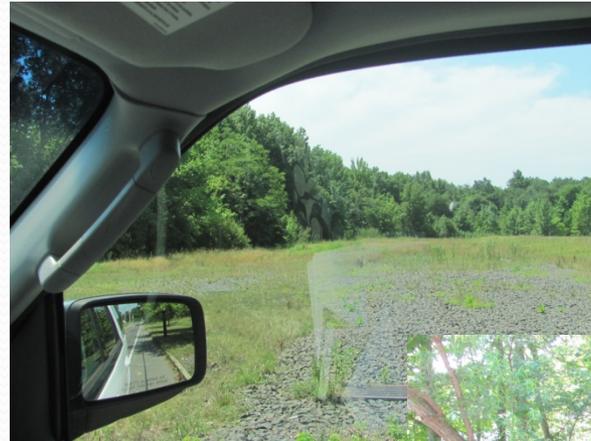
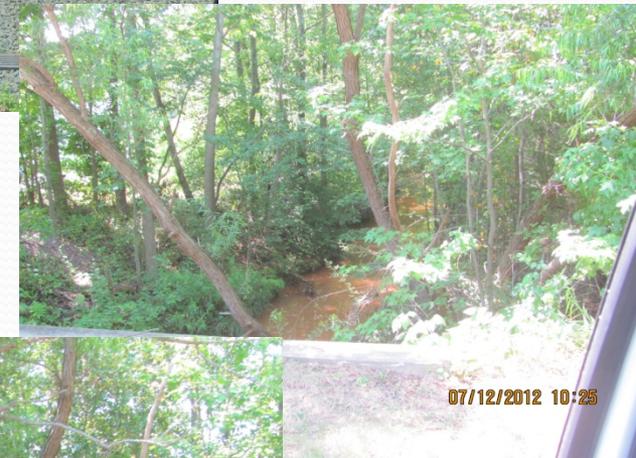
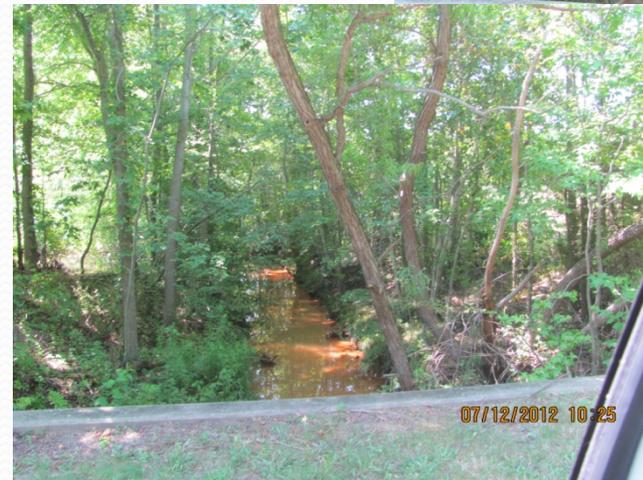
- **The stream originating from Hwy 36, Rte 18, behind Appleby's, flows along the former Metallurgical property.**
- **Metallurgical property is a Superfund site, currently operated by the state with over 20 monitoring wells.**
- **The stream flows from the Metallurgical property under Pinebrook Road**
- **The stream then flows behind Pinebrook Housing, on the opposite side of the southern tributary coming from CWA.**
- **The stream then flows behind the railroad storage yard**

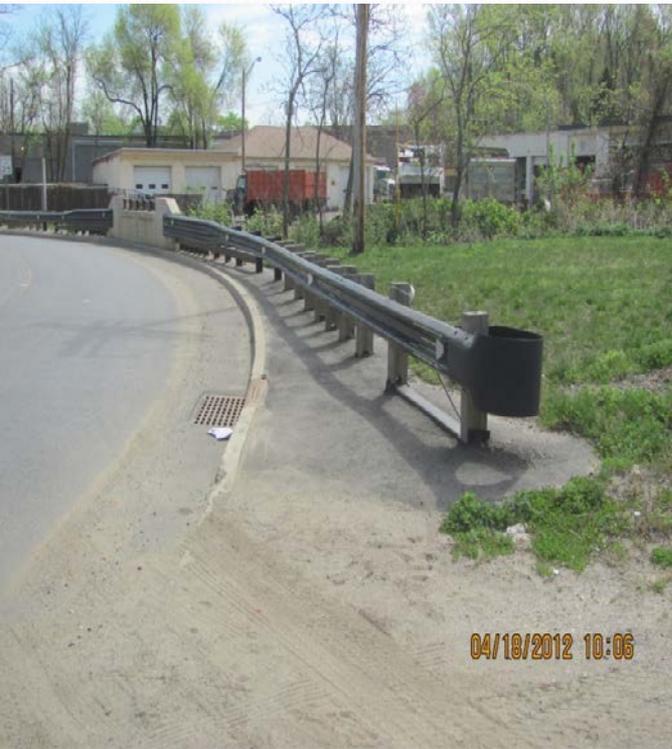
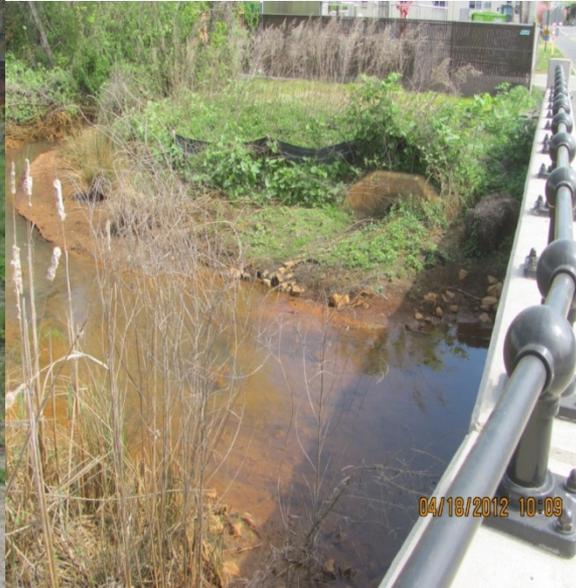
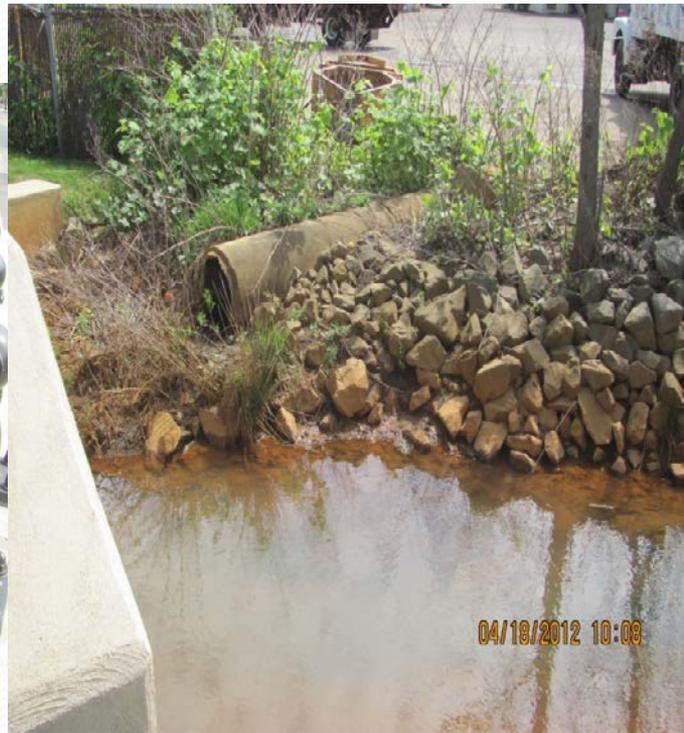
- **The stream then flows under Maxwell Road**
- **The stream flows behind the Eatontown DPW Recycling Center, between the piles of material being stored by**
- **The stream continues behind local industry , to include a metal fabrication company.**

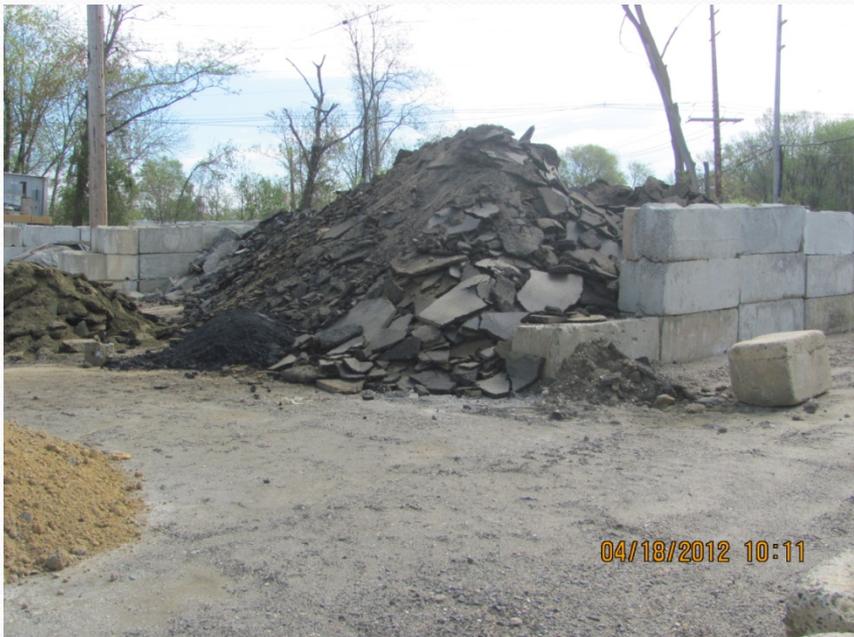
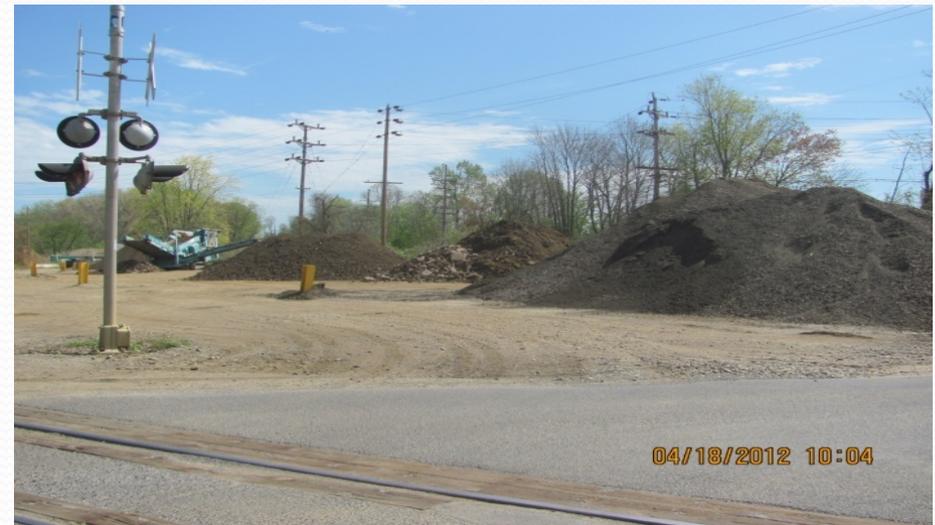
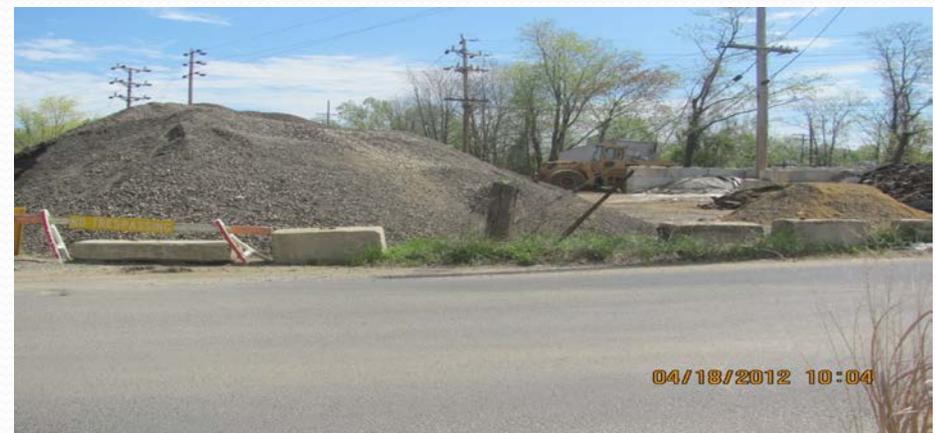
- Piles along Maxwell Road, next to the NJ railroad line
