**U.S. Army Garrison Fort Monmouth
Restoration Advisory Board (RAB)
July 12, 2012 ~ 7:00 p.m.**

MINUTES

Heavy Metal Impacts on Wampum Lake

U.S. ARMY FORT MONMOUTH RAB TOUR AND TERRAIN WALK MAY 2, 2012

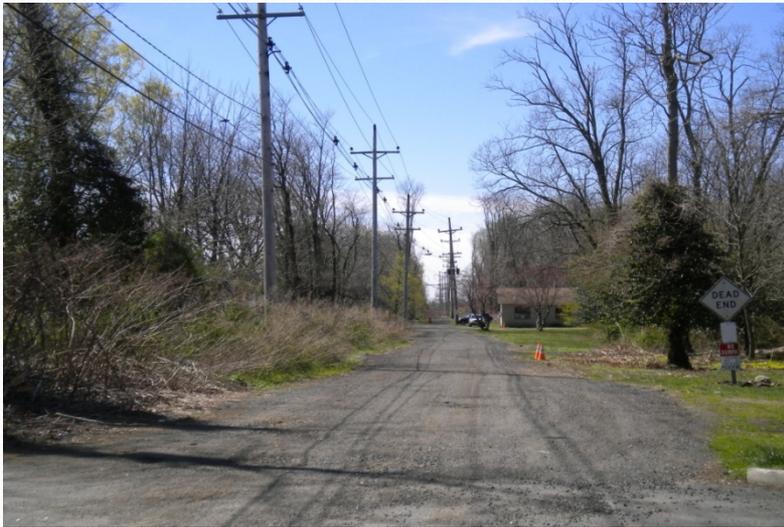
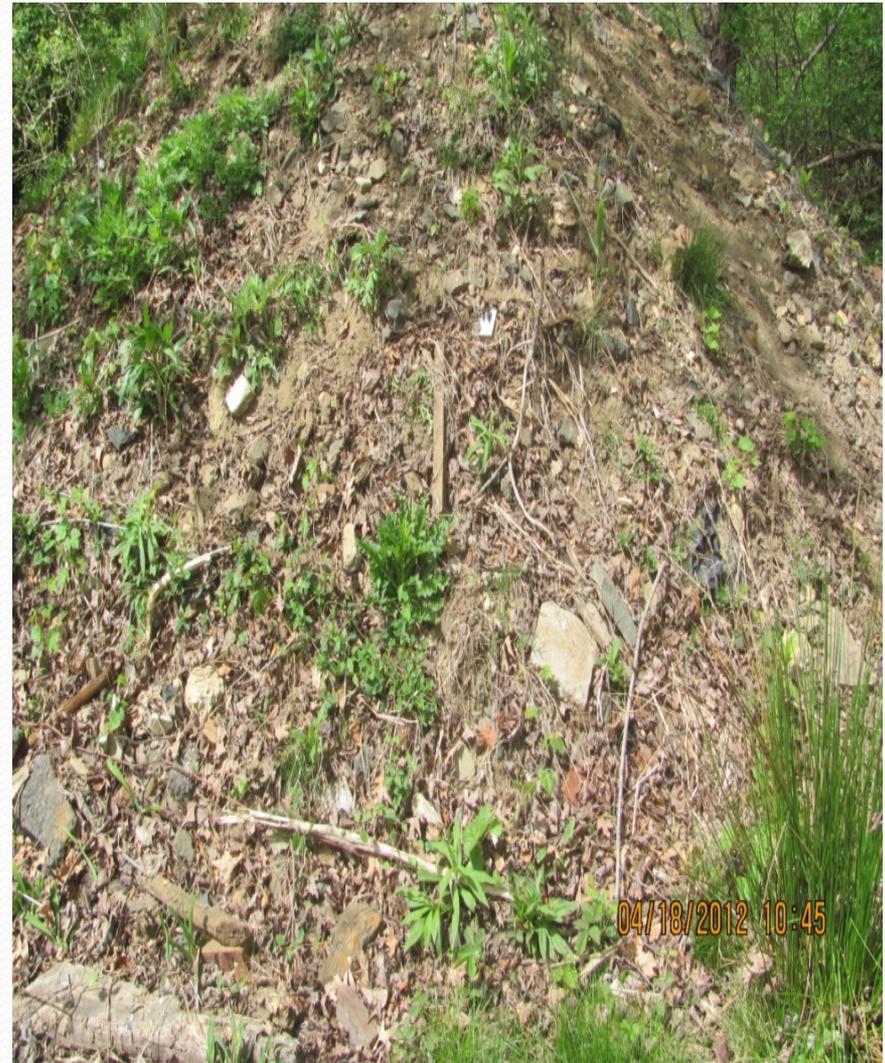
- **The dead end road that is adjacent to Wampum Lake has a large mound of dirt mixed with debris.**

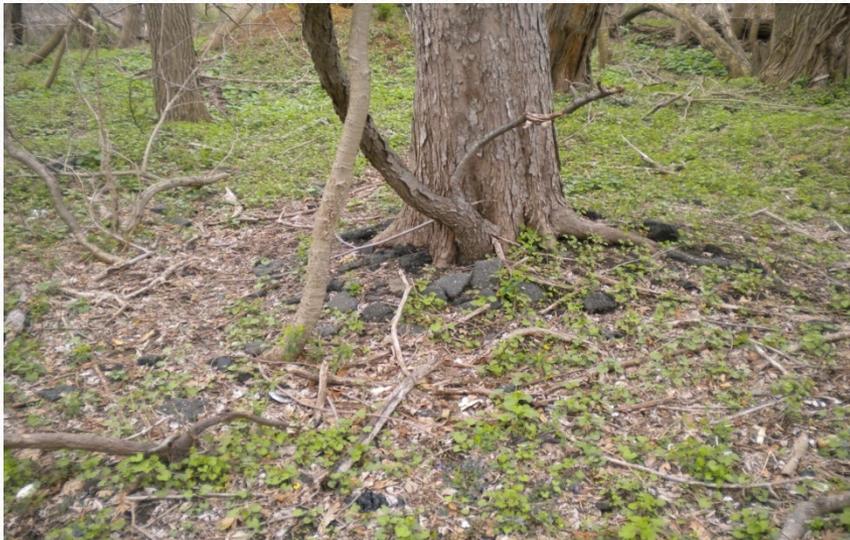
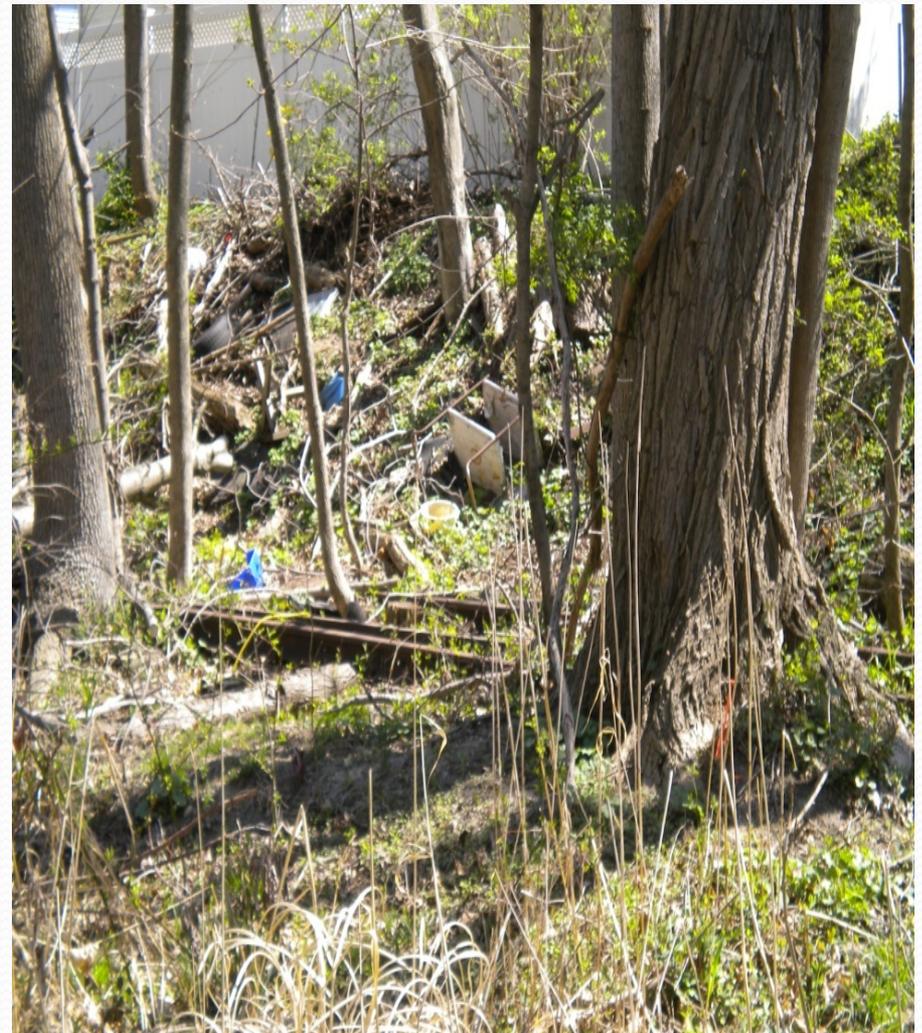
- Due to rain and slippery conditions, the RAB members were unable to walk through the woods to observe the area where there is a suspect undocumented landfill within 15 of Wampum Lake.
- A RAB member has take photos of the area.
