EVALUATION: BUILDING NO. 117

Historic Name: Stable / Storehouse No. 5 / Transient Officers Quarters
Present Name: Quarters (LC,MJ)

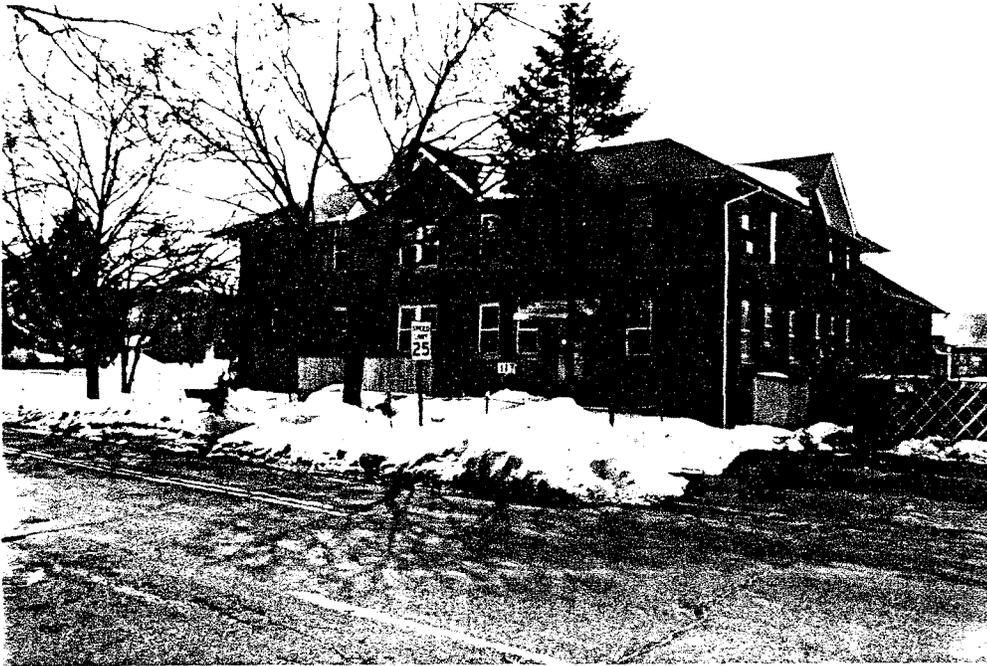
Building 117 is a two and one half-story, truncated hip-roofed, red brick quarters building (see HABS/HAER Inventory Form: 1982).
