U.S. Army Fort Monmouth
Restoration Advisory Board (RAB)
Meeting Minutes
July 11, 2013

Hurricane Sandy Landfill Inspections – Presenter, James Moore, U.S. Army Corps of Engineers, New York District

***Fort Monmouth Hurricane Sandy Landfill
Inspections
U.S. Army Corps of Engineers
New York District***

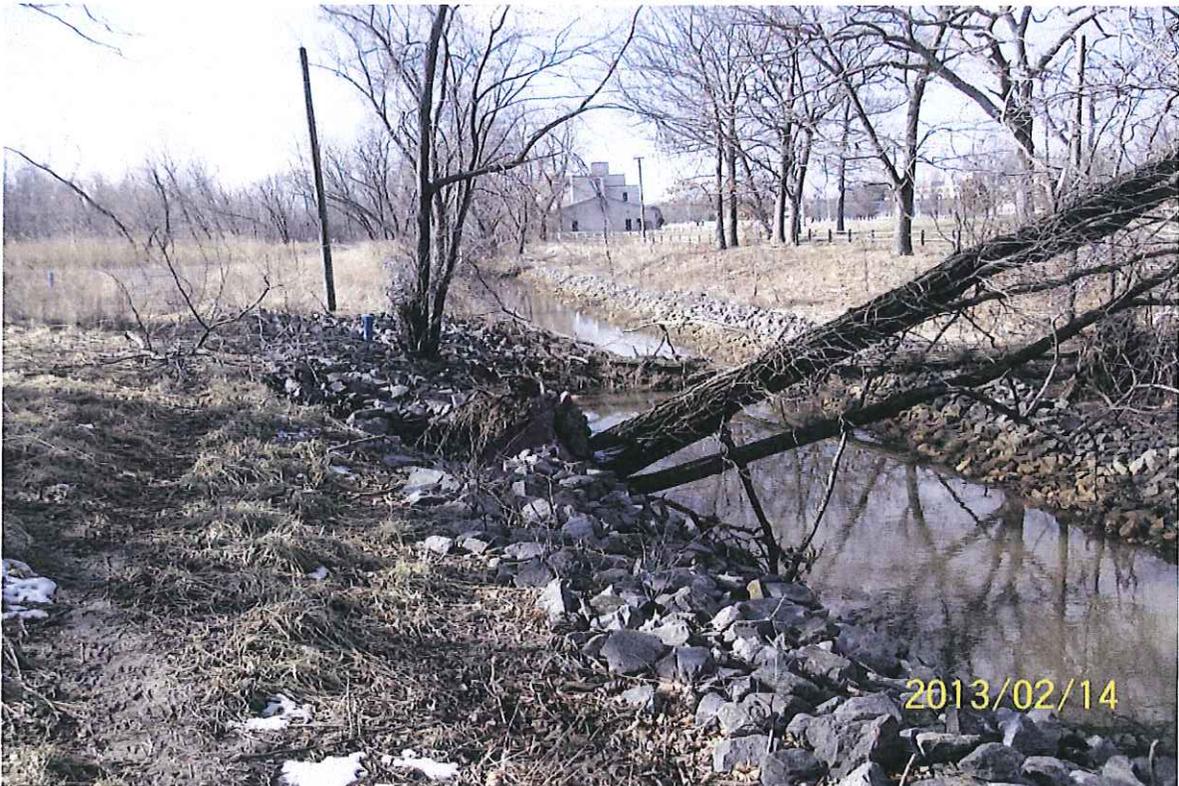
FTMM Landfill M-2

- Trees were observed to be down adjacent to the creek. The trees were located in the embankment of the creek. No environmental exposure of underlying landfill material observed in the area of the downed trees. No observed damage to the existing ground cover observed in other areas of the site. Reference attached photo.

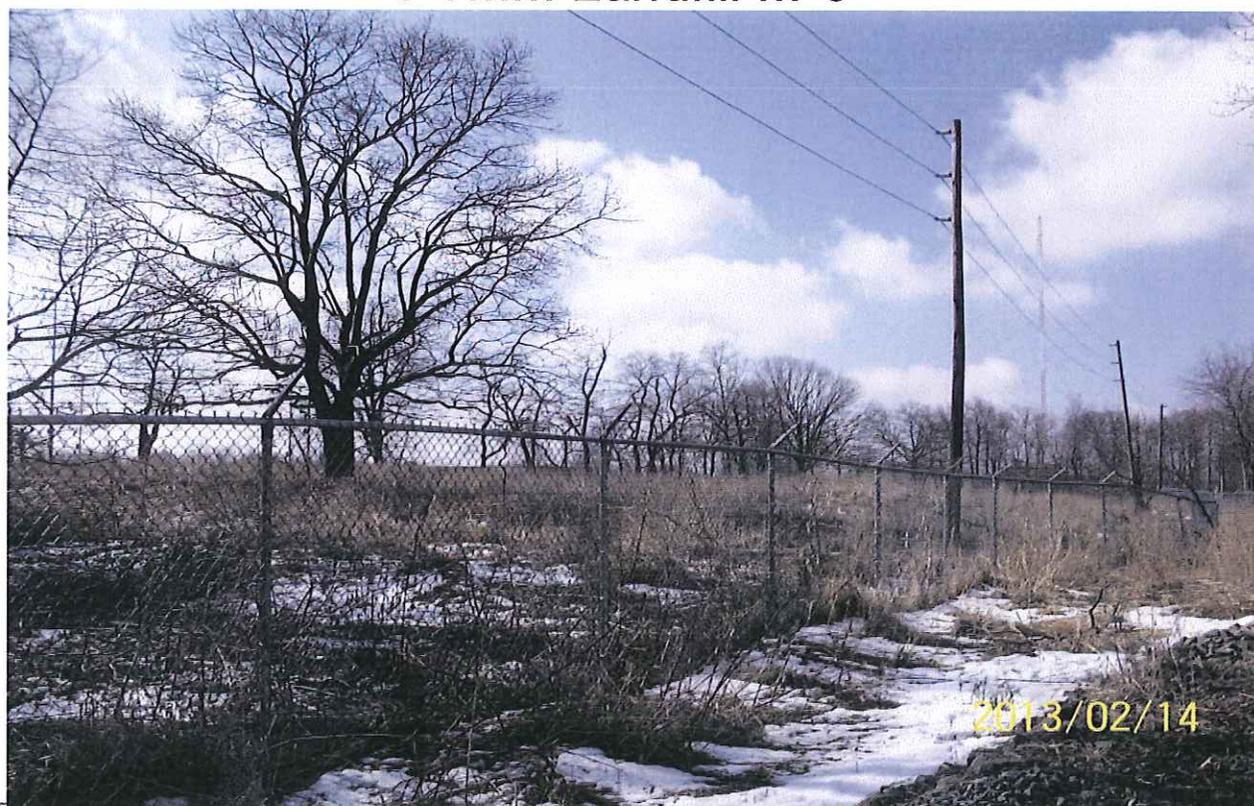
FTMM Landfill M-3

- No Hurricane Sandy damage detected to the existing ground cover or riprap embankment along the creek at the site. Reference attached photo.

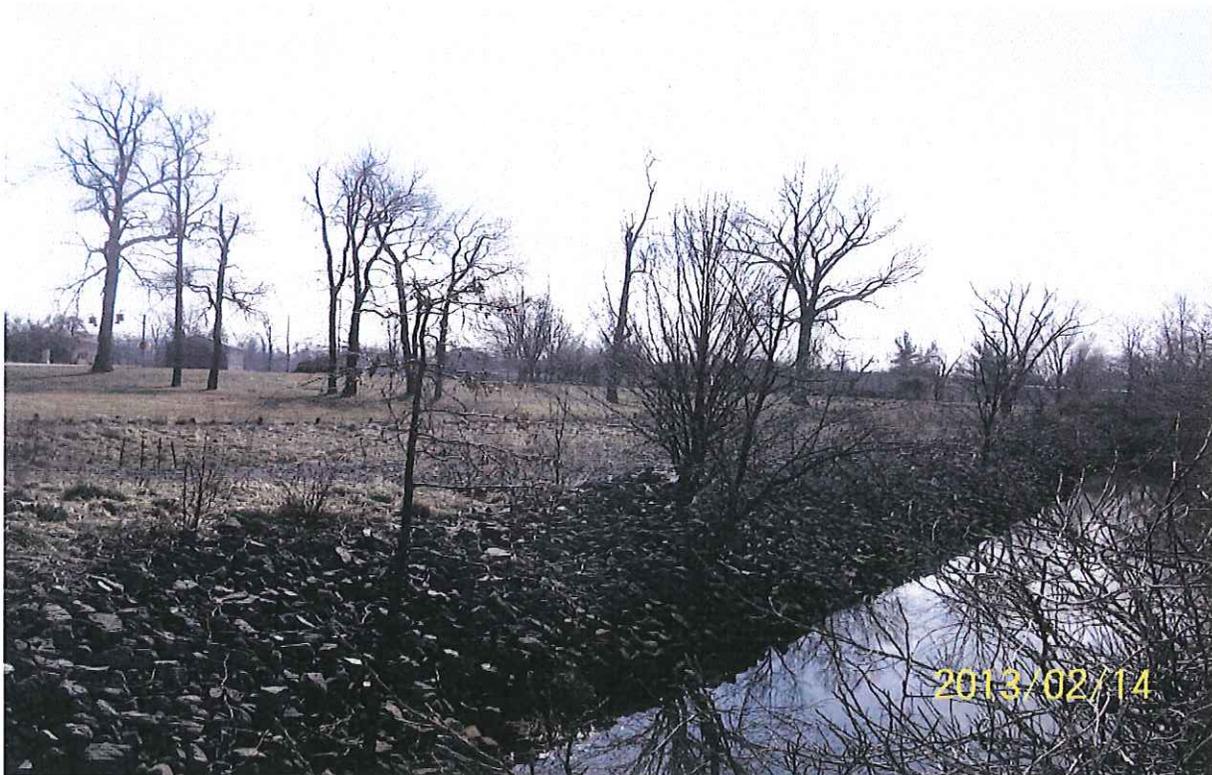
FTMM Landfill M-4

- No Hurricane Sandy damage detected to the existing ground cover or riprap embankment along the creek at the site. Reference attached photo.

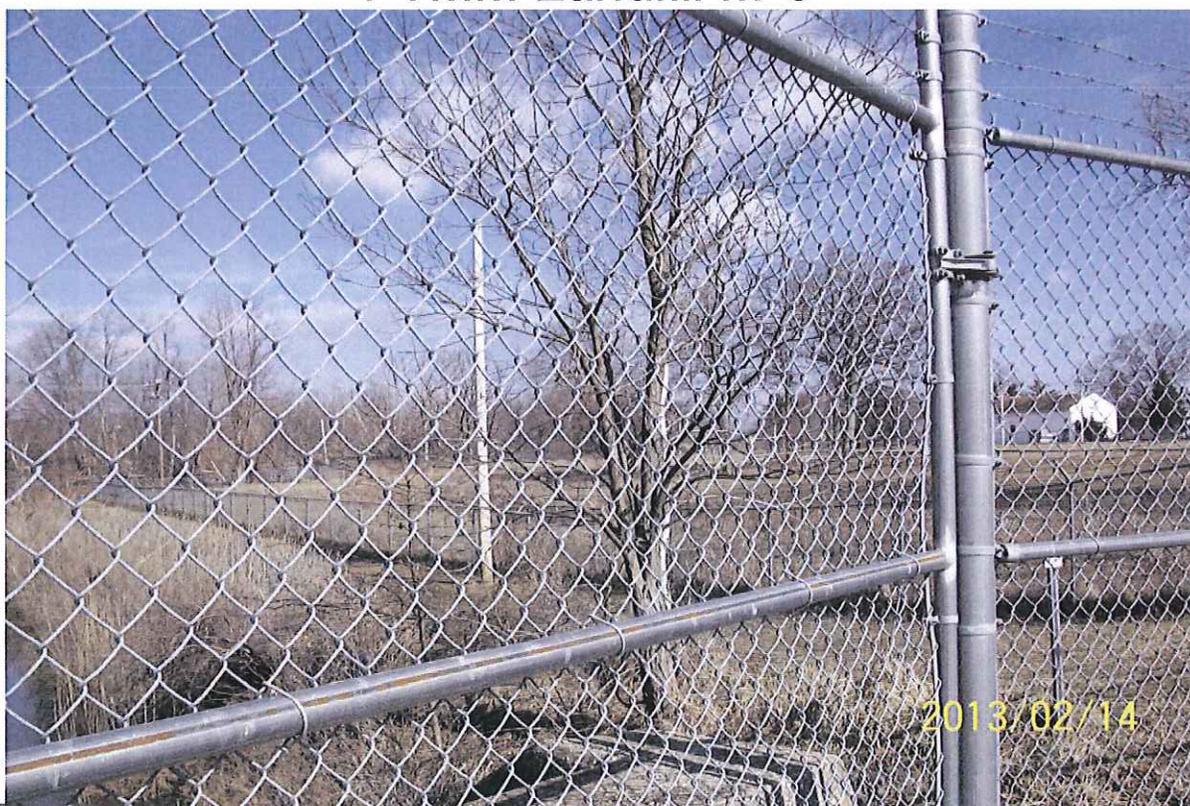
FTMM Landfill M-5

- No Hurricane Sandy damage detected to the existing ground cover or riprap embankment along the creek at the site. Reference attached photo.

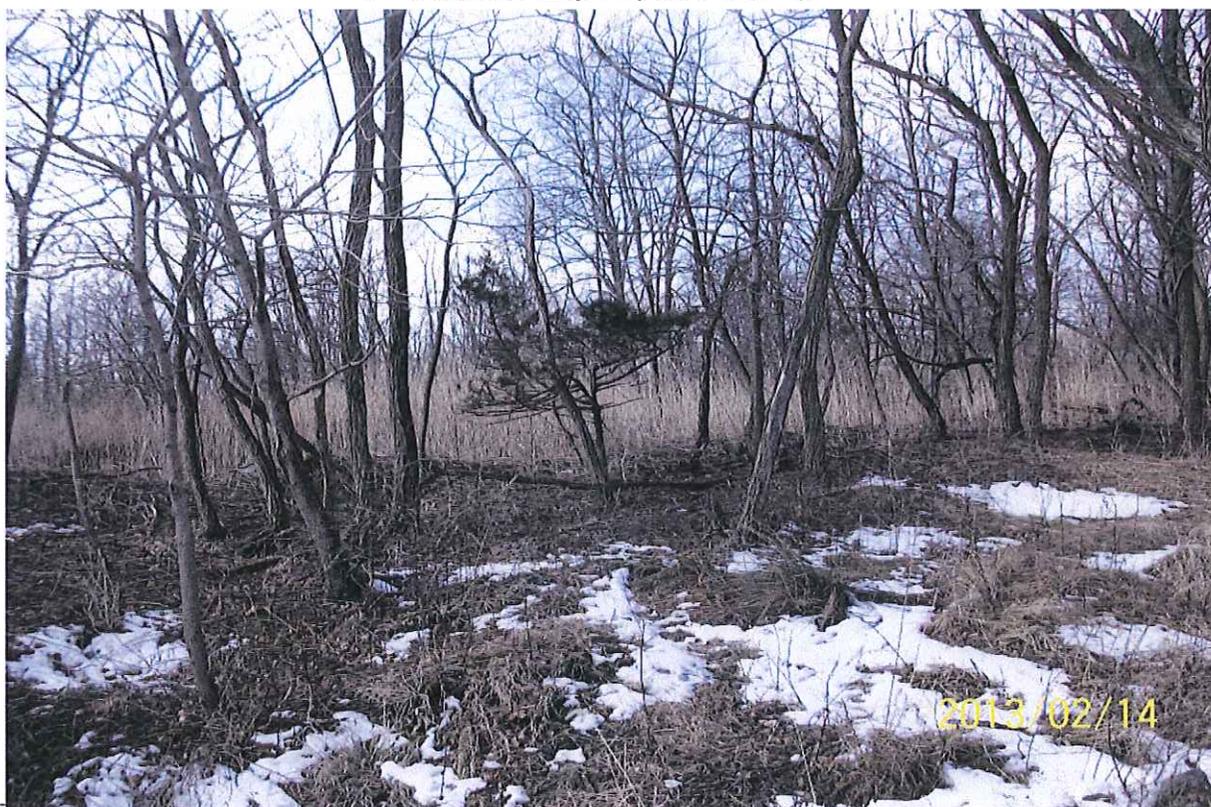
FTMM Landfill M-8

- No Hurricane Sandy damage detected to the existing ground cover or riprap embankment along the creek at the site. Reference attached photo.

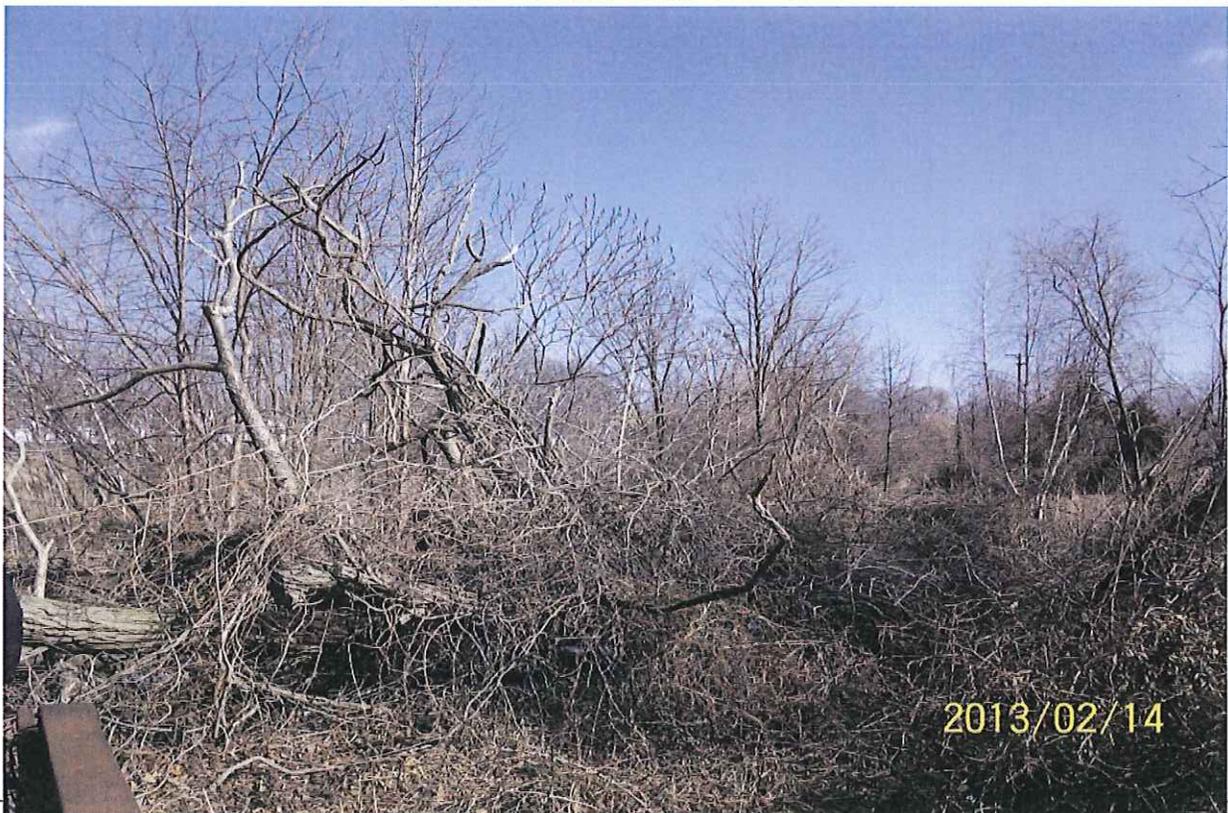
FTMM Landfill M-12

- No Hurricane Sandy damage detected to the existing ground cover or riprap embankment along the creek at the site. Reference attached photo.

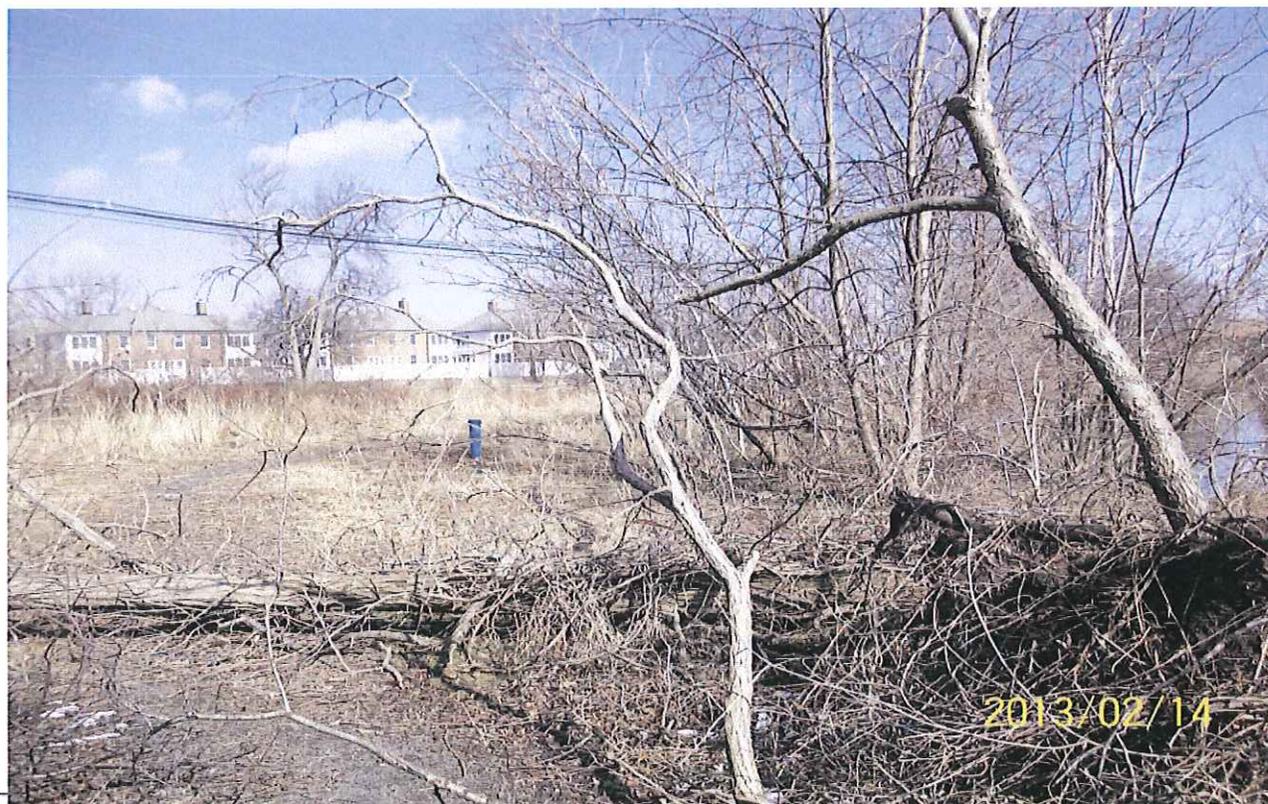
FTMM Landfill M-14

- No Hurricane Sandy damage detected to the existing ground cover or riprap embankment along the creek at the site. Reference attached photo.

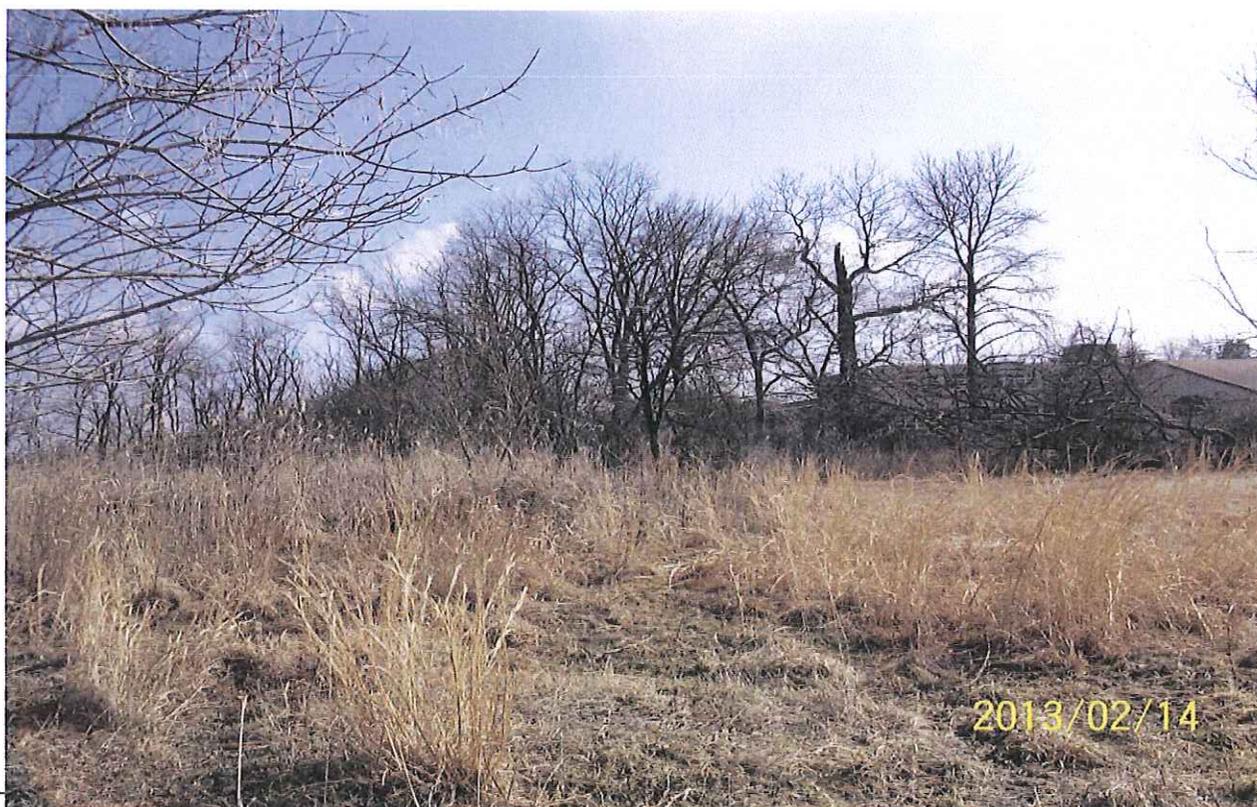
FTMM Landfill M-18

- No Hurricane Sandy damage detected to the existing ground cover or riprap embankment along the creek at the site. Reference attached photo.

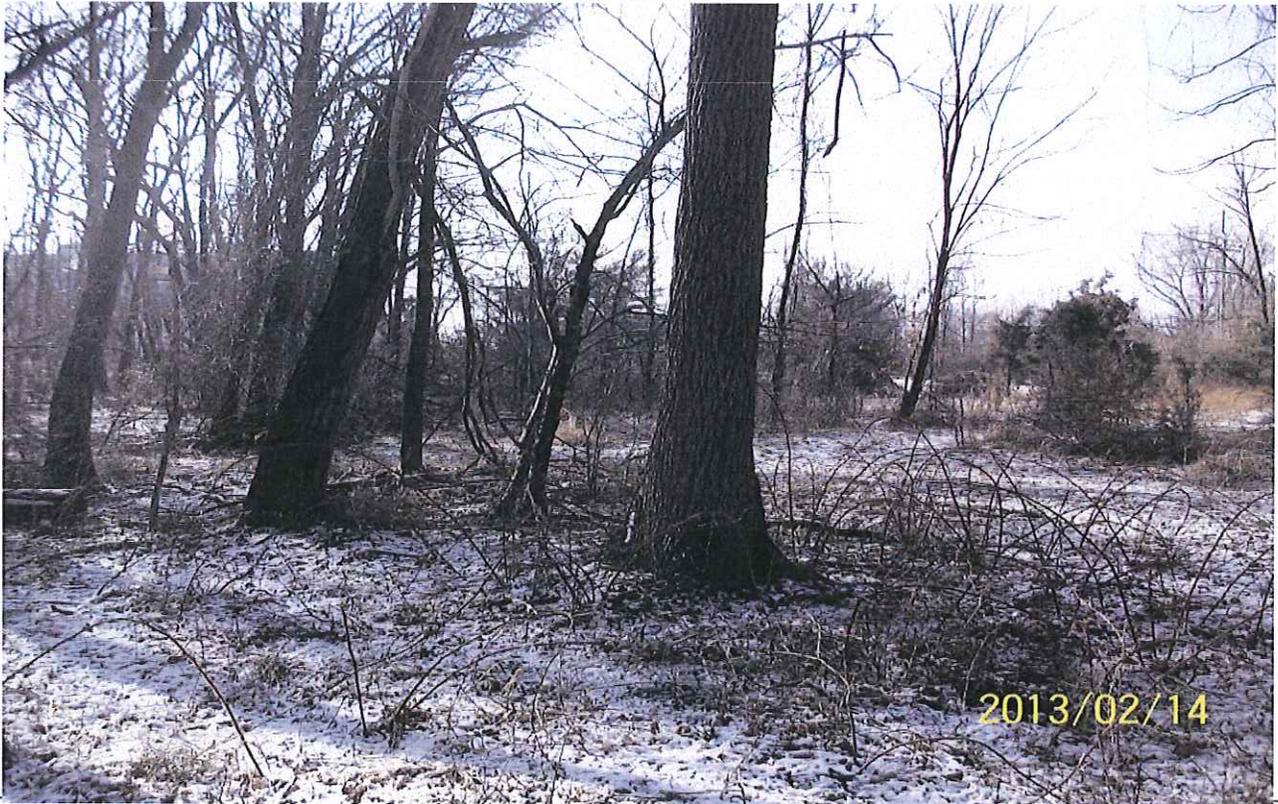
FTMM Landfill M-25

- No Hurricane Sandy damage detected to the existing ground cover or riprap embankment along the creek at the site. Reference attached photo.
