EVALUATION: BUILDING NO. 119

Historic Name: Officers Quarters / Fill Plant / Hospital

Present Name: Quarters (LC, MJ)

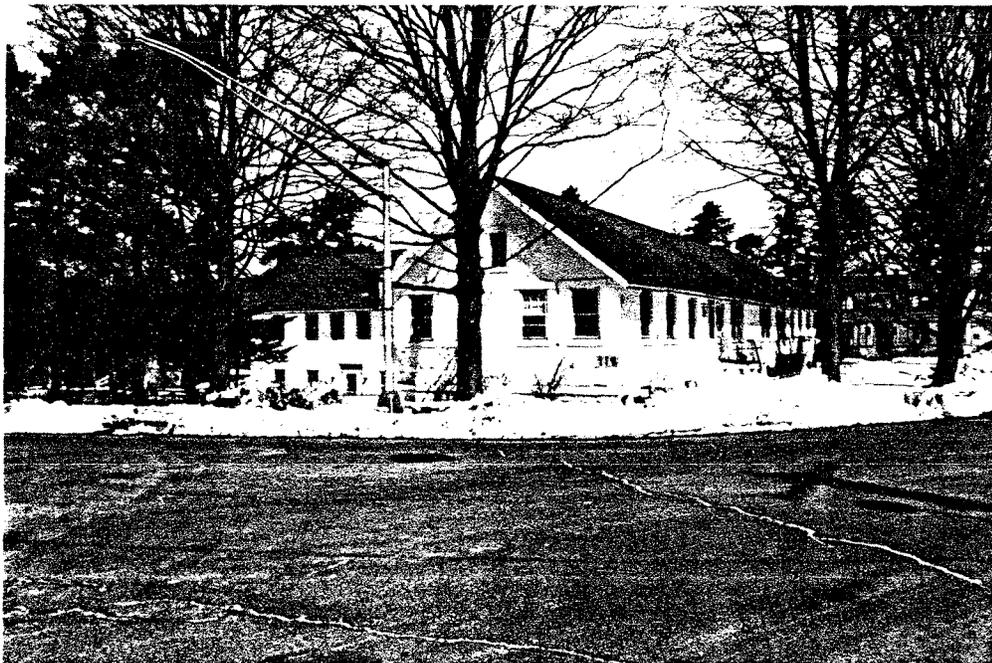
Building 119 is a large two and one half-story T-plan building built with brick bearing walls upon a stone foundation. The building has a pitched roof, clad with gray asphalt shingles, and is painted white (see HABS/HAER Inventory Form: 1982).

Building 119 retains original siting, massing, and construction, including brick exterior walls and six-over-six wood sash windows. A number of minor changes appear to have been introduced ca. 1940, including new concrete stair platforms, new concrete watertable and new garage doors at the rear. The window closest to the "119" sign in the photograph was once the front door.
